# St. Mary's County, Maryland Shoreline Situation Report Methods and Guidelines

October, 2003

## **Shoreline Situation Report - Methods and Guidelines**

Comprehensive Coastal Inventory Program, Center for Coastal Resources Management  
Virginia Institute of Marine Science

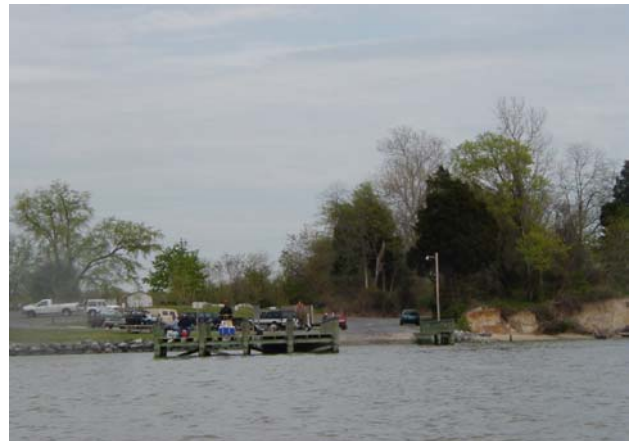
Plate 3

Location: Chaptico Bay to Manahowic Creek

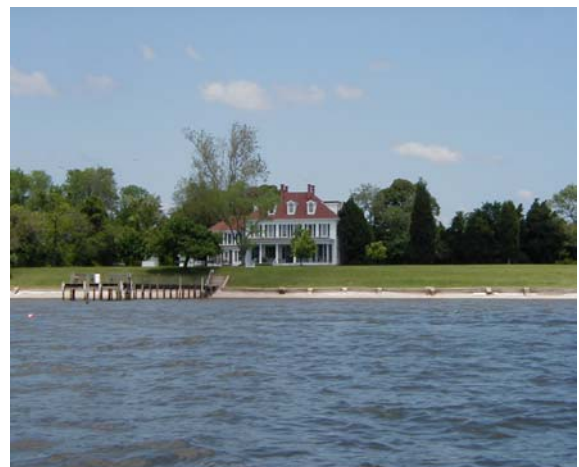
Plate 10

Location: St. Clements Shore to north of Tomakokin Creek

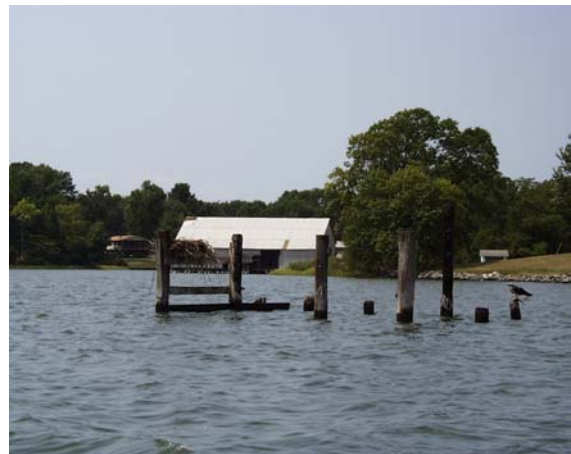
Plate 12

Location: St. Clements Shore to Newtown Neck

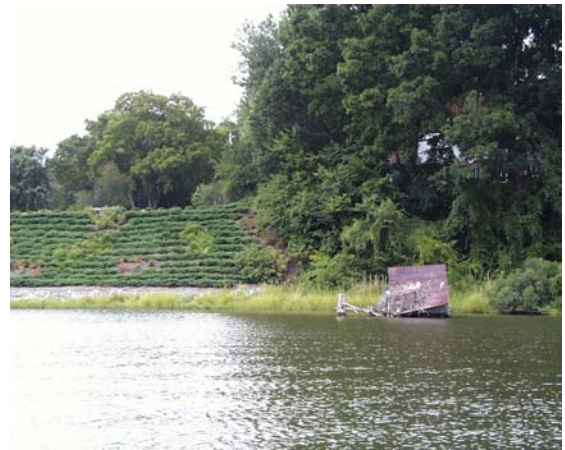
Plate 16

Location: headwaters of Breton Bay, vicinity of Leonardtown

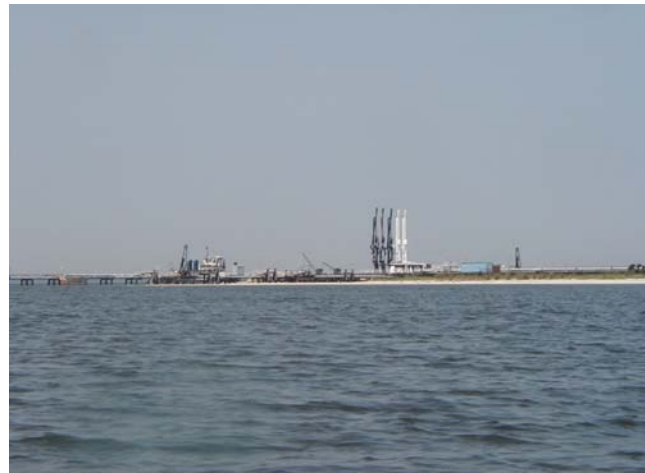
Plate 19

Location: Poplar Hill Creek to Potomac Shores

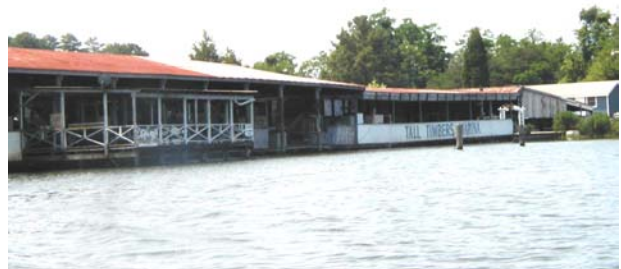
Plate 24

Location: Hodgson Point to Russell Point

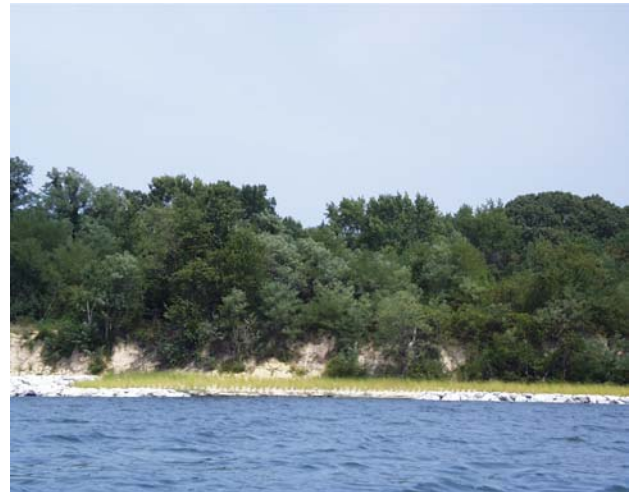
Plate 26

Location: Carthagen Creek

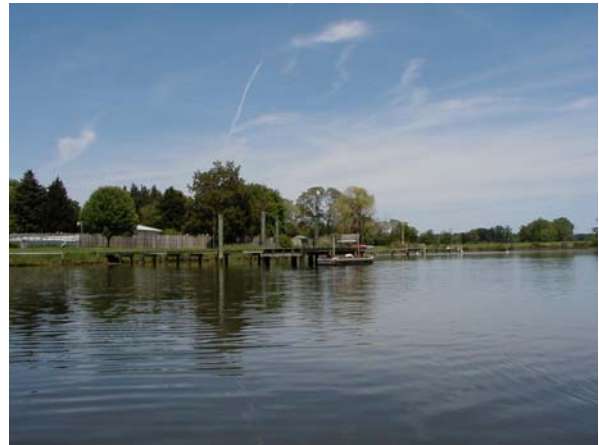
Plate 33

Location: Entrance of Smith Creek to entrance of Calvert Creek

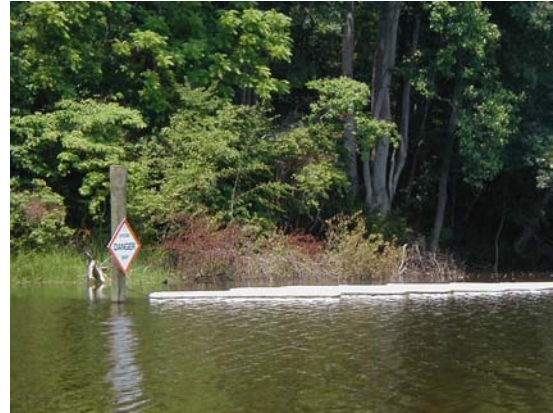
Plate 36

Location: Point Lookout

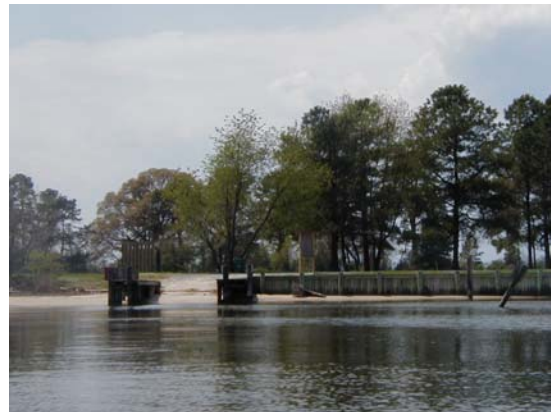
Plate 37

Location: Long Neck Creek to Fresh Pond Neck

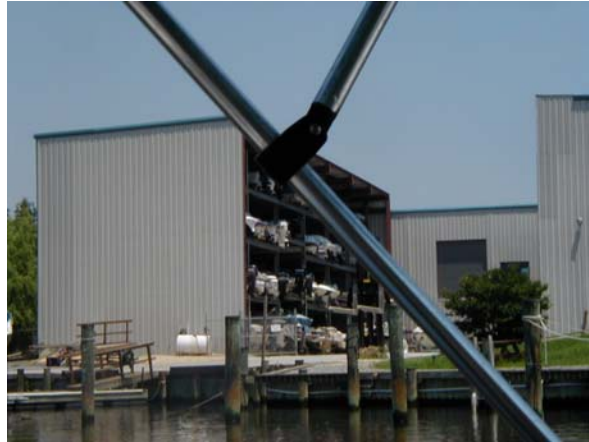
Plate 42

Location: Biscoe Pond to Page Pond

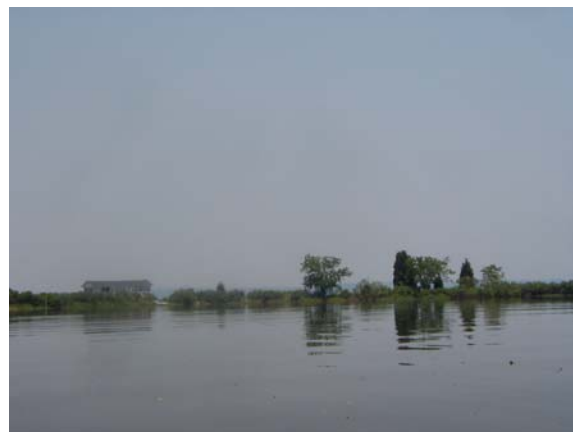
Plate 44

Location: Pine Hill Run to Goose Creek

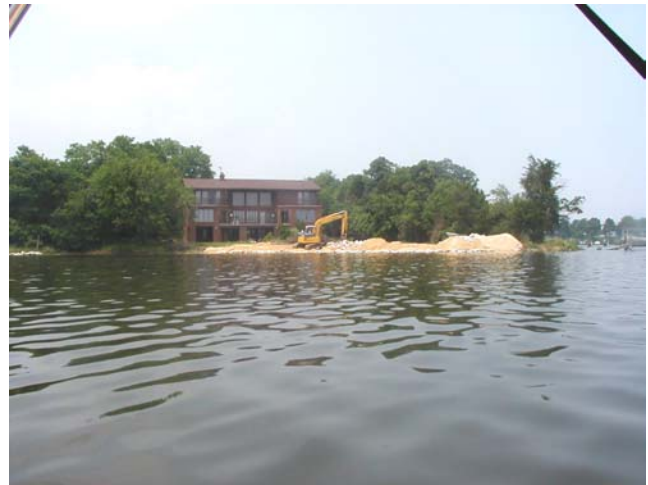
Plate 53

Location: Queen Tree Landing to Marsh Point
