# Shoreline Situation Report GLOUCESTER COUNTY, VIRGINIA

Chesapeake Research Consortium Report Number 17

Special Report In Applied Marine Science and Ocean Engineering Number 83 of the

VIRGINIA INSTITUTE OF MARINE SCIENCE  
Gloucester Point, Virginia 23062

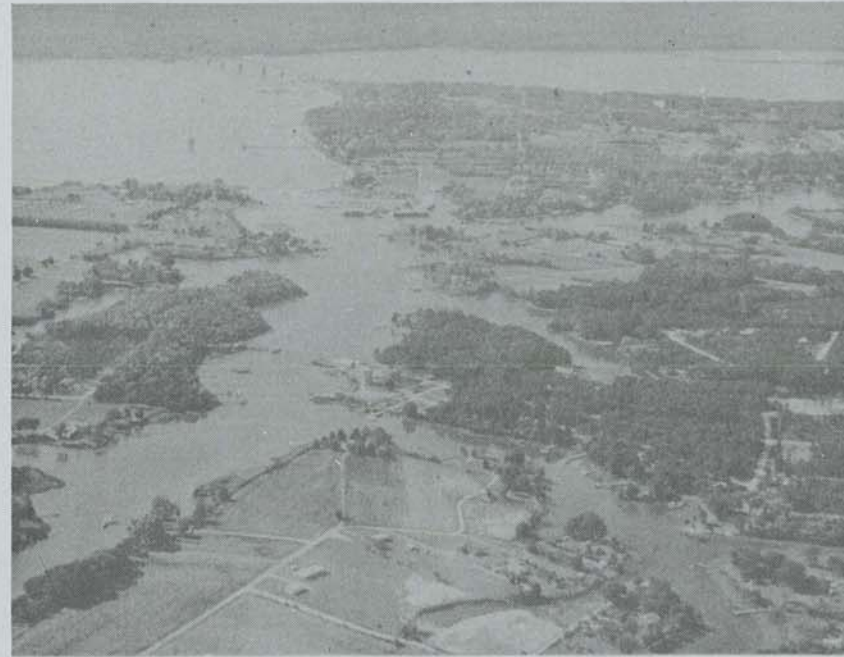
FIGURE 4

FIGURE 4: Commercial and residential pollutants have closed Sarah Creek to shellfishing. Planning should be instituted to prevent the degradation of water quality in this and other creeks.

Erosion is but one of several problems which face the users of Gloucester County's shoreline. An ever increasing problem is the deterioration of the water quality. Increasing residential and commercial development and the lack of adequate sewage treatment facilities have led to several closures of shellfish grounds (Figure 4, Map 1E). Related actions such as over-fertilization of

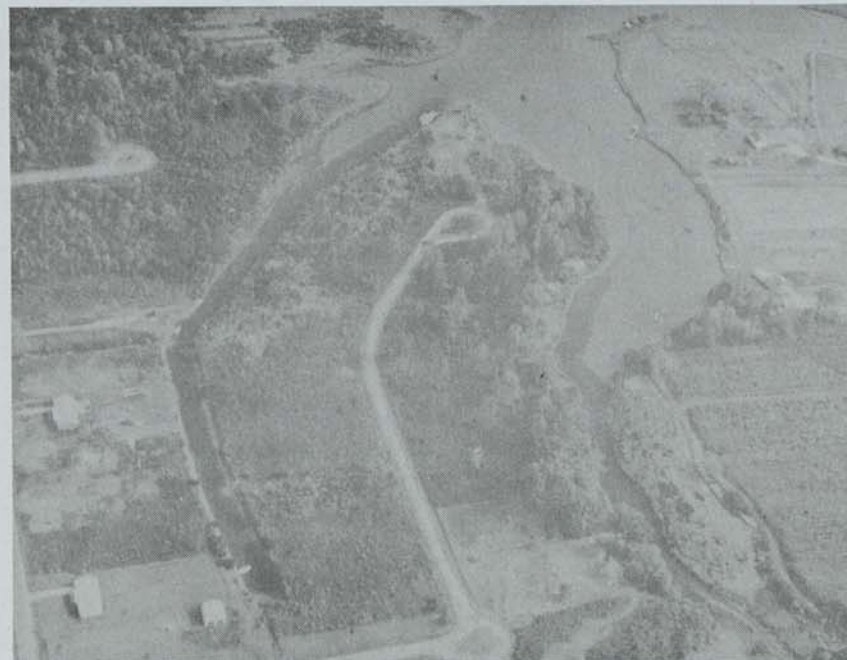
FIGURE 5

FIGURE 5: Dredged dead end canals like these on the Severn River are generally discouraged. The canals have not caused an increase in boat use because extensive flats are located between them and the river channel. Dead end canals can also produce biological deserts on their bottoms. This is a result of lack of circulation in the lower water layers.

lawns and over use of pesticides also contribute to the degradation of the water quality. Localized reduction in water quality is typified by actions such as those illustrated in Figure 5. This type of dredging creates an unproductive bottom due to the lack of circulation within the lower sections of the canal.

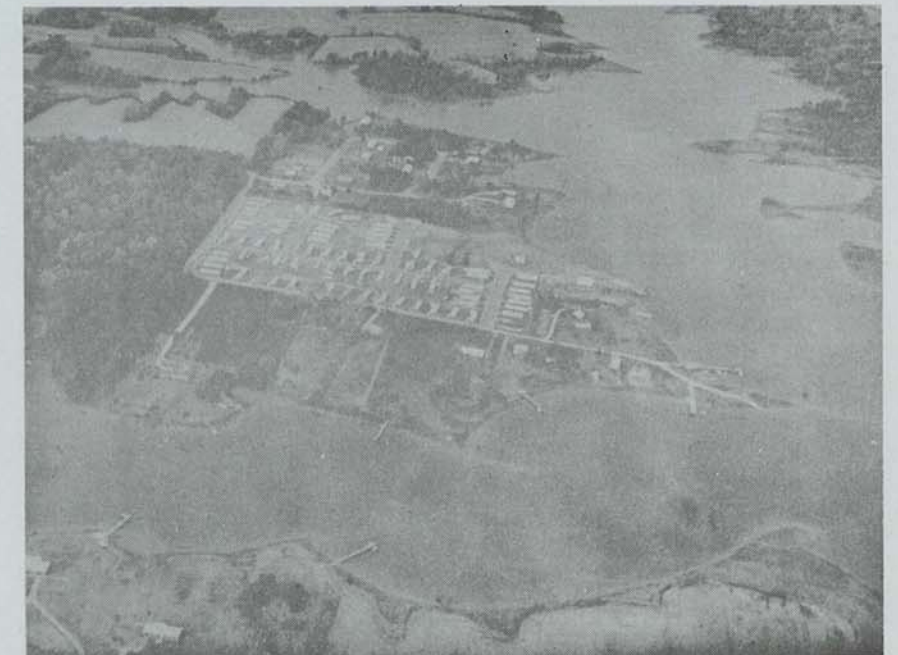
FIGURE 6

FIGURE 6: Intensive developments such as this can lead to a degradation of the water quality. Septic fields are only marginally effective and are easily flooded. The flood hazard is high for most of Gloucester's shoreline.

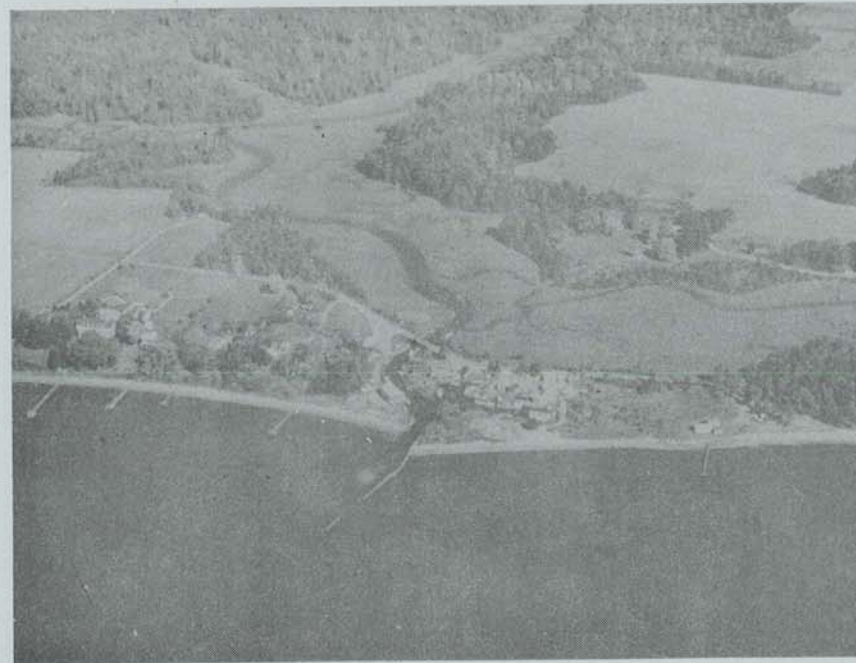
FIGURE 7

FIGURE 7: The Fox Creek area has the potential of being a good shore oriented public recreational facility. An area such as this could be developed publicly or privately to meet the county's growing recreational demand.

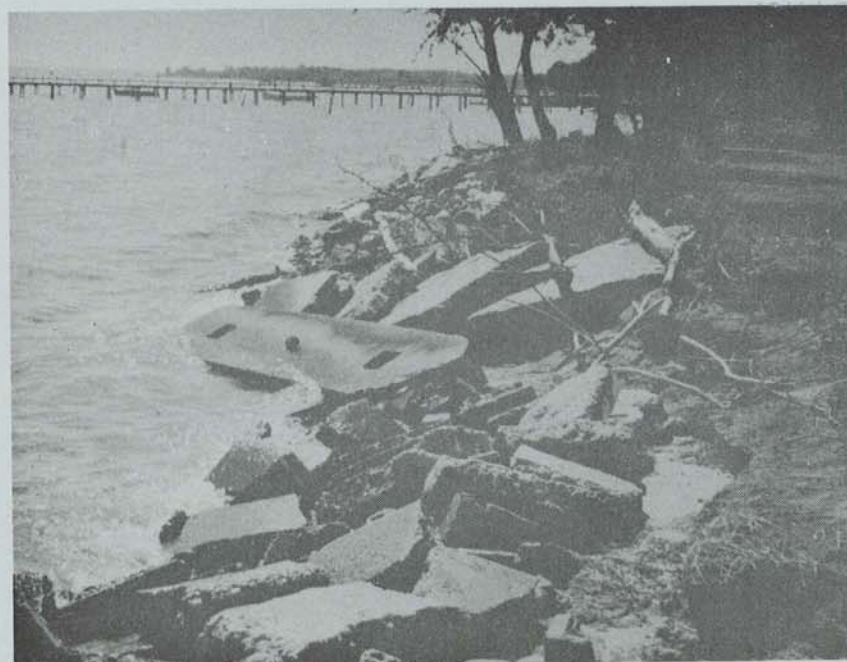
FIGURE 9

FIGURE 9: When used properly, riprap revetments can be very effective at slowing erosion. Proper application includes the use of filter cloth and adequate size stone. The stones should be placed rather than dumped on the shoreline.
