# Shoreline Situation Report CITY OF HAMPTON, VIRGINIA

Chesapeake Research Consortium Report Number 11

# Shoreline Situation Report

## CITY OF HAMPTON, VIRGINIA

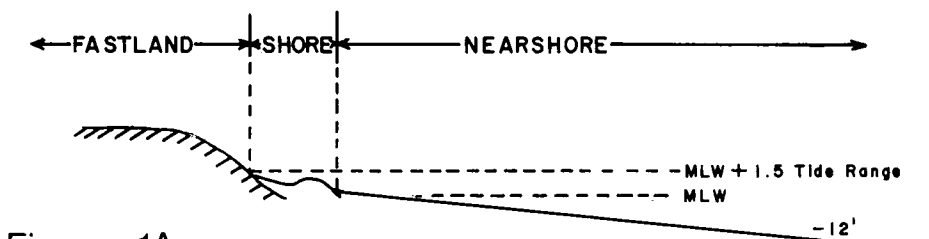
Figure 1A

An illustration of the definition of the three components of the shorelands.

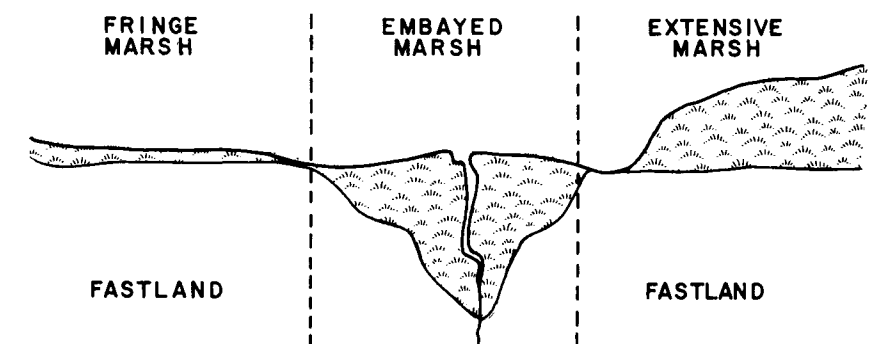
Figure 1B

A generalized illustration of the three different marsh types.

The physiographic character of the marshes has also been separated into three types (see Figure 1B). Fringe marsh is that which is less than 400 feet in width and which runs in a band parallel to the shore. Extensive marsh is that which has extensive acreage projecting into an estuary or river. An embayed marsh is a marsh which occupies a reentrant or drowned creek valley. The purpose in delineating these marsh types is that the effectiveness of the various functions of the marsh will, in part, be determined by type of exposure to the estuarine system. A fringe marsh

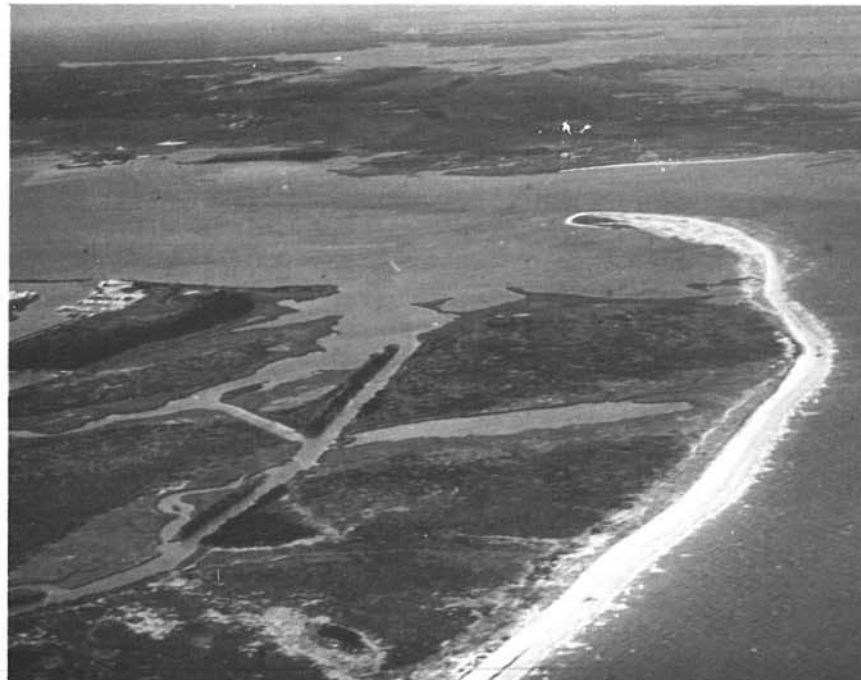
Figure 2

Figure 2: Northend Point and the Back River from near Grand View. The dune area is the site of an experimental grass planting. Most of the marsh is city owned.

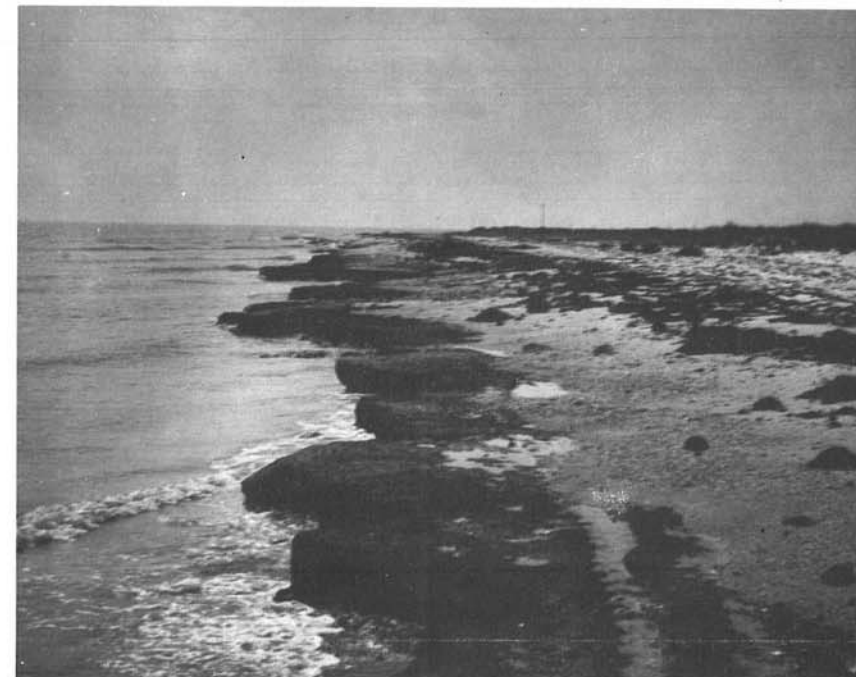
Figure 5

Figure 5: The beach north of Grand View. As the beach retreats over the marsh, peat blocks erode out of the thin beach face.

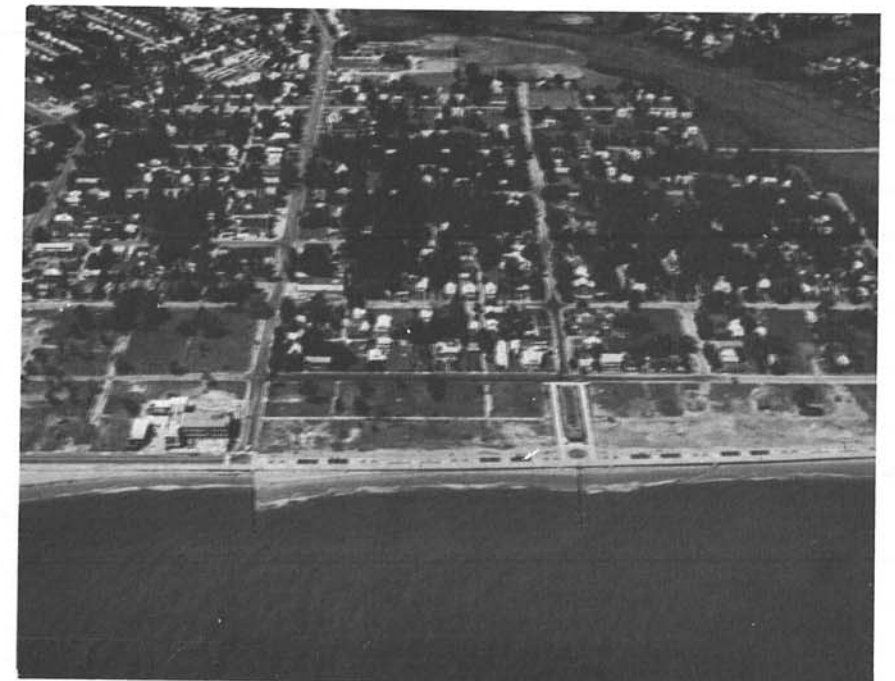
Figure 6

Figure 6: Seawall north of Buckroe. The groins are approximately 200 feet long and 600 feet apart.

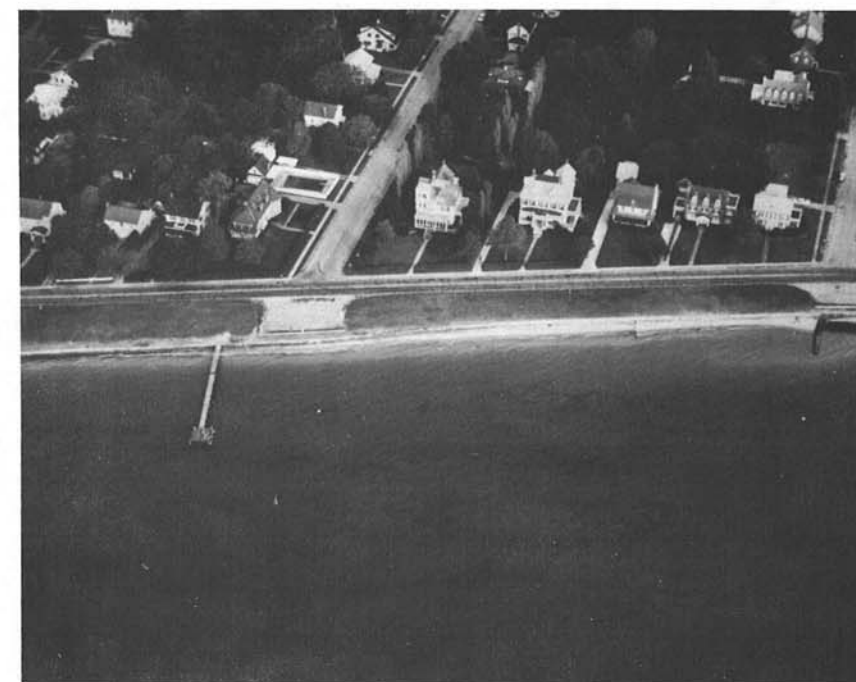
Figure 8

Figure 8: The Wythe area of Hampton on Hampton Roads. Most of the shoreline of this segment has been bulk-headed to the detriment of the beach. A better beach might be established through a program of artificial nourishment.

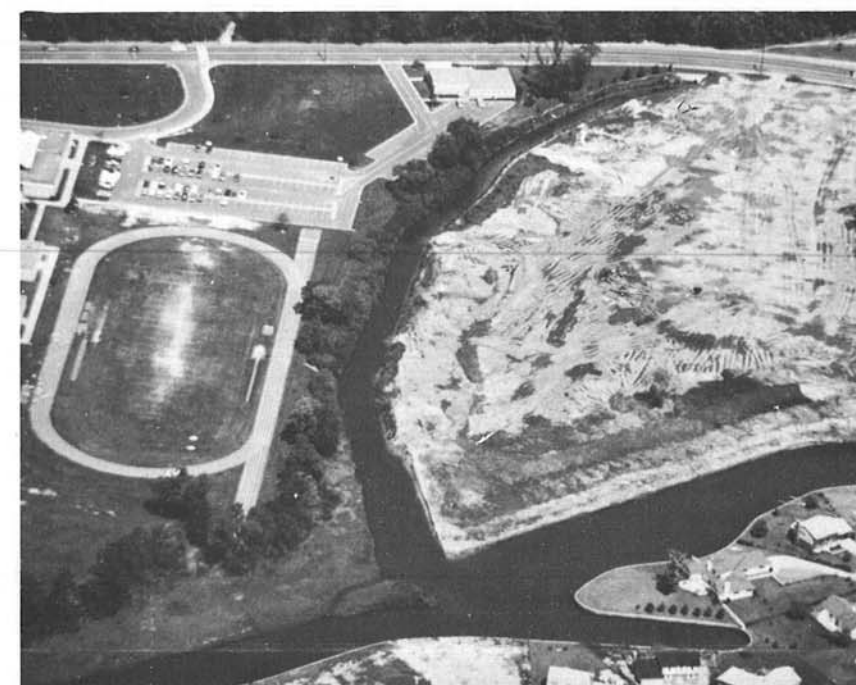
Figure 10

Figure 10: Hampton Creek near Syms Junior High School. The area is an example of dredge and fill canals dug into existing small creeks and upland areas to produce waterfront property.
