# Shoreline Situation Report ISLE OF WIGHT COUNTY, VIRGINIA

Chesapeake Research Consortium Report Number 46

Special Report In Applied Marine Science and Ocean Engineering Number 97 of the

## ISLE OF WIGHT COUNTY, VIRGINIA

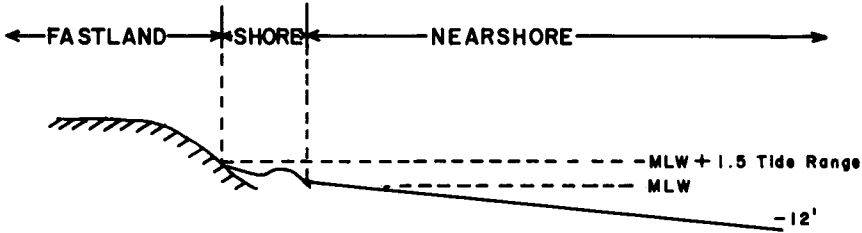
Figure 1 An illustration of the definition of the three components of the shorelands.

For each subsegment there are two length measurements, the shore-nearshore interface or shoreline, and the fastland-shore interface. The two interface lengths differ most when the shore zone is embayed or extensive marsh. On the subsegment maps, a dotted line represents the fastland-shore interface when it differs from the shoreline. The fastland-shore interface length is the base for the fastland statistics.

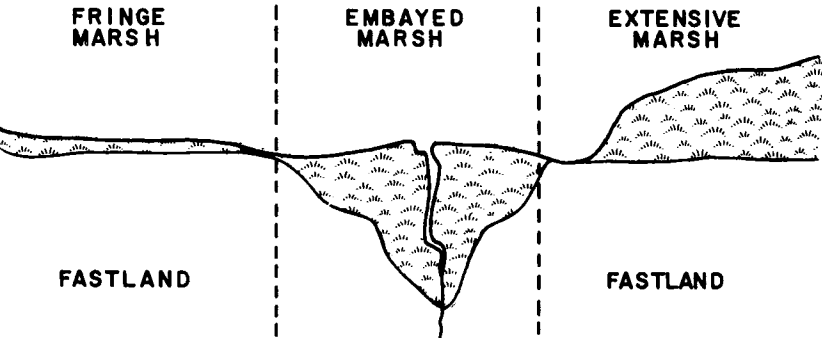
Figure 2 A generalized illustration of the three different marsh types.

The physiographic character of the marshes has also been separated into three types (see Figure 2). Fringe marsh is that which is less than 400 feet in width and which runs in a band parallel to the

shore. Extensive marsh is that which has extensive acreage projecting into an estuary or river. An embayed marsh is a marsh which occupies a reentrant or drowned creek valley. The purpose in delineating these marsh types is that the effectiveness of the various functions of the marsh will, in part, be determined by type of exposure to the estuarine system. A fringe marsh may, for example, have maximum value as a buffer to wave erosion of the fastland. An extensive marsh, on the other hand, is likely a more efficient transporter of detritus and other food chain materials due to its greater drainage density than an embayed marsh. The central point is that planners, in the light of ongoing and future research, will desire to weight various functions of marshes and the physiographic delineation aids their decision making by denoting where the various types exist.

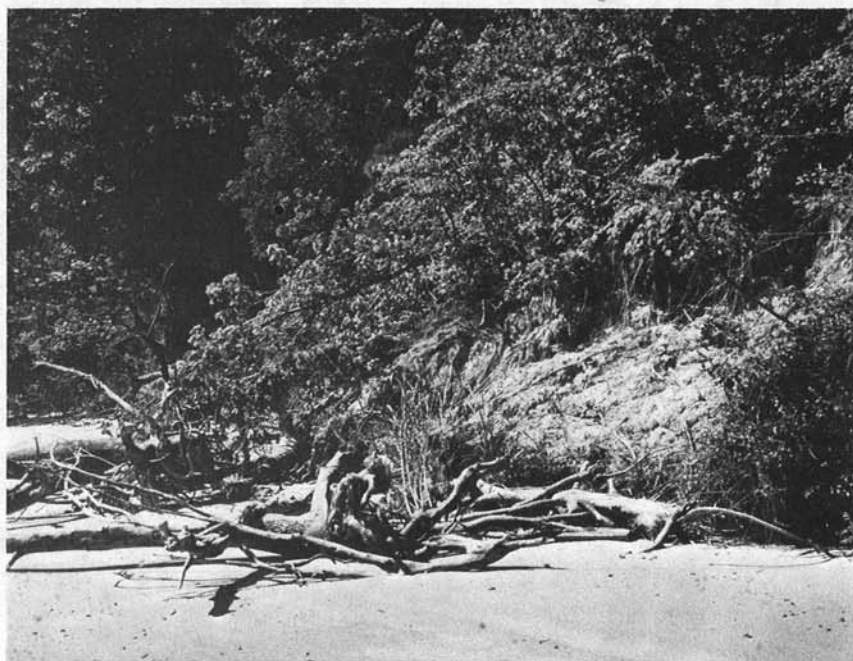
FIGURE 3

Figure 3: Eroding bluffs at Lawnes Neck. The falling trees uproot large amounts of soil, further adding to the erosion problem.

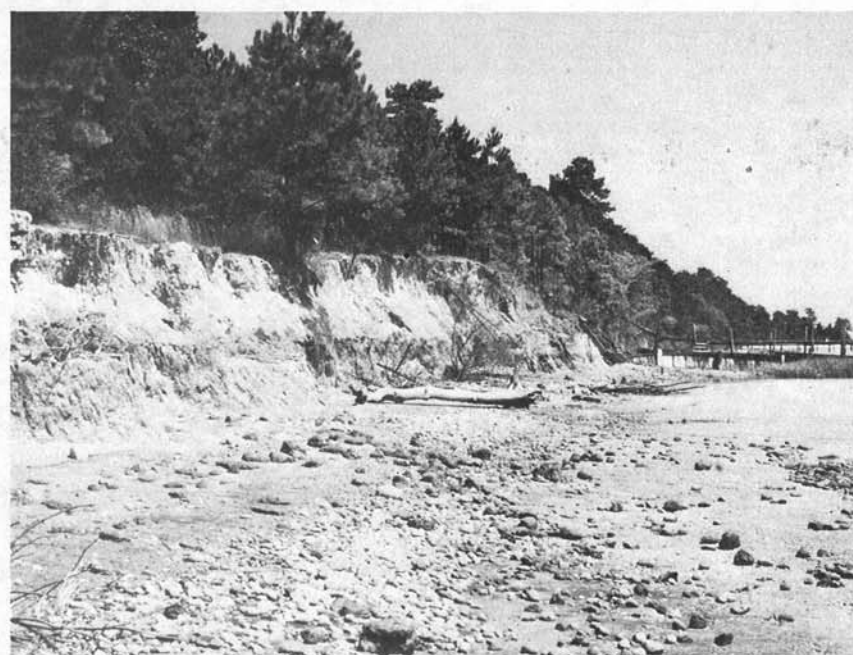
FIGURE 6

Figure 6: Eroding bluffs just north of previous photo. The beach and lower half of the bluffs are mostly clay and are not suitable for most recreational activities. When the Reserve Fleet extended south this far, the area was mostly stable. Without that offshore protection, erosion is again a problem.

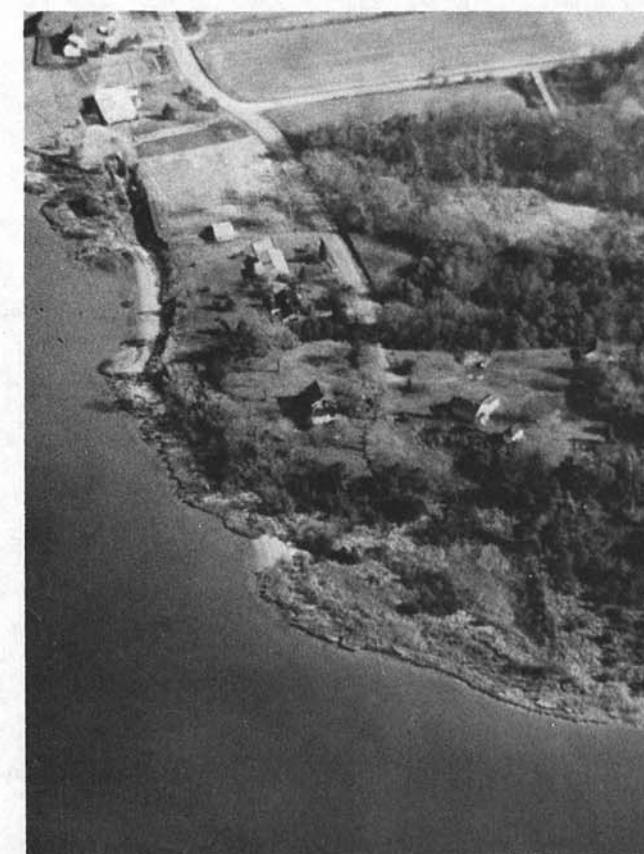
FIGURE 7

Figure 7: An aerial view of Goodwin Point. Parts of the shoreline have been bulkheaded, but unprotected stretches are very vulnerable to wind and wave attacks.

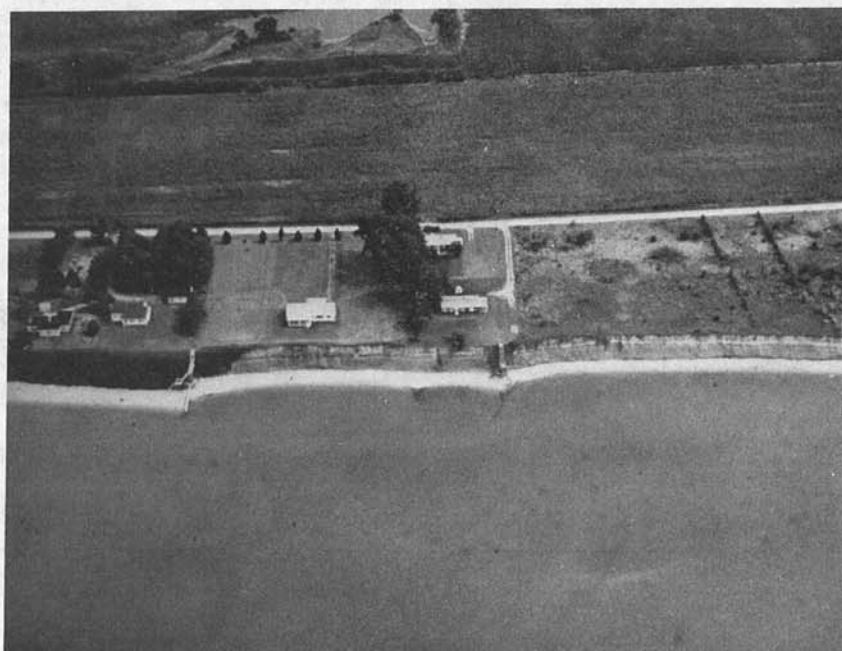
FIGURE 8

Figure 8: Aerial view of Mogarts Beach. This area had an erosion rate of 3.8 feet per year until the Reserve Fleet was anchored to the north. Although erosion is still a problem in some areas, it is not as severe.

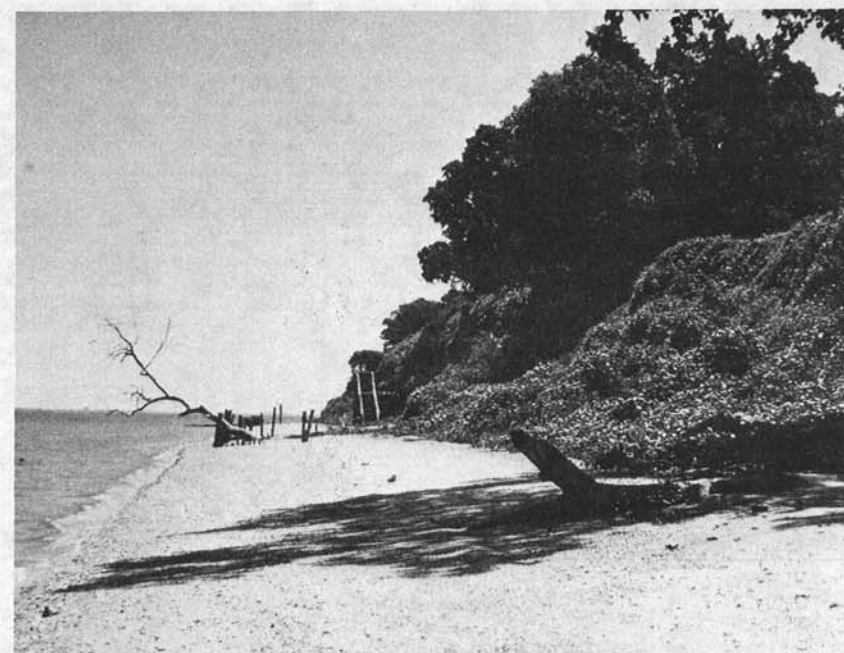
FIGURE 9

effectively cut off the long fetch to the north-northwest, protecting the shoreline from severe storm effects. Along Mogarts Beach, the once eroding 30-foot high bluffs are now covered with vegetation (Figure 9). However, this condition of stability probably will be short lived, for the Reserve Fleet is being constantly diminished in numbers. This was the case at Rushmere Shores. When the Fleet was offshore, the area stabilized and a beach developed. Since the Fleet has been moved from offshore, the area has again been suffering from erosion (Figure 6). When the Reserve Fleet is no longer interrupting the long north-west fetch to Mogarts Beach, the area will once again suffer from the effects of the severe north-western storms.

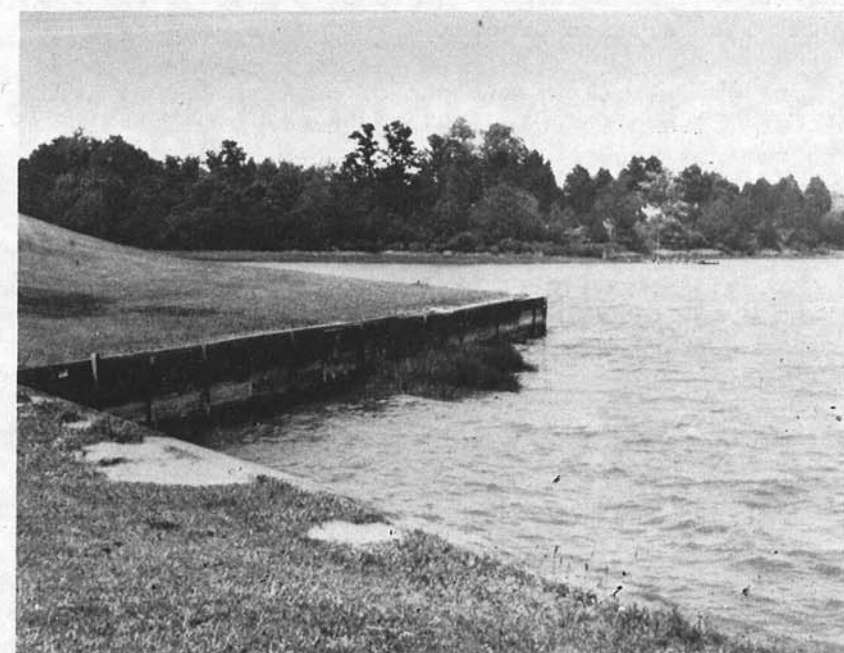
FIGURE 11

Figure 11: Wooden bulkhead near the mouth of Brewers Creek. The structure is in very good shape and is retaining fill in front of several residences.

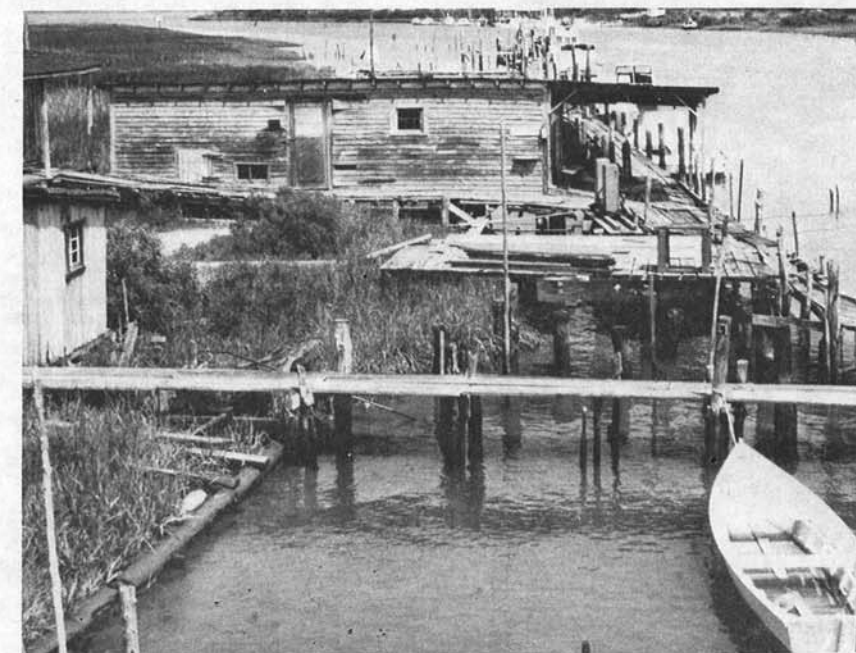
FIGURE 12

Figure 12: View at bridge along Jones Creek. The logs lying in front of the marsh act as a buffer against boat wake erosion in this low intensity area. A marina is directly across the creek.

Along the creeks, where boat wakes are the major erosion cause, some type of protection in front of affected marsh areas may be necessary. In one place, logs have been staked in front of the marsh to cut down on the wave energy reaching the grasses. Such devices can sometimes achieve the desired effect in low intensity areas. Speed limits for boats traveling in the creeks should be enforced.
