# Shoreline Situation Report KING GEORGE AND CAROLINE COUNTIES

Special Report In Applied Marine Science and Ocean Engineering Number 165 of the

VIRGINIA INSTITUTE OF MARINE SCIENCE

1979

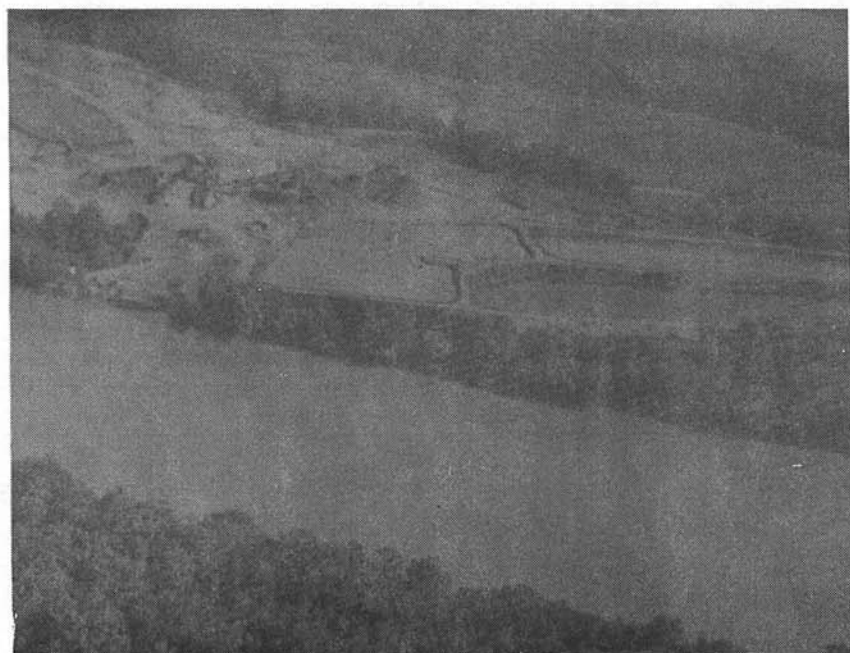
FIGURE 4

FIGURE 4: Gravel pit near Lambs Creek, Subsegment KG-1C. This is one of the few industrial sites along the Rappahannock River in King George County.

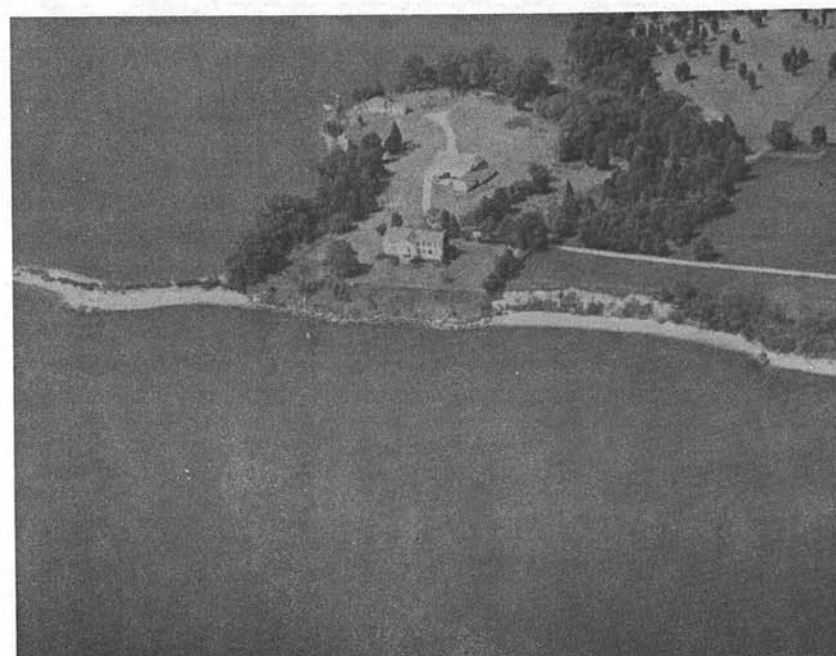
FIGURE 5

FIGURE 5: King George Point, Segment KG-2. The bluff area in front of the house has riprap protecting the toe. Erosion is continuing along the bluff area to the right of the riprap.

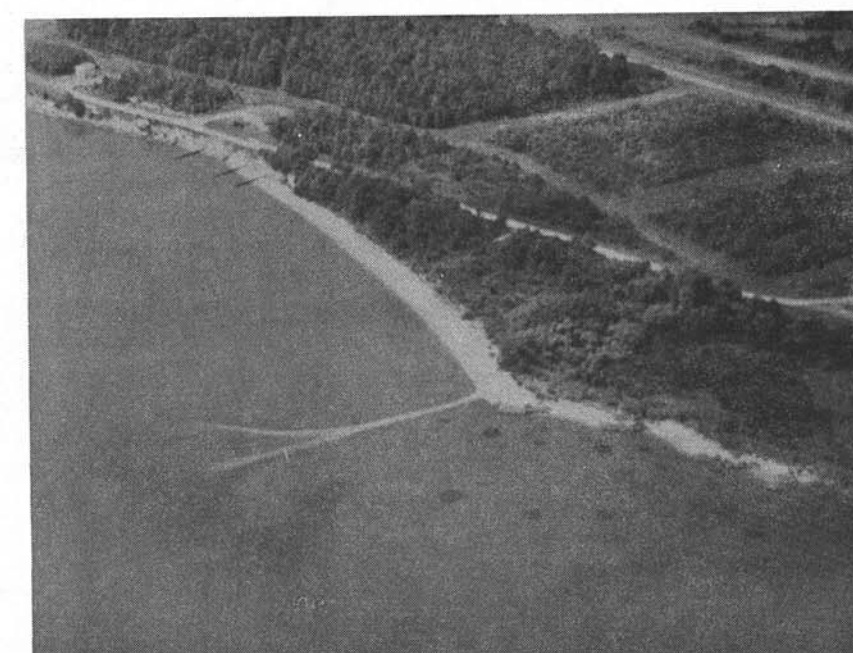
FIGURE 7

FIGURE 7: Near the mouth of Upper Machodoc Creek, Segment KG-3. This area is part of the Dahlgren Weapons Laboratory. The sand spit in this photo has probably formed due to a submerged obstruction, such as an out-fall pipe.

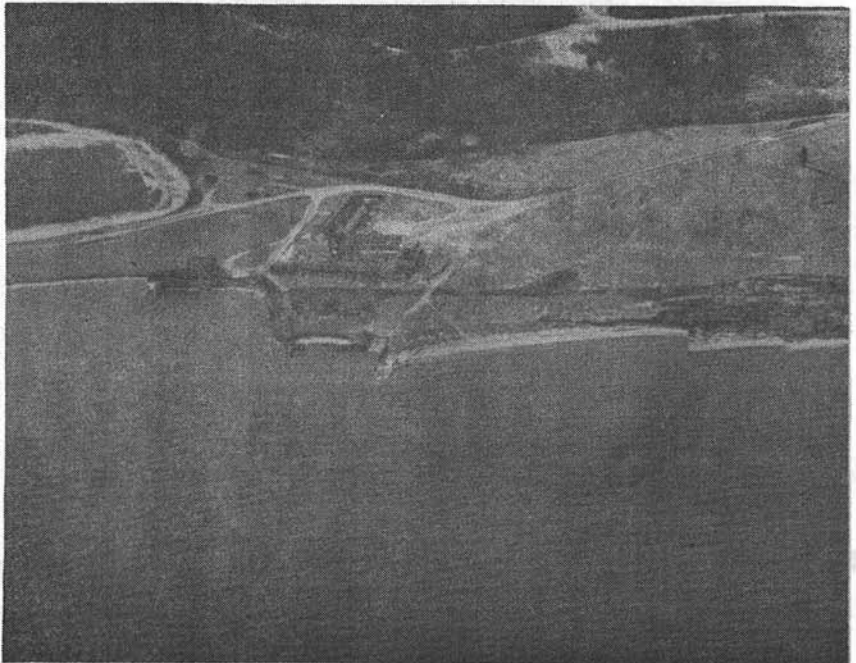
FIGURE 10

FIGURE 10: Belvedere Beach, Segment KG-6. This facility appears to be abandoned. Notice the erosion behind the failed bulkhead directly in front of the large building.

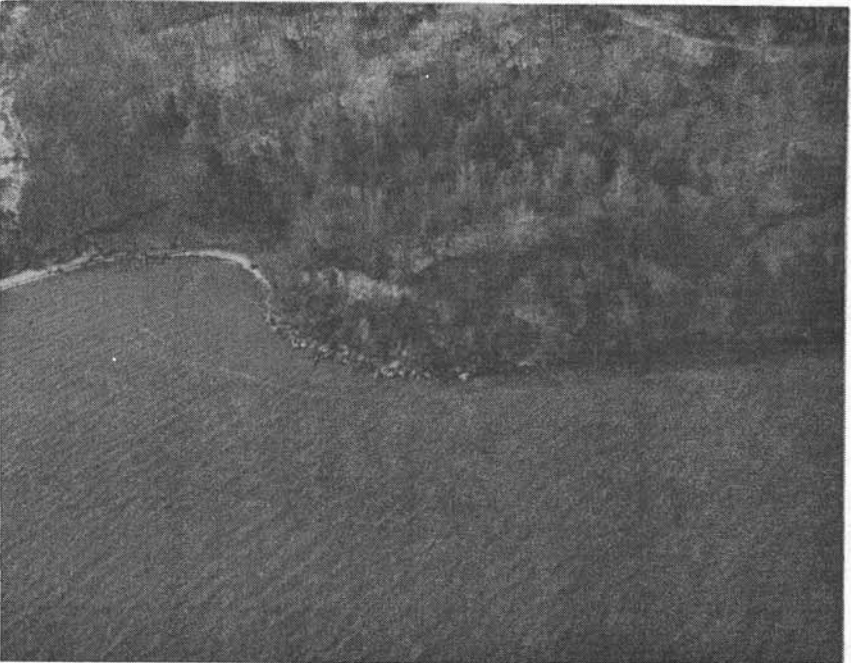
FIGURE 11

FIGURE 11: Bull Bluff, Segment KG-6. This area has rubble acting as riprap at the base of the bluffs.

SHORE PROTECTIVE STRUCTURES: There are approximately 7,200 feet of artificially stabilized shoreline in the segment, of which 2,400 feet are bulkhead and the rest riprap. The 4,800 feet of riprap is found at the base of Bull Bluff. Aerial photography of the area shows stone rubble at the cliff base. However, this may be due to natural causes rather than man's efforts.

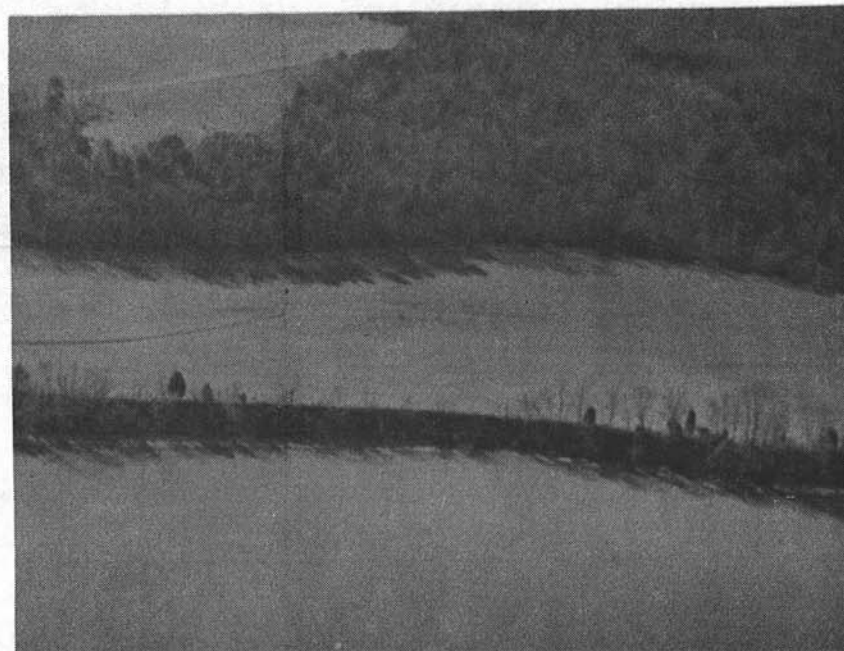
FIGURE 12

FIGURE 12: Along Portobago Bay, Subsegment CA-1A. These bluffs fronting the agricultural area are continuing to erode due to downhill rain runoff.

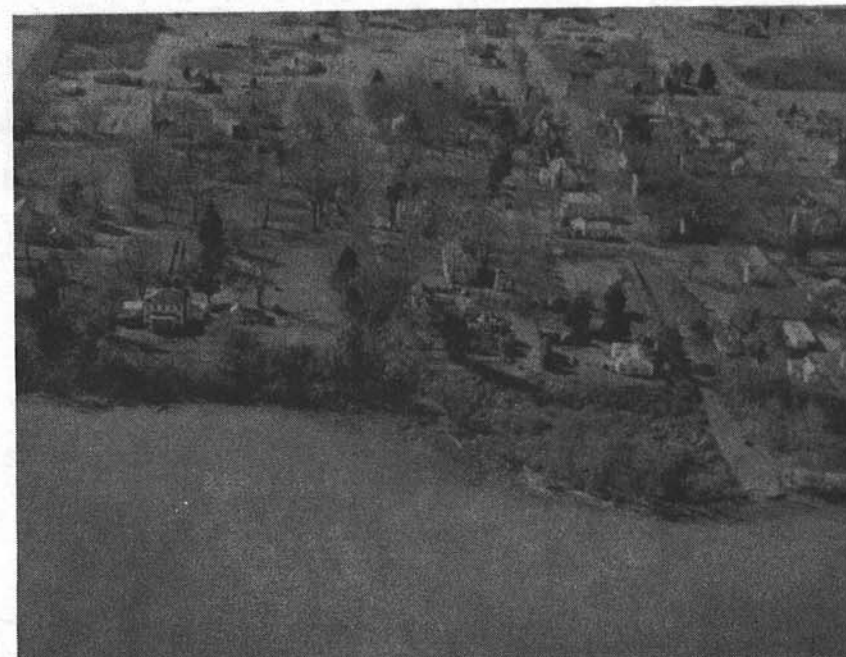
FIGURE 13

FIGURE 13: Port Royal, Subsegment CA-1A. This is the largest residential area along the Rappahannock River in Caroline County.

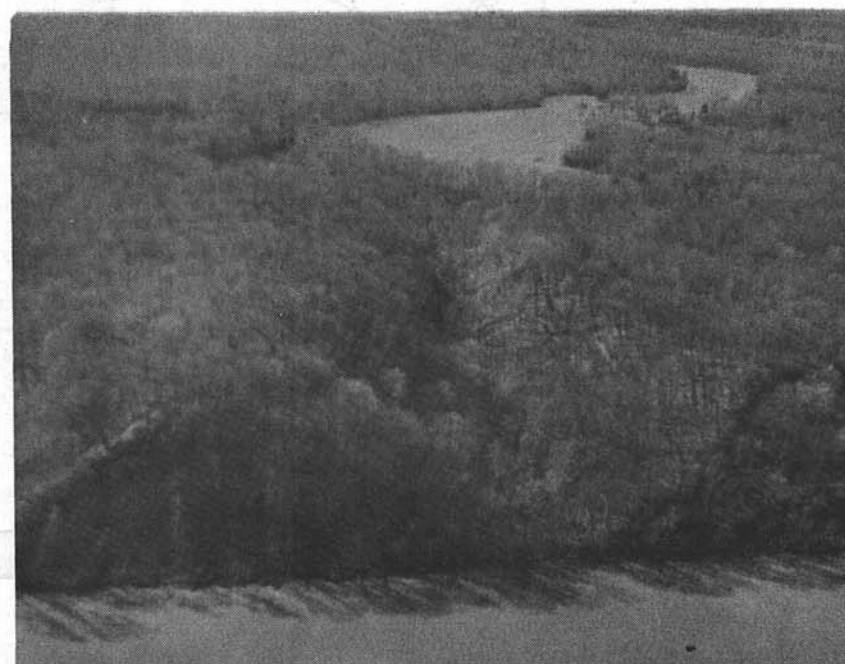
FIGURE 14

FIGURE 14: Bluffs east of Moons Mount Wharf, Subsegment CA-1B. Typical view of the high bluff areas along this section of the Rappahannock River.

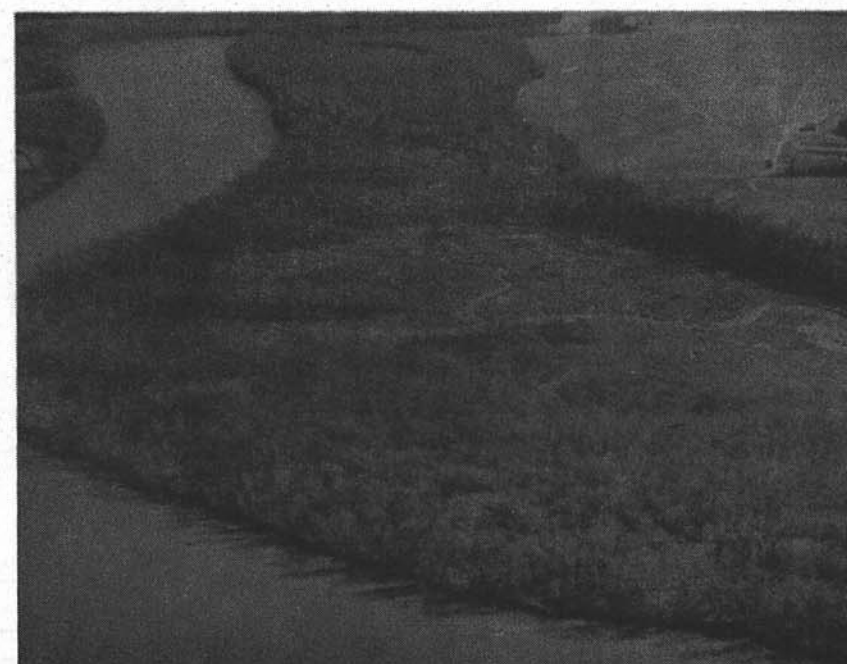
FIGURE 15

FIGURE 15: Skinkers Neck overview, Subsegment CA-1C. The marsh areas should be protected.
