# Shoreline Situation Report NORTHAMPTON COUNTY, VIRGINIA

Chesapeake Research Consortium Report Number 9

# Shoreline Situation Report

## NORTHAMPTON COUNTY, VIRGINIA

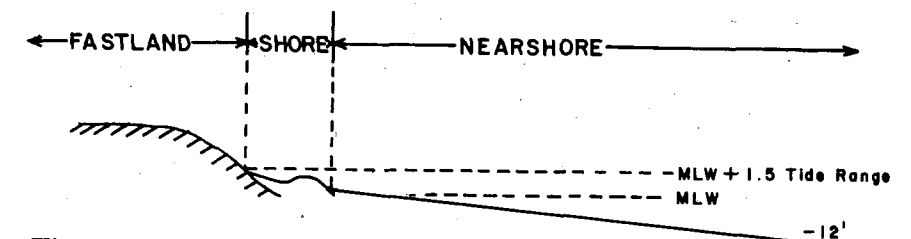
Figure 1A

An illustration of the definition of the three components of the shorelands.

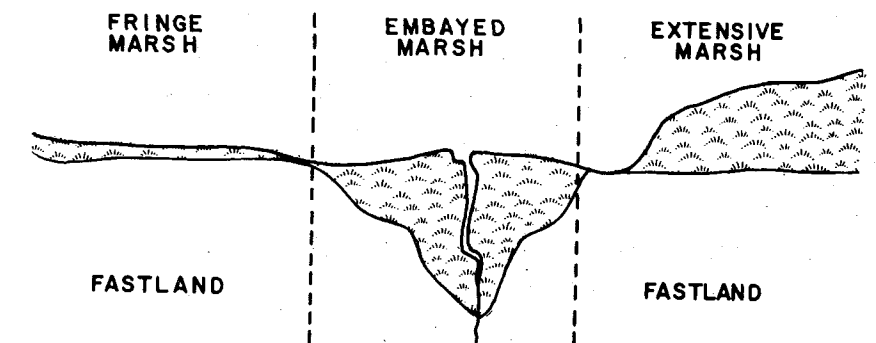
Figure 1B

A generalized illustration of the three different marsh types.

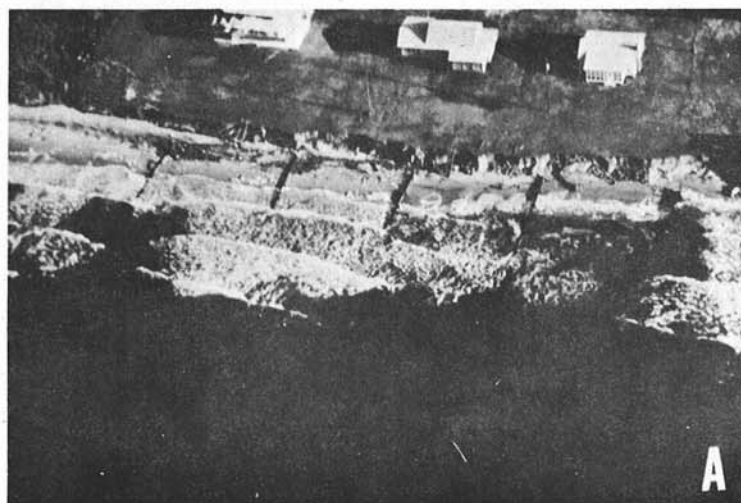
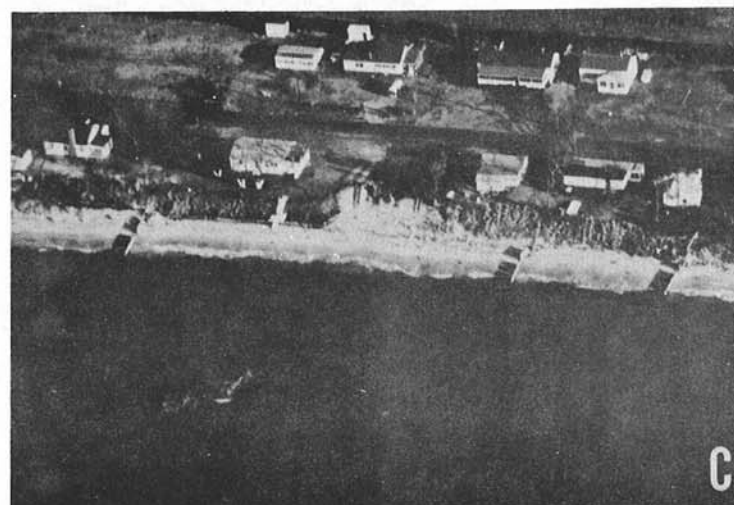
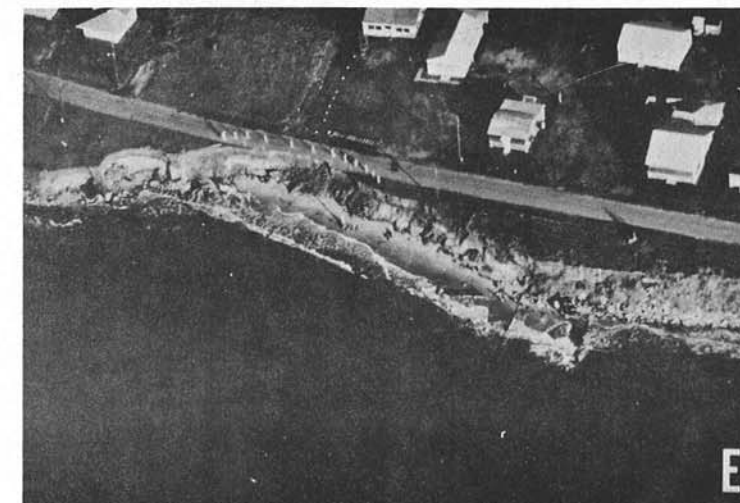
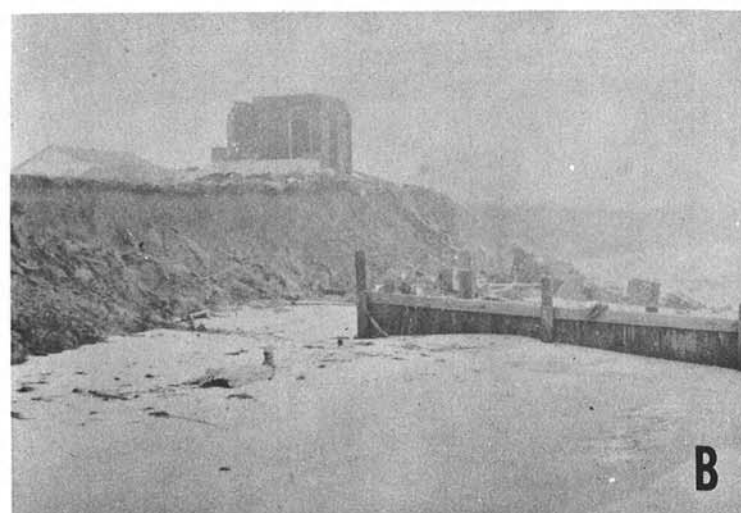
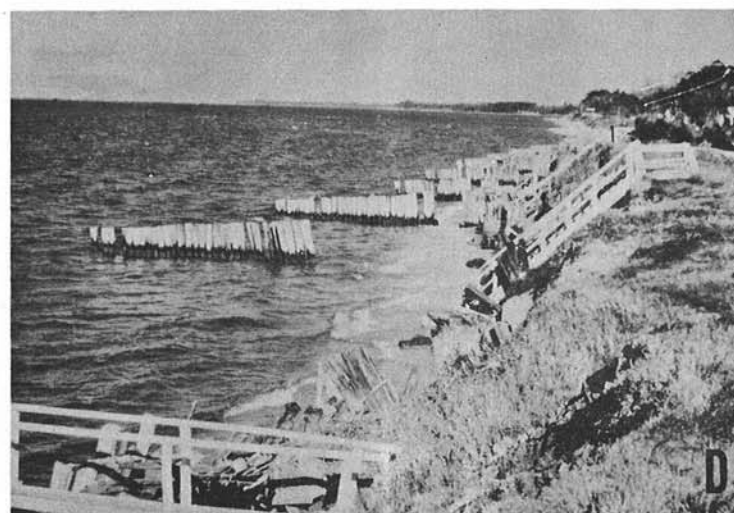
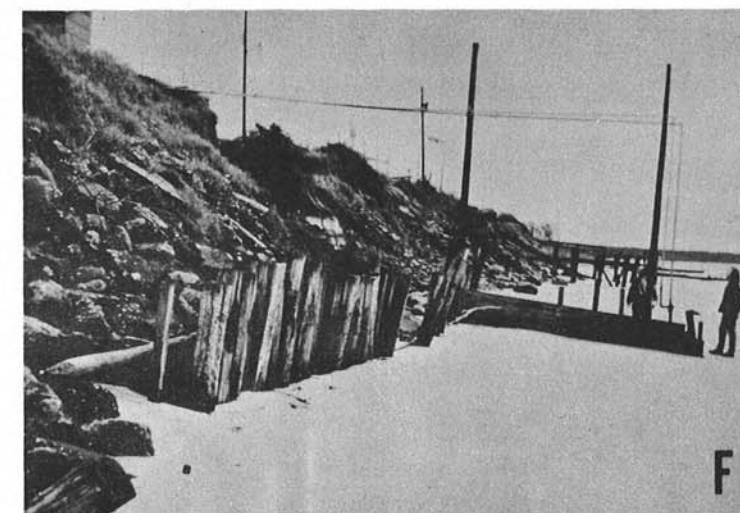
PLATE I

**A** Tankards Beach Groin System

**B** Tankards Beach May 8, 1973

- c) If possible the individual groins in a groin system should be placed in a time sequential manner with the most down-drift groin being the first installed. In those cases where groins alone are being utilized, this procedure will reduce the likelihood of flanking. Furthermore, the observed trapping characteristics will assist in the determination of the spacing between groins.

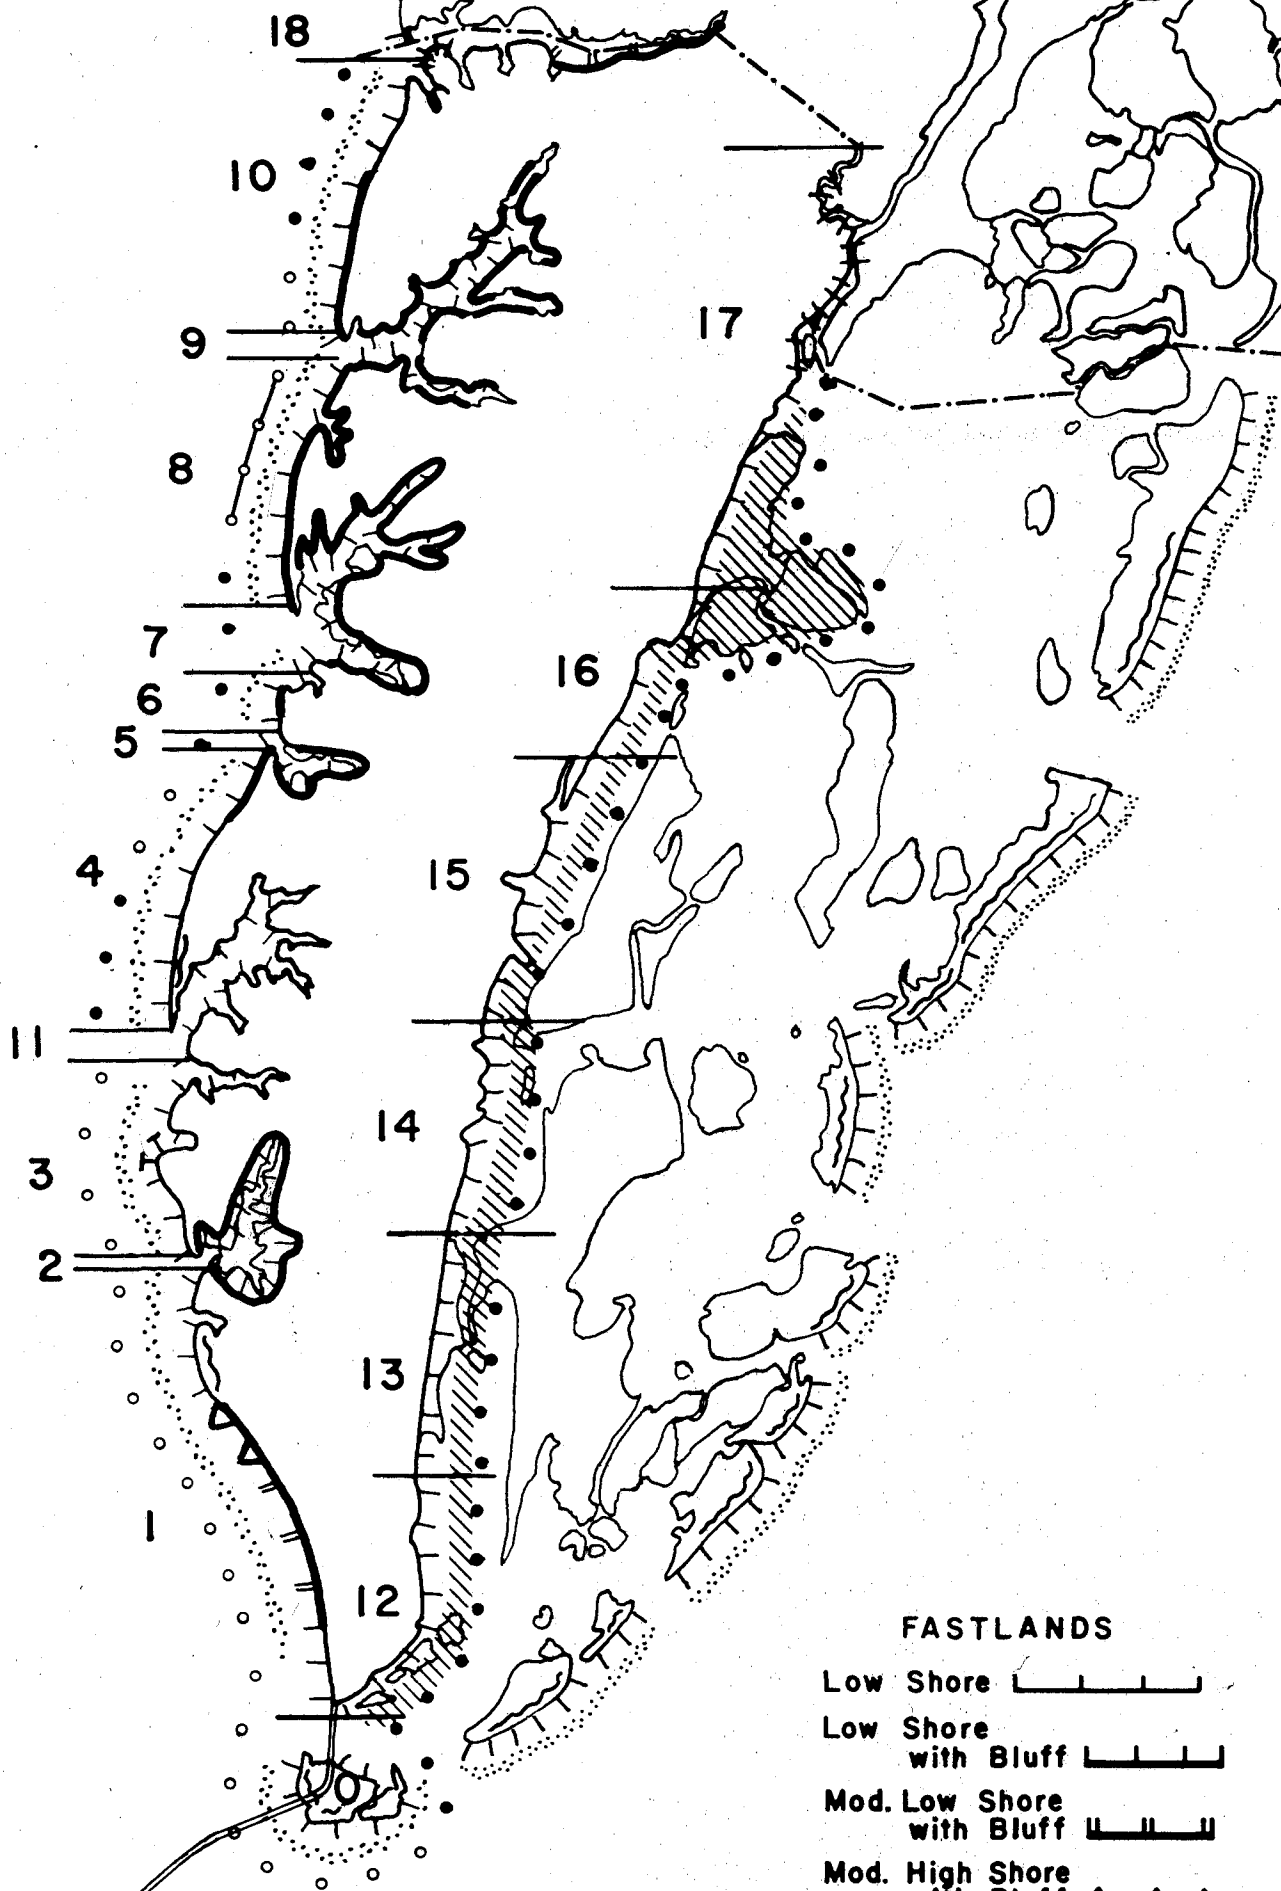
# MAP 1C NORTHAMPTON COUNTY SHORELAND USES AND OWNERSHIP

- Private = 1
- Federal = 2
- State = 3

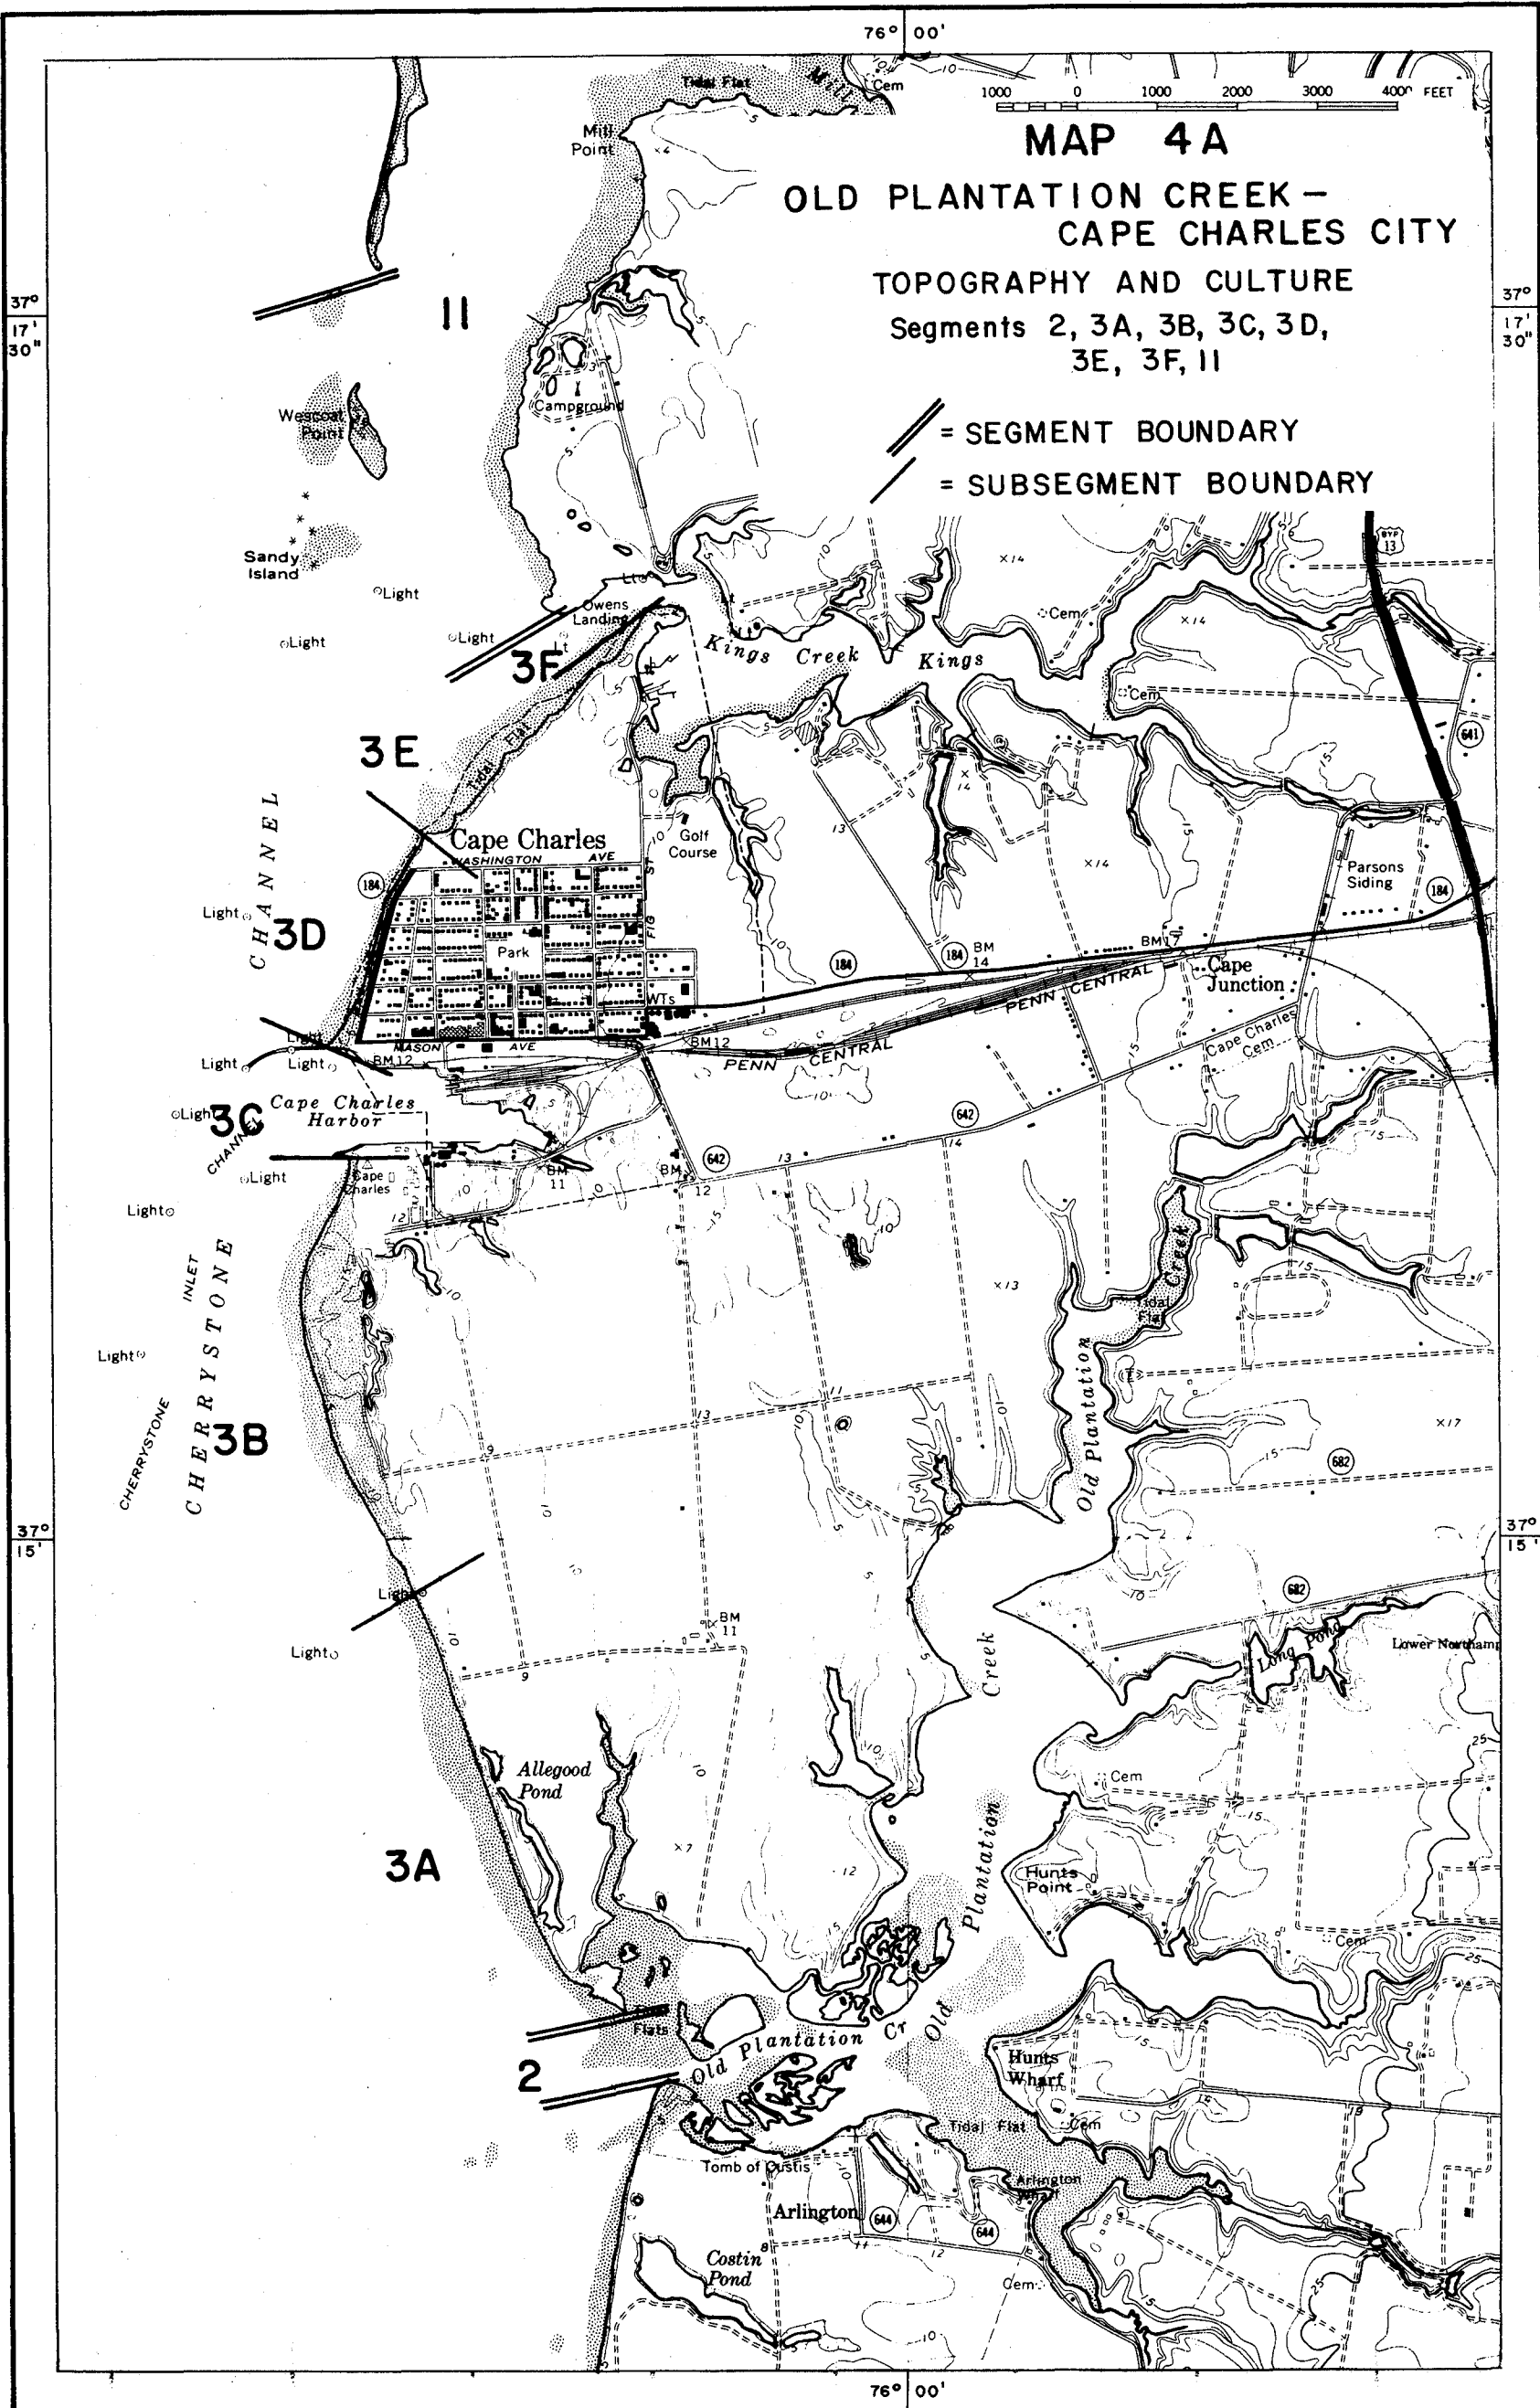
# MAP 4B OLD PLANTATION CREEK - CAPE CHARLES CITY

SHORELANDS TYPES  
Segments 2, 3A, 3B, 3C, 3D,  
3E, 3F, II

**SHORE**  
Beach  
Fringe Marsh  
Embayed Marsh  
Artificially  
Stabilized

**NEARSHORE**  
Narrow  
Intermediate

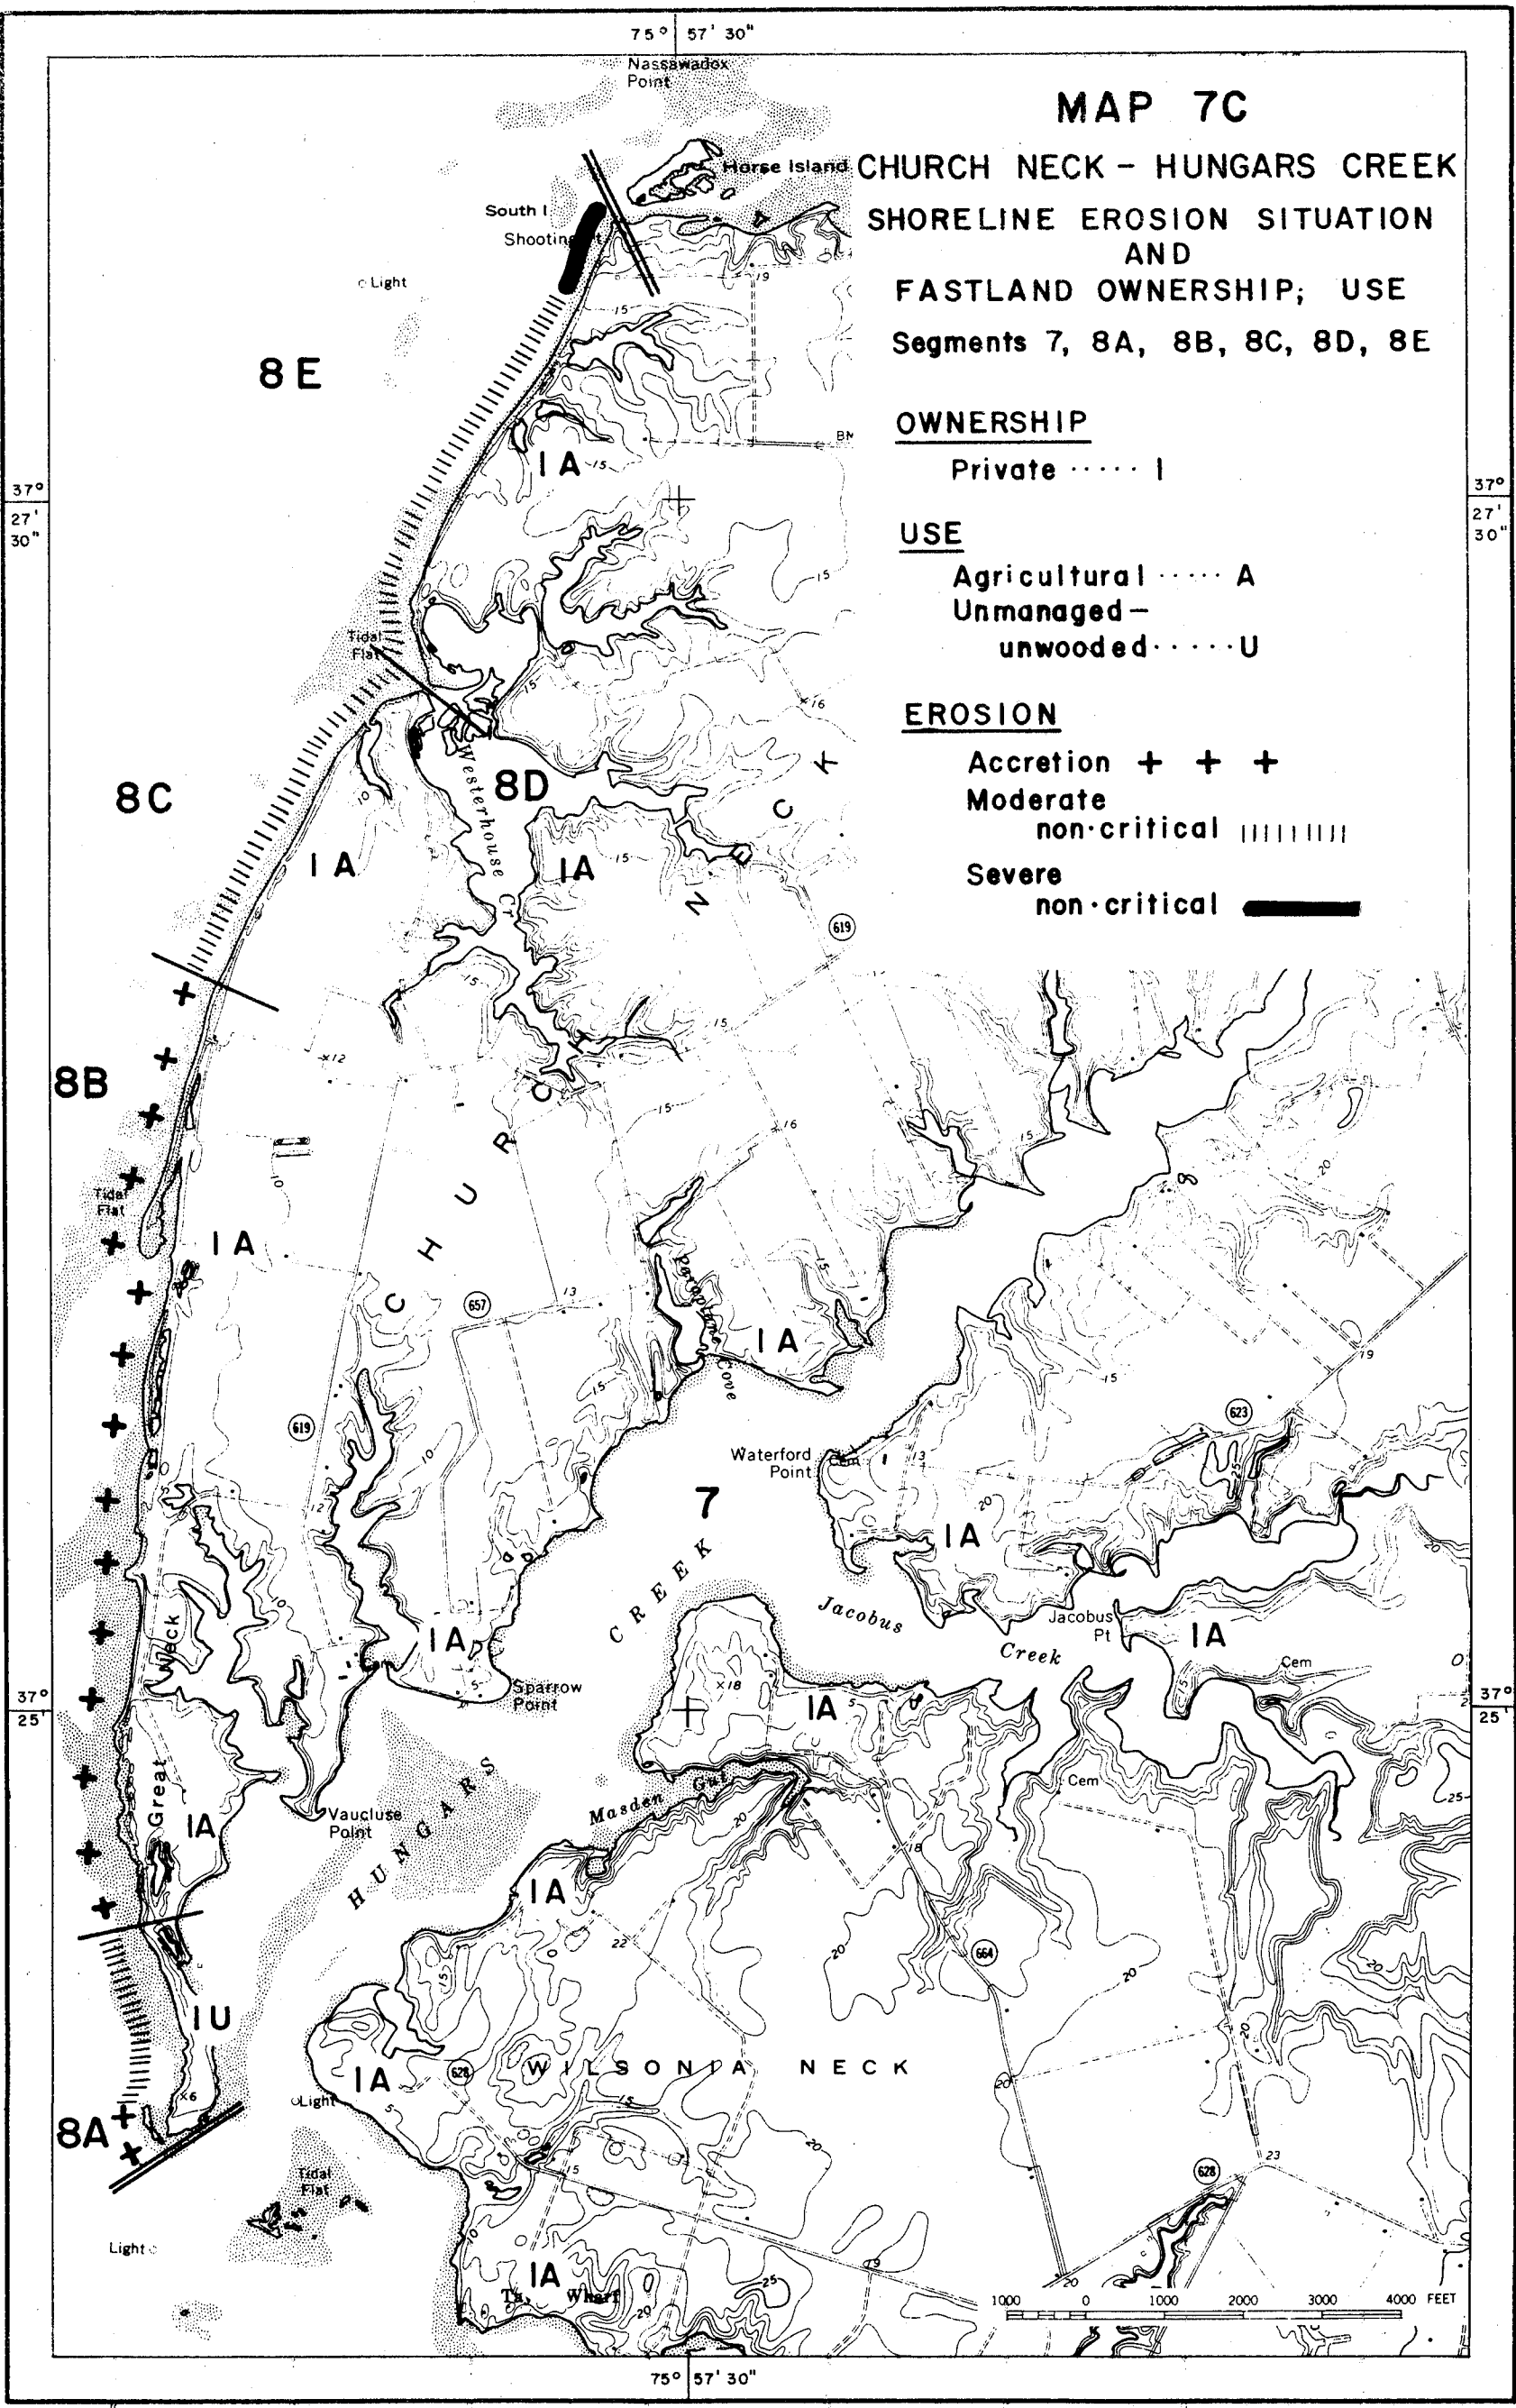
# MAP 7C

CHURCH NECK - HUNGARS CREEK  
SHORELINE EROSION SITUATION  
AND  
FASTLAND OWNERSHIP; USE  
Segments 7, 8A, 8B, 8C, 8D, 8E
