# Shoreline Situation Report NORTHUMBERLAND COUNTY, VIRGINIA

Special Report In Applied Marine Science and Ocean Engineering Number 161 of the

# Shoreline Situation Report

## NORTHUMBERLAND COUNTY

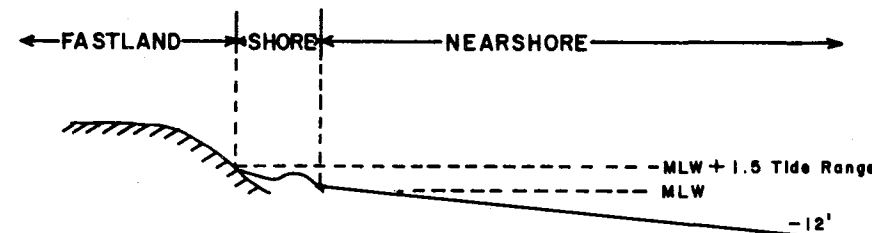
Figure 1

A profile of the three shorelands types.

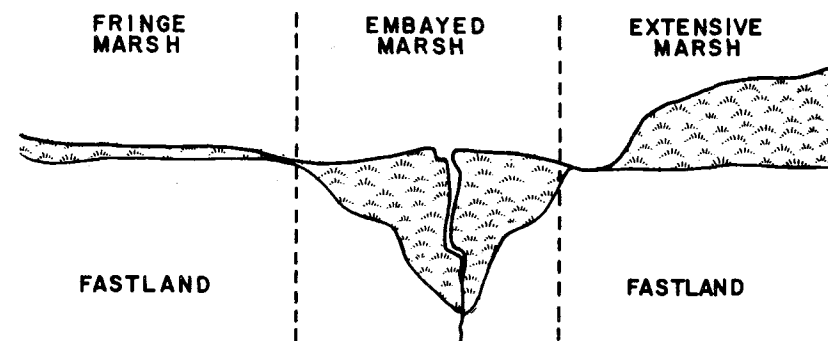
Figure 2

A plan view of the three marsh types.

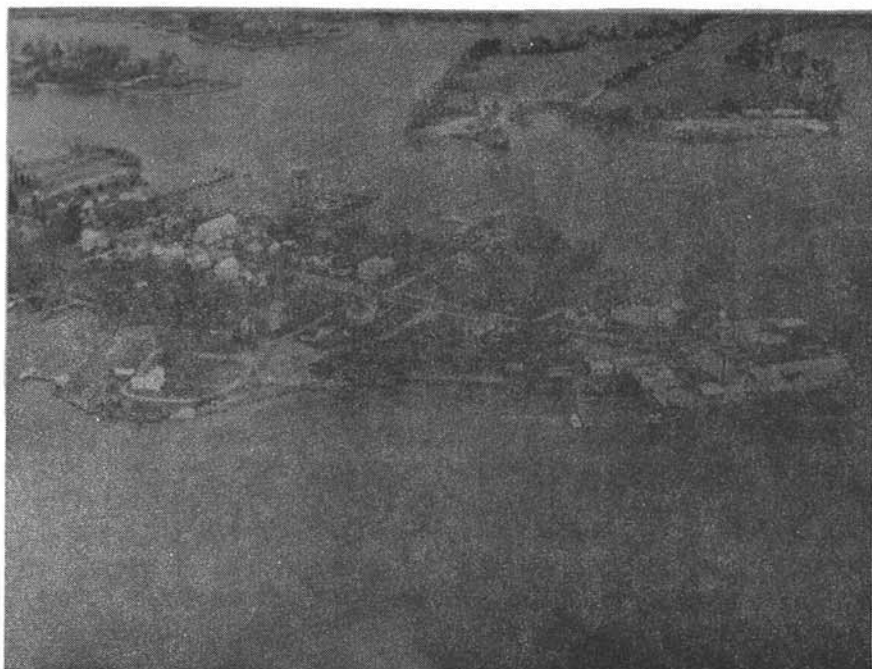
Figure 3

FIGURE 3: Reedville, Subsegment 7F. The tip of the peninsula would be flooded during times of abnormally high water, damaging or destroying the structures. Cockrell Creek has high bacteriological counts due to septic tank leachate around Reedville.

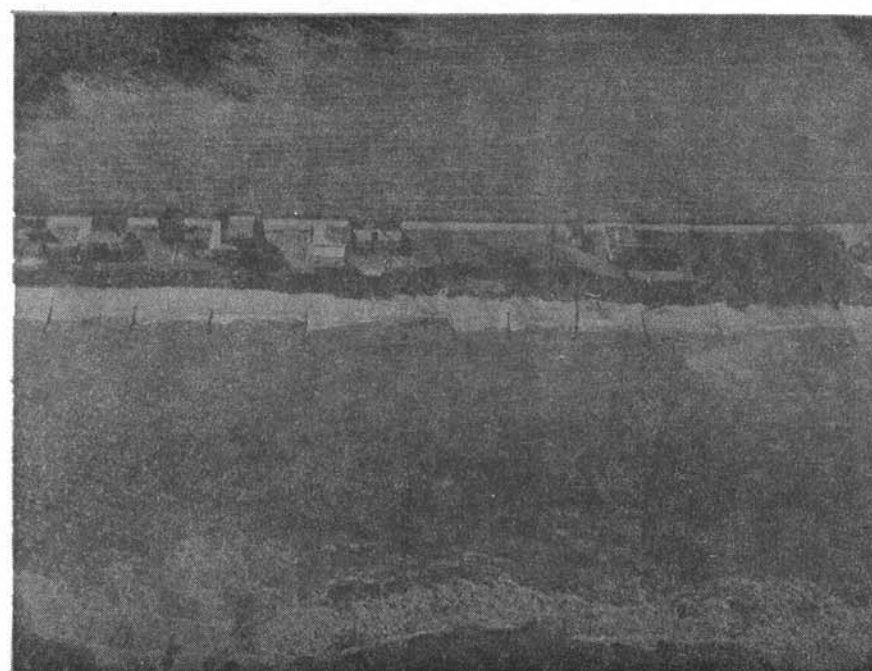
Figure 6

FIGURE 6: Vir-Mar Beach, Segment 10. The groins have been effective in trapping buffer beaches. However, erosion is continuing along many bluff areas of the shoreline.

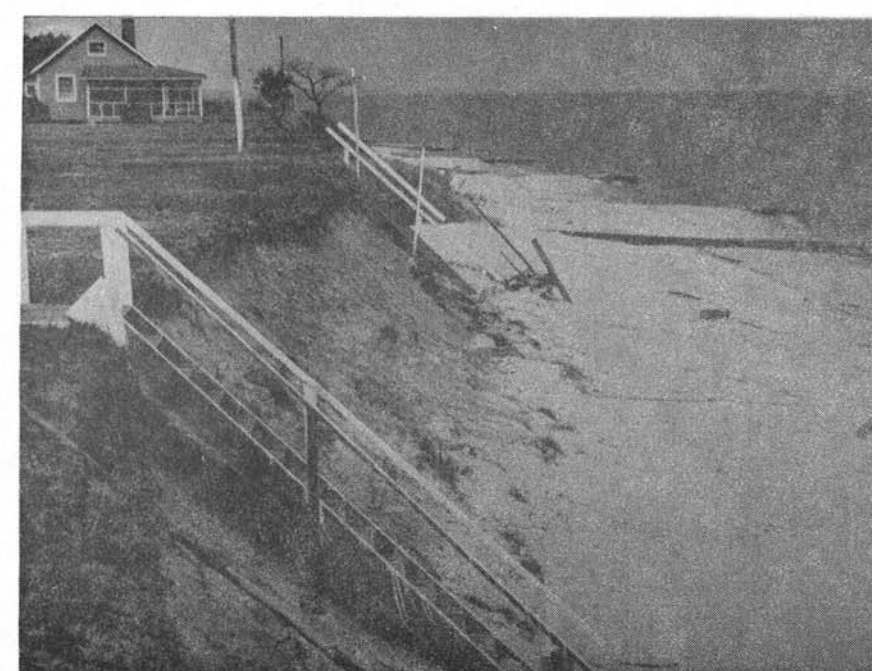
Figure 7

FIGURE 7: Marshalls Beach, Segment 11, ground view. The groins have been very successful in trapping sand. Beach material is coming from the eroding bluffs along this section of shoreline.

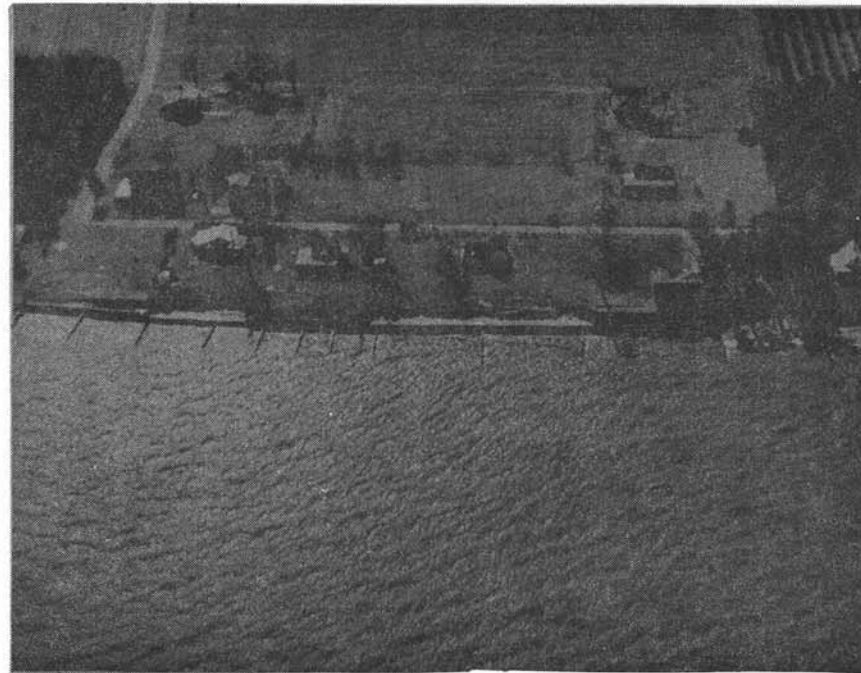
Figure 8

FIGURE 8: Cordreys Beach, Segment 11. The two new sections of bulkhead and groins need to be backfilled. Notice the evidence of past erosion.

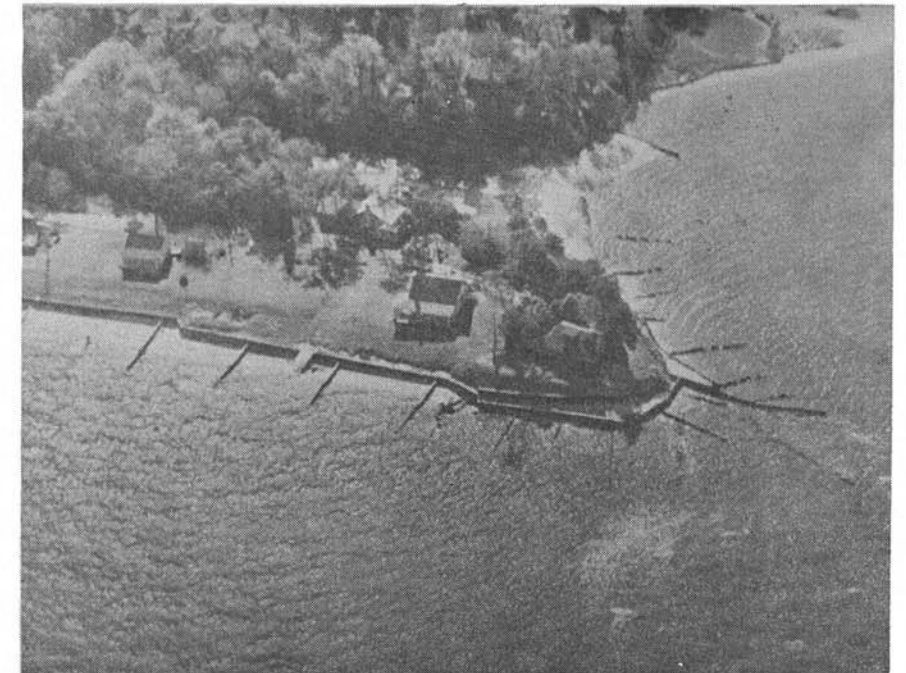
Figure 9

FIGURE 9: Mouth of Rogers Creek, Segment 11. The variety of structures here tends to be self-defeating. Note the different angles which the groins approach the shoreline. A simplified, but well-engineered, plan of shoreline protection would probably be more effective.

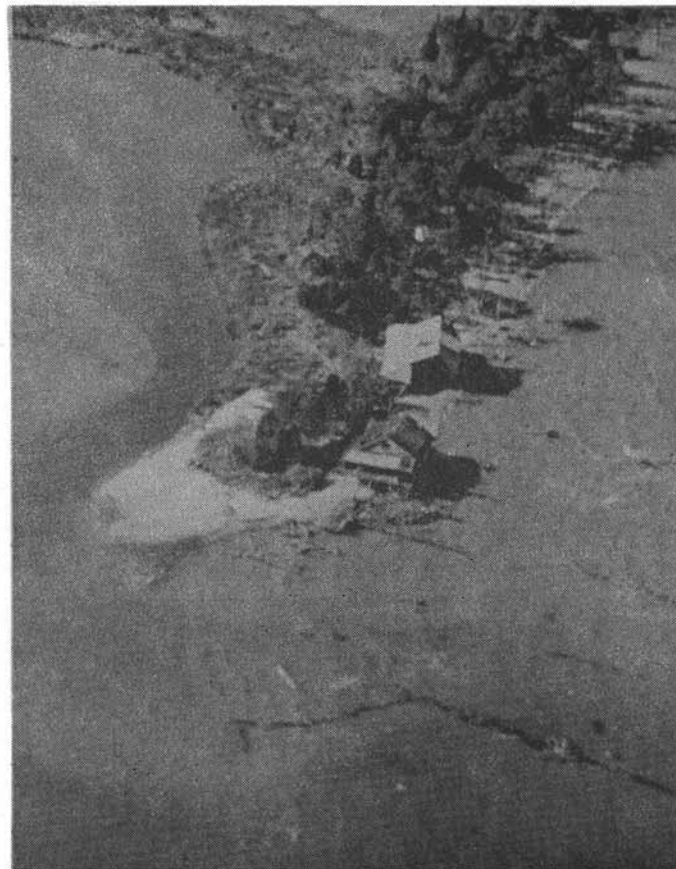
Figure 10

Most shoreline structures have been located a sufficient distance inland not to be endangered by erosion. However, two houses at the mouth of Hull Creek have been severely damaged by erosion and by flood forces (Figure 10). Several other houses along the shoreline of Northumberland County, though not imminently endangered, will be affected by erosion in the next ten to fifteen years if the shoreline is not stabilized.

FIGURE 10: Mouth of Hull Creek, Segment 11. These two houses, damaged by continued erosion, have been abandoned.

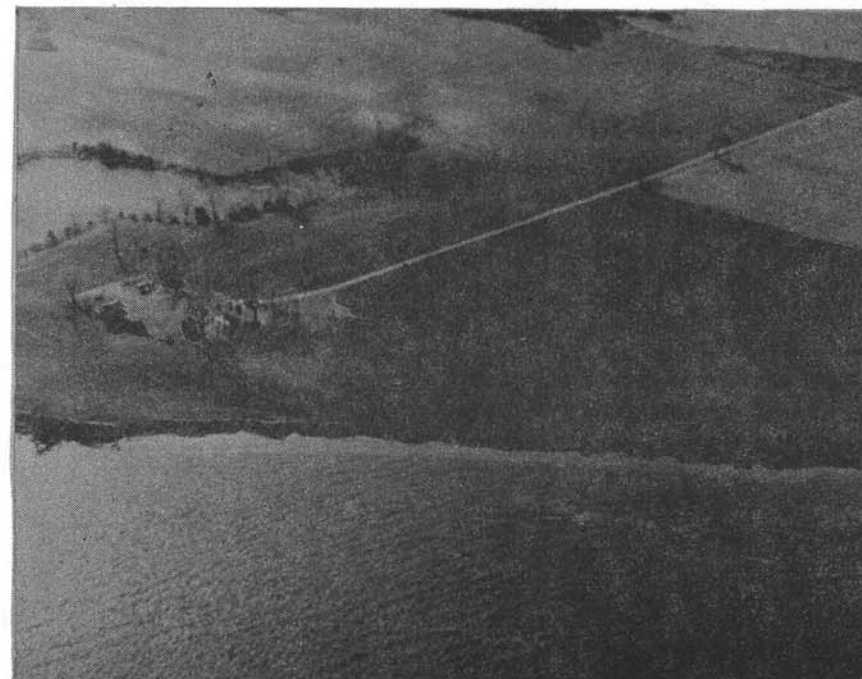
Figure 11

FIGURE 11: Toward Corbin Pond, Segment 11. Continued erosion of the agricultural lands also causes pollution of the water, as fertilizers and insecticides are washed into the river.

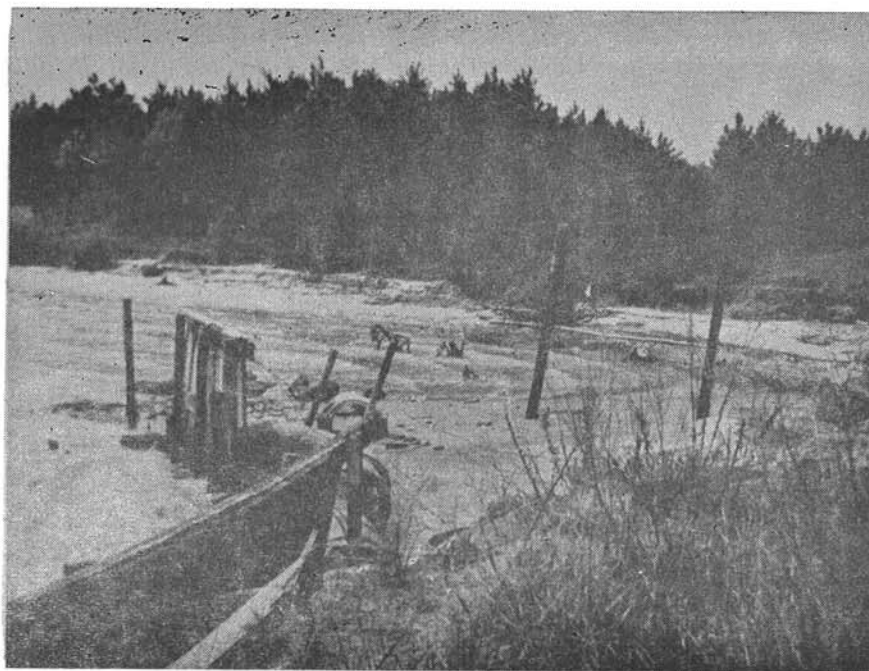
Figure 12

Creek (Segment 11) has an historical average erosion rate of 5.7 feet per year. However, this section is being developed for residential purposes and the shoreline has been mostly artificially stabilized. Several areas between stabilized sections are continuing to erode. One section of bulkhead is failing and scouring is occurring (Figures 12 and 13).

FIGURE 12: Bay Quarter Neck, Segment 11, ground view. The bulkhead has failed and the area behind is eroding.

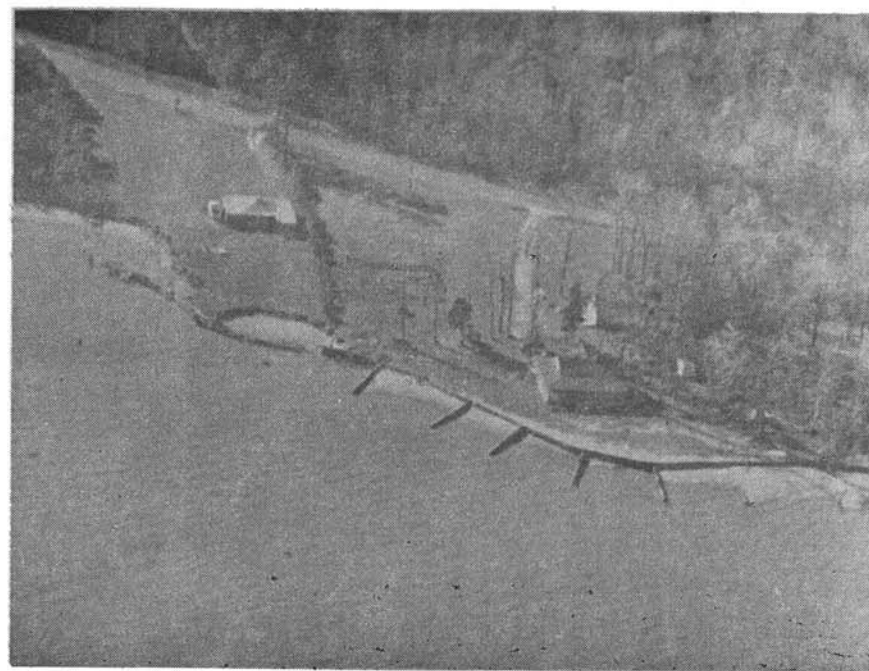
Figure 13

FIGURE 13: Bay Quarter Neck, Segment 11. Aerial view of Figure 12. Notice the erosion behind the failed bulkhead.

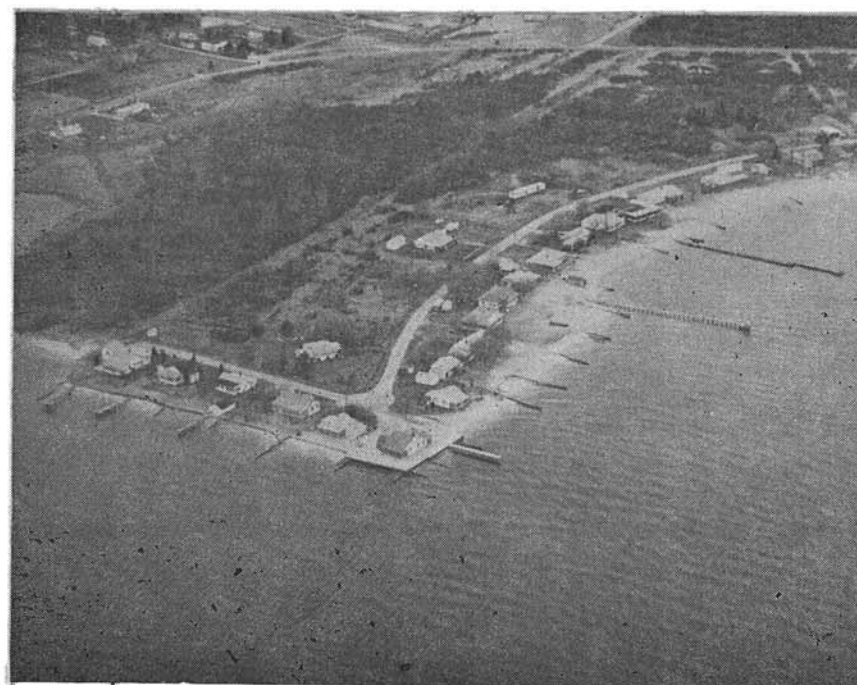
FIGURE 15

FIGURE 15: Mouth of Judith Sound, Segment 13. This area has been artificially stabilized using bulkhead and groins. Both have been effective. Notice the strip development along the shoreline.

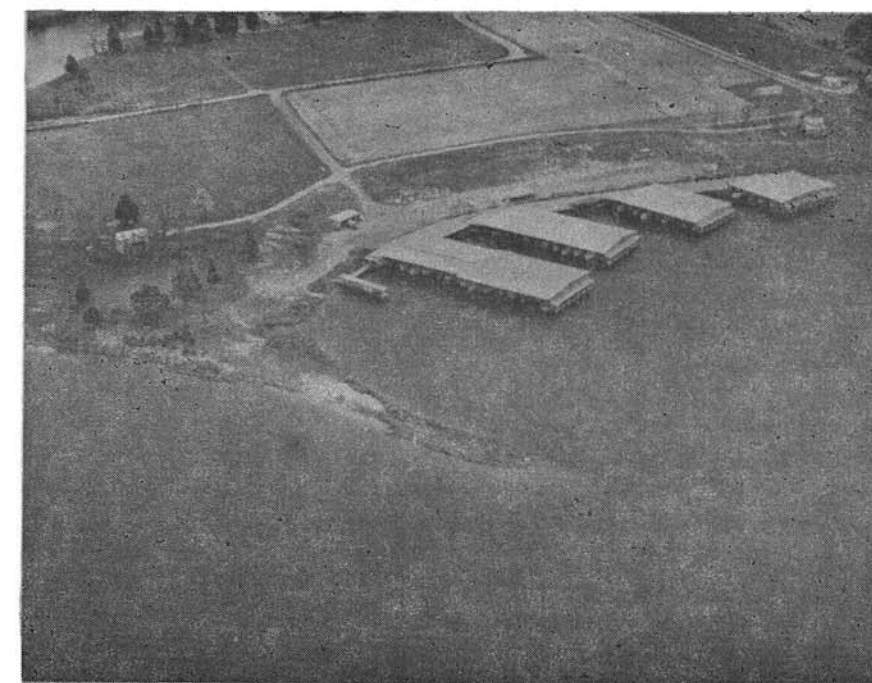
FIGURE 16

FIGURE 16: East bank of Lodge Creek, Segment 15. This is a large marina facility for such a rural area.
