# Shoreline Situation Report RICHMOND COUNTY

Special Report In Applied Marine Science and Ocean Engineering Number 164 of the

VIRGINIA INSTITUTE OF MARINE SCIENCE

## RICHMOND COUNTY

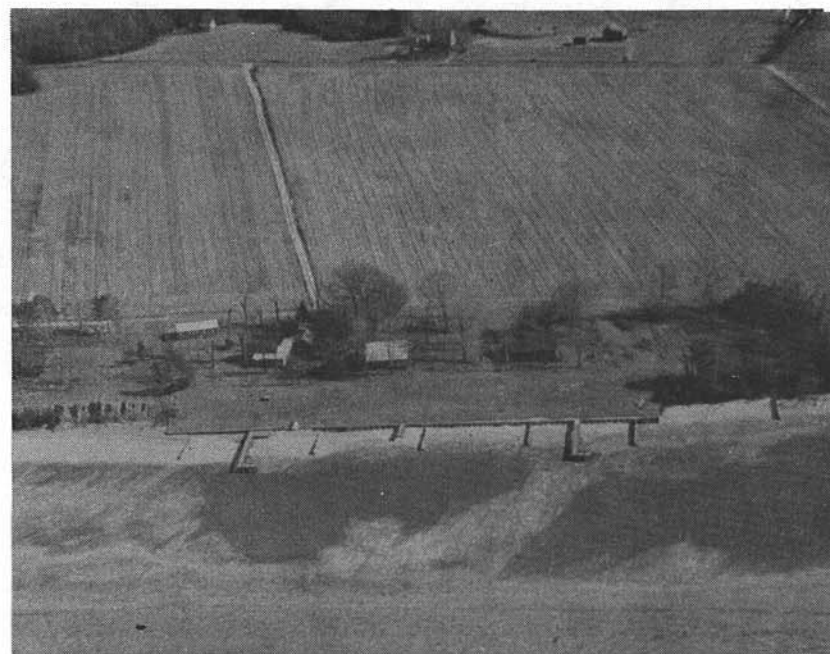
FIGURE 5

FIGURE 5: North of Wellford, Segment 3. The bulkhead in front of the houses is effective in stopping erosion. Note the erosion to the left side of the bulkhead.

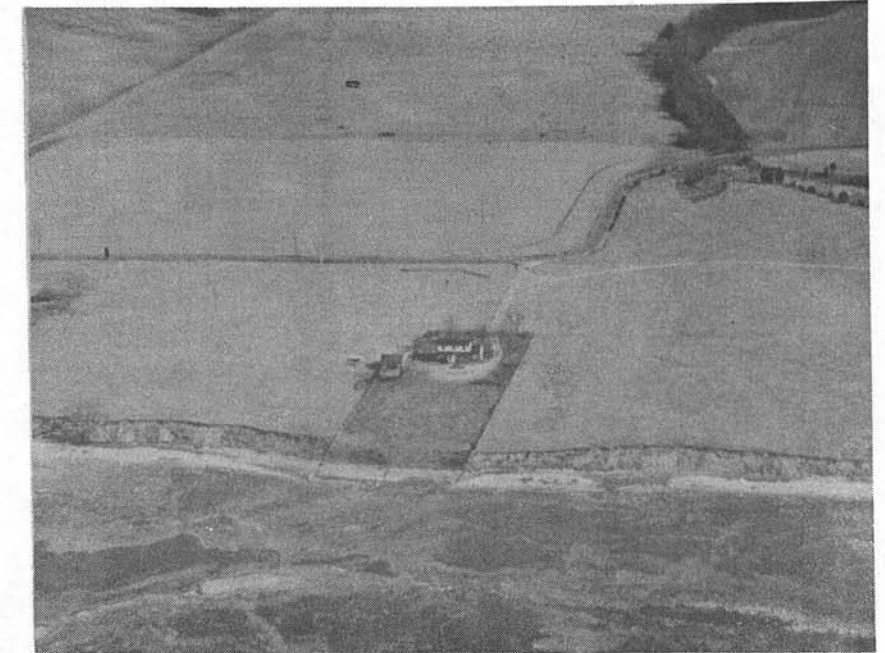
FIGURE 8

FIGURE 8: South of Route 634, Segment 3. The shoreline in front of the house has been sloped and vegetated and is artificially stabilized. Erosion is continuing on either side of the structure.

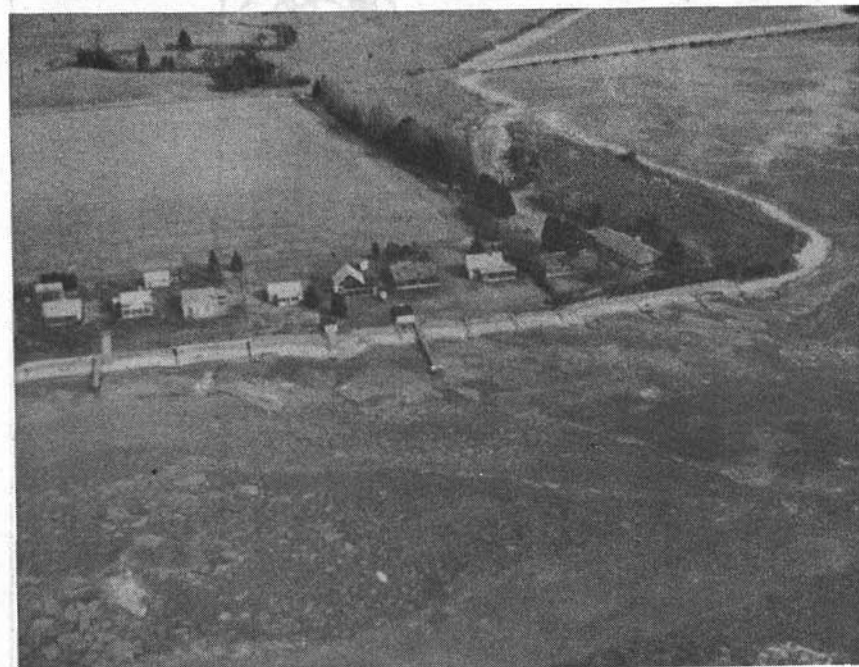
FIGURE 9

FIGURE 9: Naylors Point, Segment 1. This area has one of the few residential concentrations in the county. The houses are located in a strip bordering the shoreline. Agricultural fields are behind.
