# Development of the Maryland Shoreline Inventory Methods and Guidelines for Calvert County

Prepared by the Comprehensive Coastal Inventory Program,  
Center for Coastal Resources Management, Virginia Institute of Marine Science,  
College of William and Mary, Gloucester Point, Virginia.

August, 2006

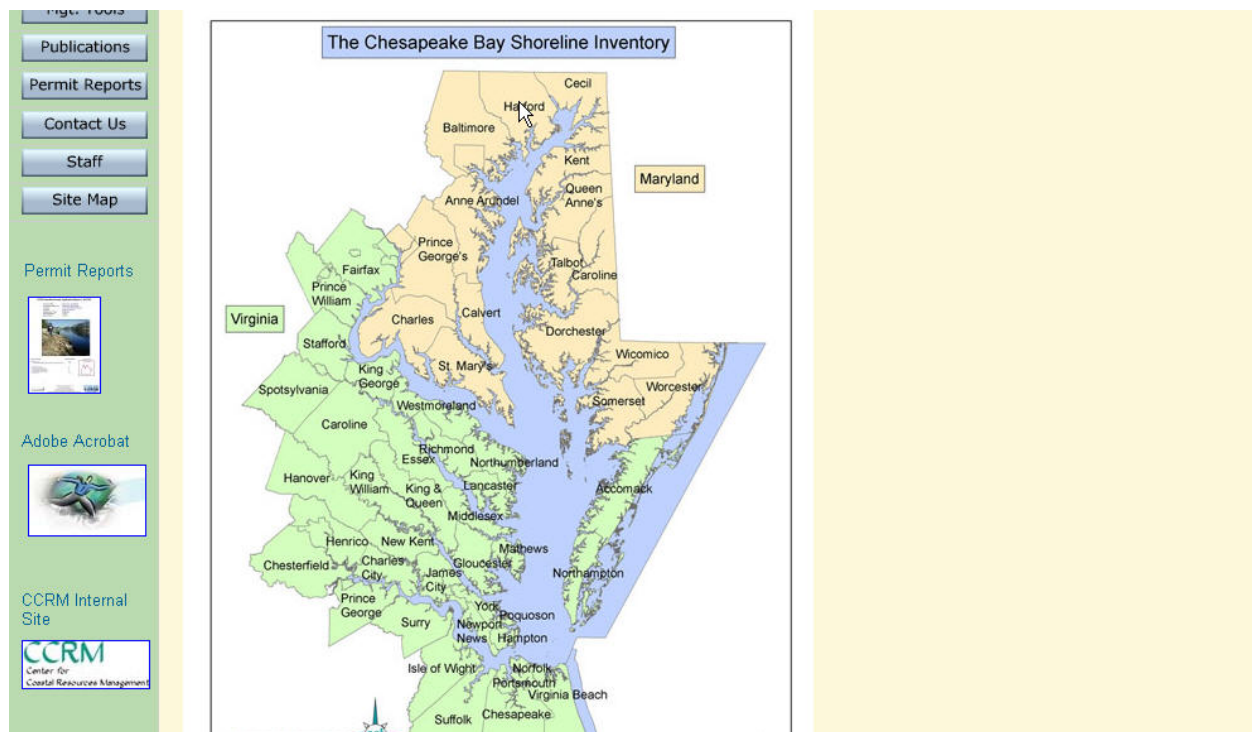
Figure 1. Shoreline (Inventory) Situation Report Website

From the page above, the user will be linked to a project review and disclaimer page where basic project and data use limitations are presented. There are 6 links at the bottom of the disclaimer page. The links are self-explanatory. The link to maps will take you to an index page illustrating the plate boundaries (Figure 2). This is useful if you are interested in a specific area. When you click on “Maps” the county index page will appear. The index illustrates the distribution of plates geographically.

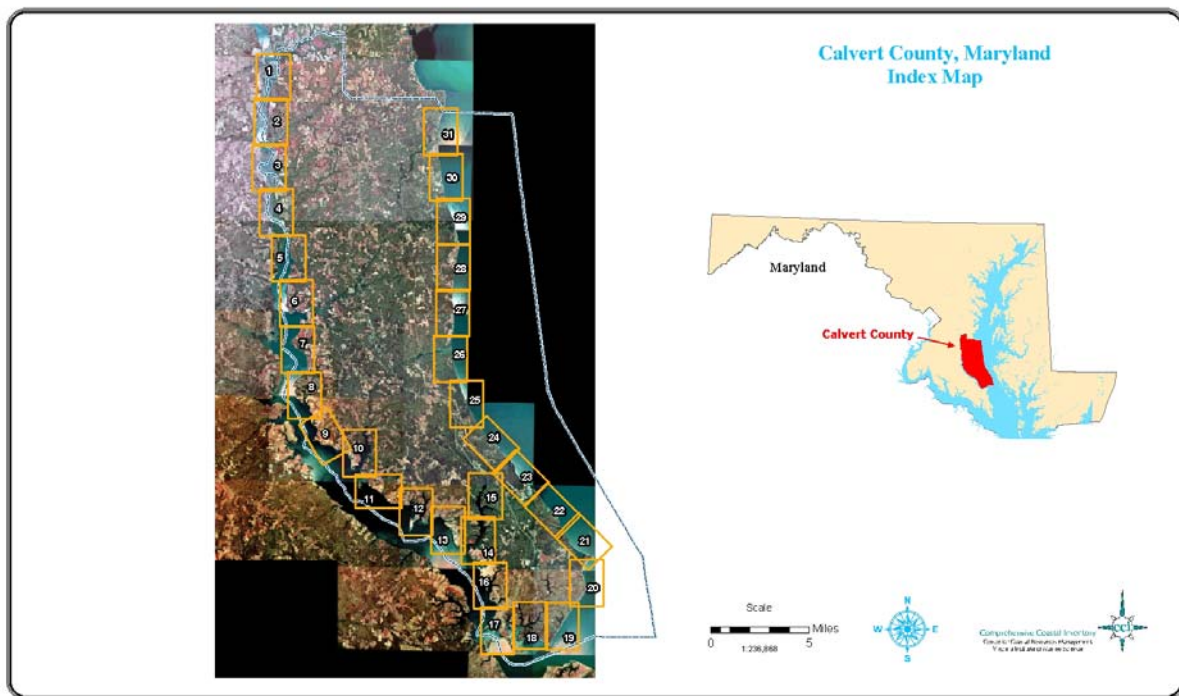
Figure 2. Map index for Calvert County

Once you determine which plate you want, the scroll down menu on the left has links to the three part series for each plate. Riparian Land Use is first (Figure 3). You can scroll down to see the link to Bank and Buffer conditions and Shoreline Features. The content and details of the three part plate series was described in detail in Chapter 2. The actual map will come up when you click on the plate number. For example, Figure 4 is the riparian land use map for plate 10. Figure 5 is the map illustrating Bank and Buffer conditions for plate 10, and Figure 6 shows all the shoreline features for that same area. You may open all three plates for the series, but can view only one at a time in most browsers. Tools for zooming and panning should be on the tool bar. The maps can be printed at full resolution up to 11x17 color. Color printers are necessary. Summary statistics for all data are reported in tables (see link on the project disclaimer page).
