# **Accomack County, Virginia Shoreline Inventory Report Methods and Guidelines**

Special report in Applied Marine Science and Ocean Engineering No. 450 of the Virginia Institute of Marine Science

## Accomack County- Shoreline Inventory Report

September 2016

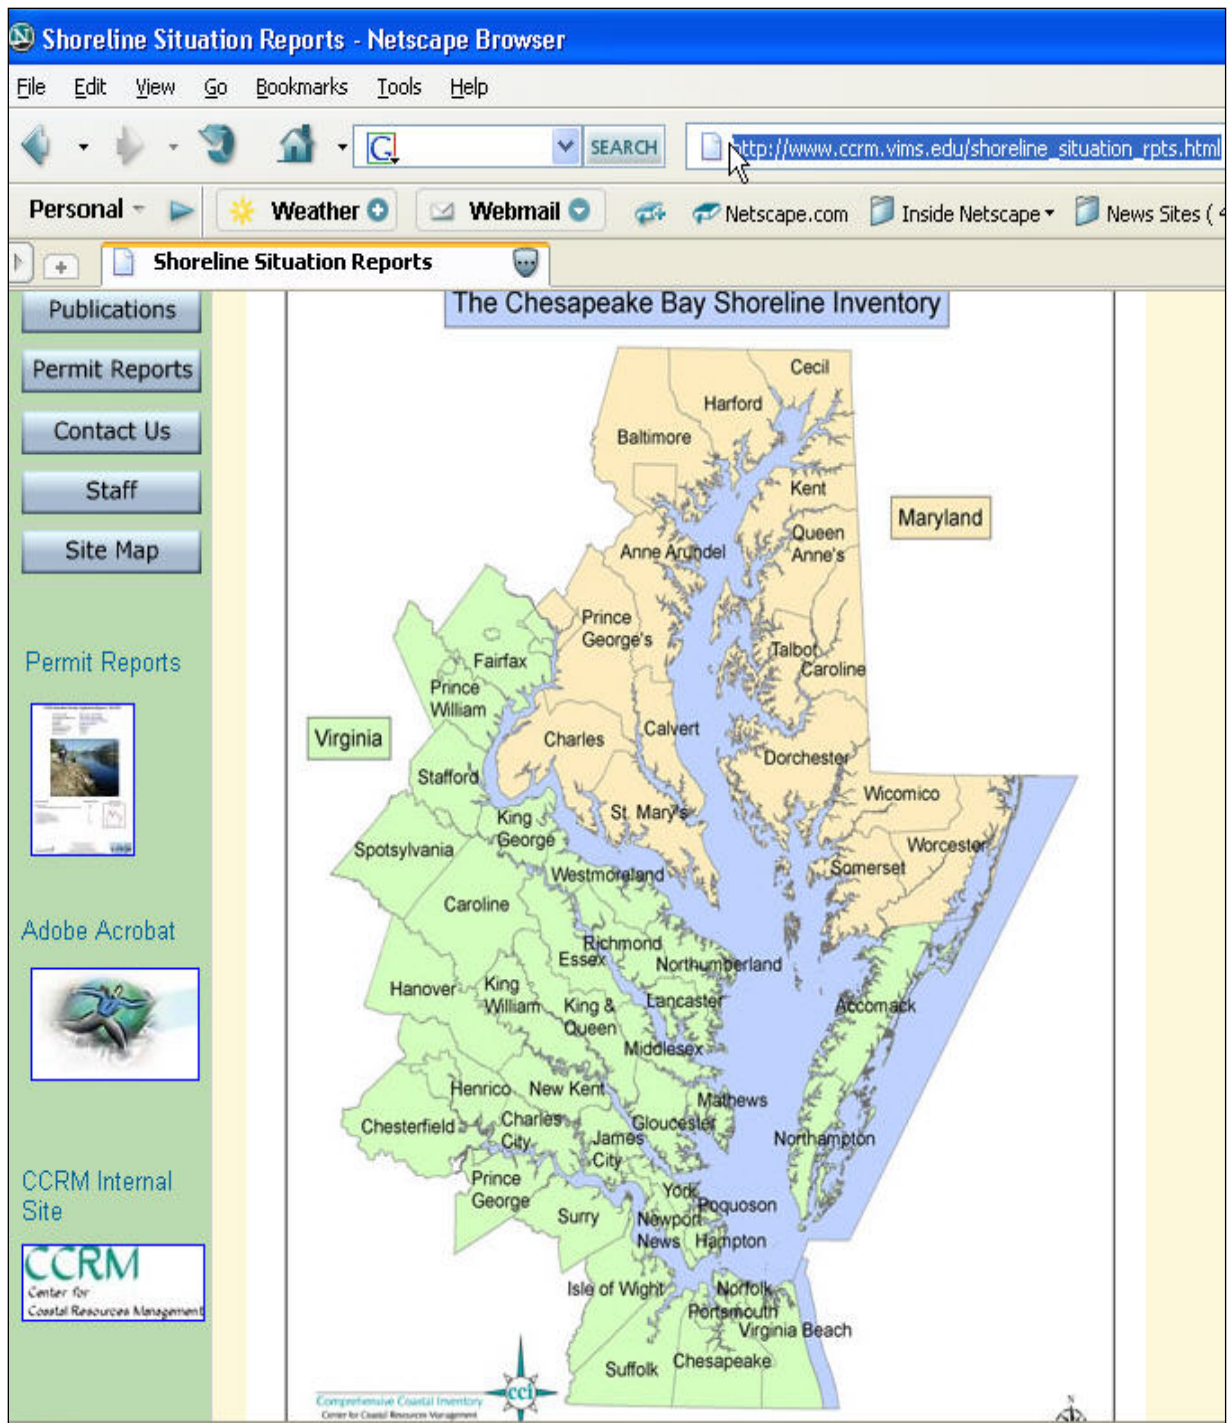
Figure 1. Shoreline Inventory Website

2.4c.) Map Viewer and Summary Tables: The Accomack County Shoreline Inventory is delivered to the end user through a website; [http://ccrm.vims.edu/gis\\_data\\_maps/shoreline\\_inventories/index.html](http://ccrm.vims.edu/gis_data_maps/shoreline_inventories/index.html) (Figure 1.), by clicking on Accomack County in the map or list of localities. The new format for Shoreline Inventories includes a map viewing tool rather than maps in pdf format. The map viewer allows users to interact with the datasets within a familiar “google” type map service that was developed with Javascript. Here they can view data of their choice and customize map products for printing themselves. Access to the GIS data, summary tables and methods report is also available through this website.

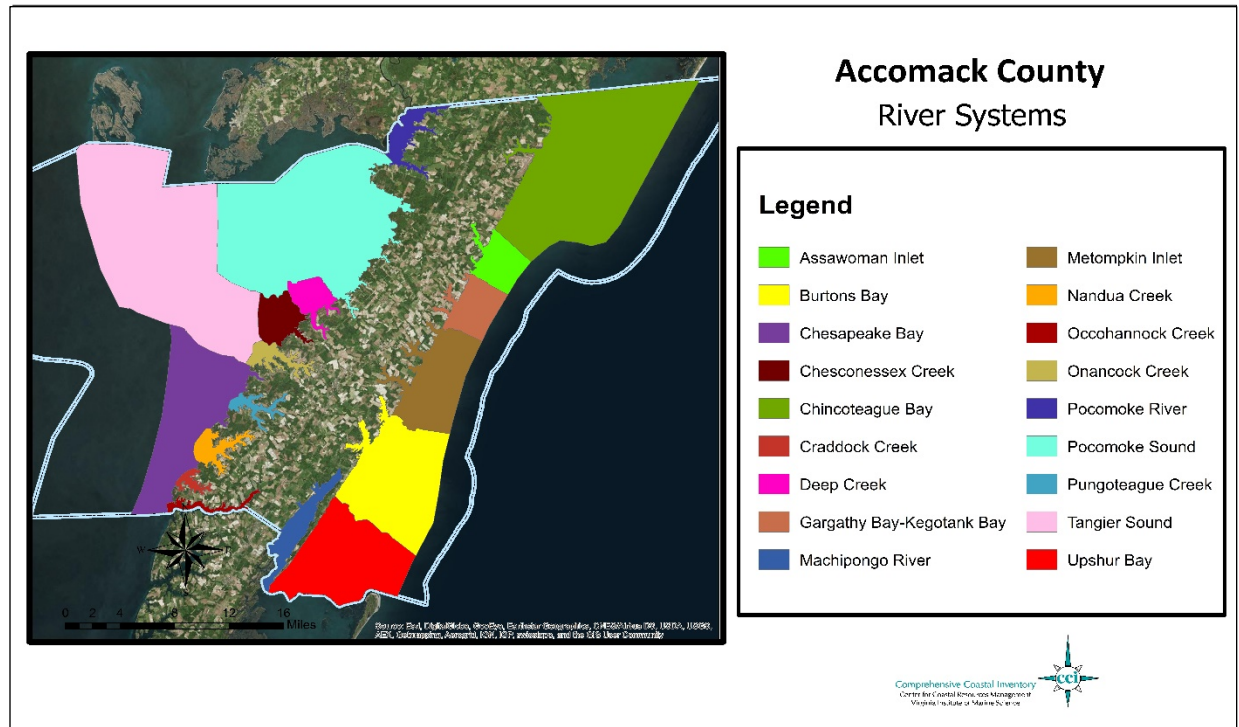
Figure 2. River Systems in Accomack County

Summary tables (Tables 4-7) quantify conditions observed on the basis of river systems (Figure 2). Refer to Figure 2 for the location of these rivers systems. Note, river systems do not correspond to watershed boundaries. They were developed for convenience in reporting data.

The top toolbar also includes tabs to access some important status information for the locality. By clicking on the “River System Pie Charts” button, users can obtain a statistical summary distribution of the riparian land use and amount of hardened shoreline for a specific water body selected from the drop down menu in the upper left (Figure 7). More detailed results in table format can be found by clicking the Accomack County Summary PDF button also in the window. The summary statistics are reported by river systems (Figure 2).

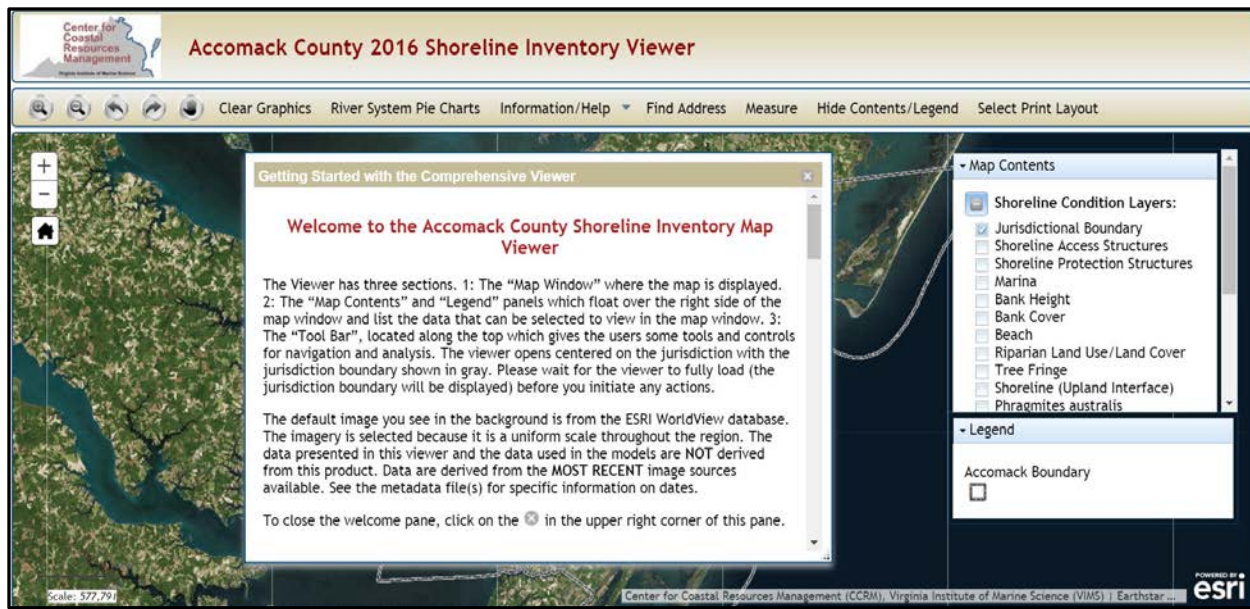
Figure 3. Opening page for the Accomack County Shoreline Inventory Viewer

The Viewer has two panels: “Map Window”, where the map is displayed and “Map Contents and Legend”, where data that can be selected and viewed in the map window are listed. A tool bar is located along the top of the “Map Window” which gives users some controls for navigation and analysis (Figure 3.).

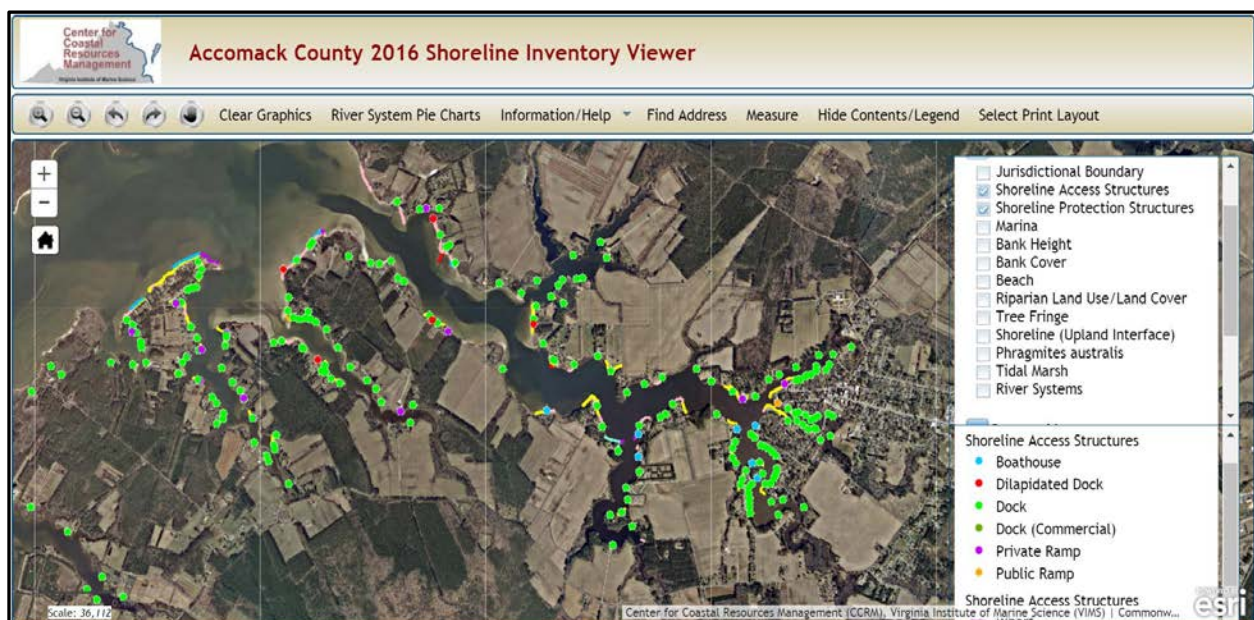
Figure 4. Map Viewer illustrates Shoreline Access and Protection Structures for a section of Accomack County.

In Figure 4 Shoreline Access Structures, and Shoreline Protection structures are selected. Shoreline Access structures are point features that includes piers and boat ramps. The actual footprint of these structures is not measured; only their location. Shoreline Protection Structures are line features and are mapped and illustrated in the viewer to show where they occur along the shoreline. Figure 5 illustrates riparian land use in the riparian zone for the same section of the County.

From the “Map Contents” the user may check various attribute layers on or off. The user must use the scroll bar on the far right to see the complete list of layers available. When layers are turned on, the corresponding legend appears in the “Legend” panel, and the data are displayed in the “Map Window” (Figure 4).

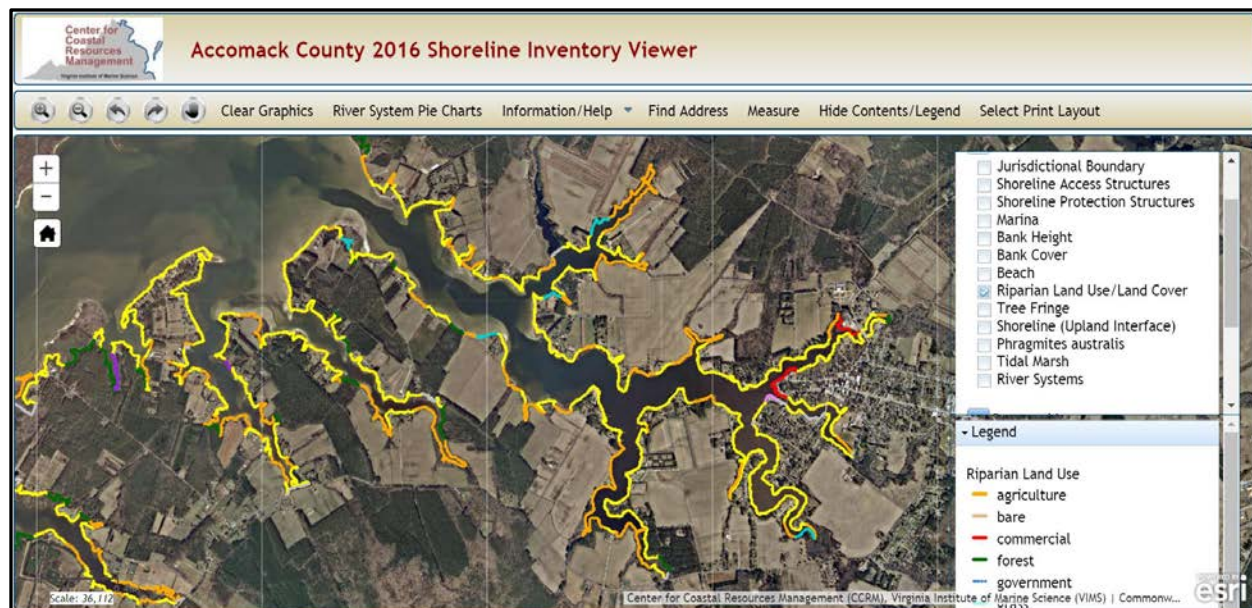
Figure 5. Distribution of land use in the riparian zone is displayed for this region of Accomack County.

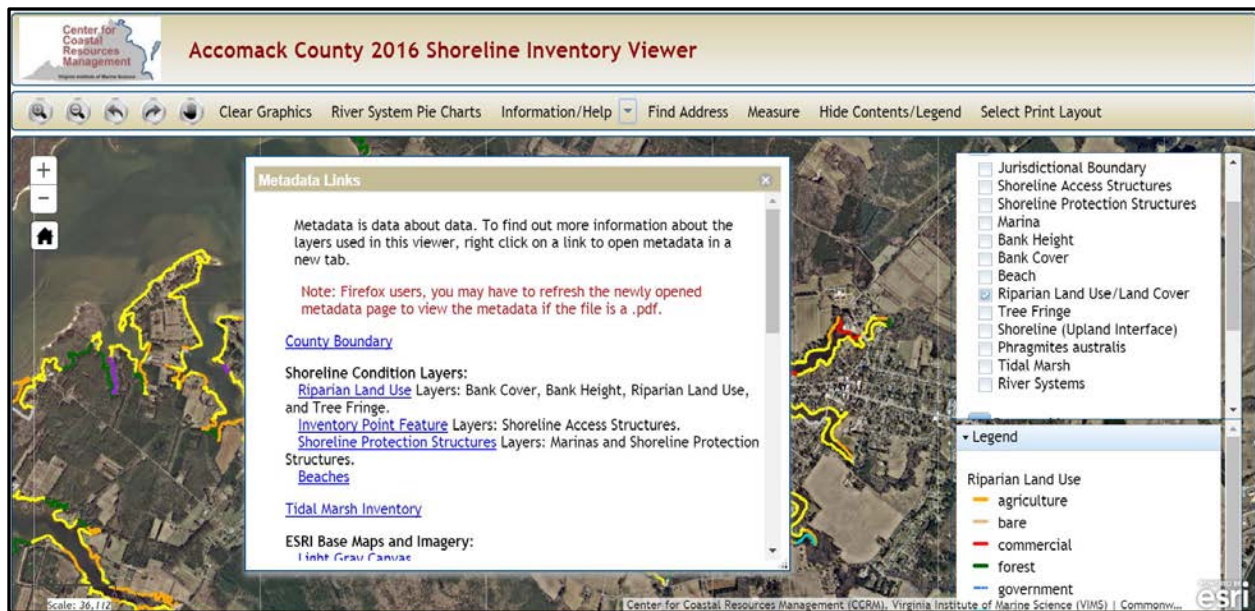
The user can use the zoom and pan tools from the top toolbar or the slide bar on the left side of the map window to change their map extent. If the map resolution is exceeded the window will become illegible. Detailed information can be obtained about the data by selecting the “Information/Help” tab at the top of the map viewer. From here the inventory glossary and metadata records can be easily accessed. In Figure 6 the selection for metadata has been made and 5 possible records can be retrieved.

Figure 6. Link to Metadata records has been selected from the top Information tab in the toolbar.

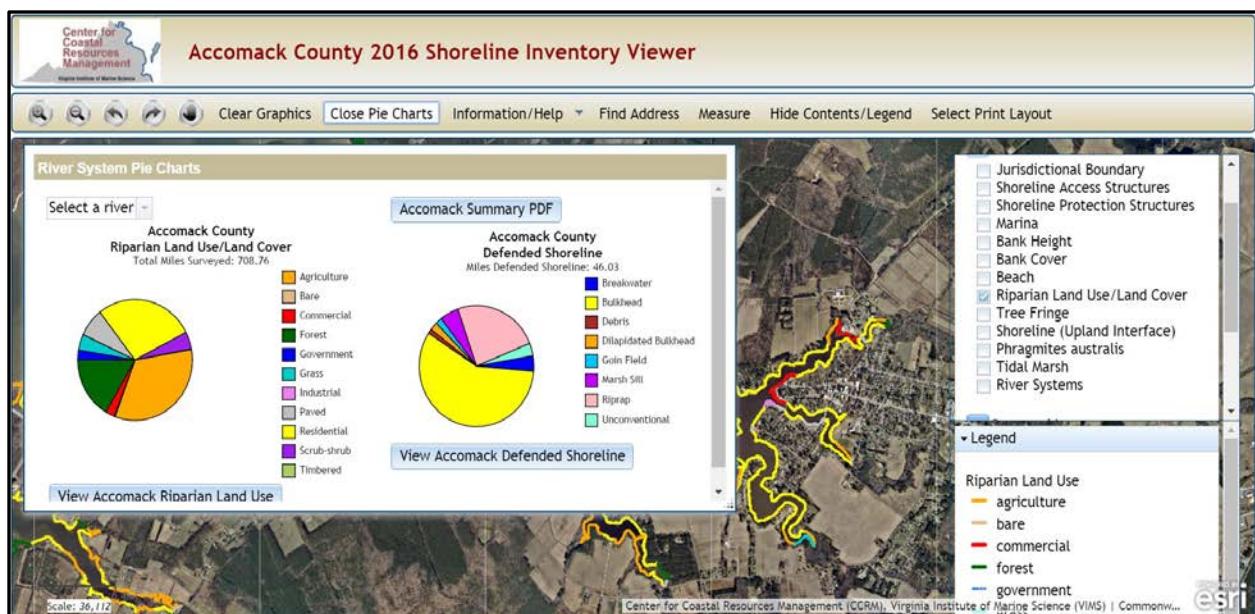
Figure 7. Pie charts display land use and shoreline hardening statistics for each tributary.

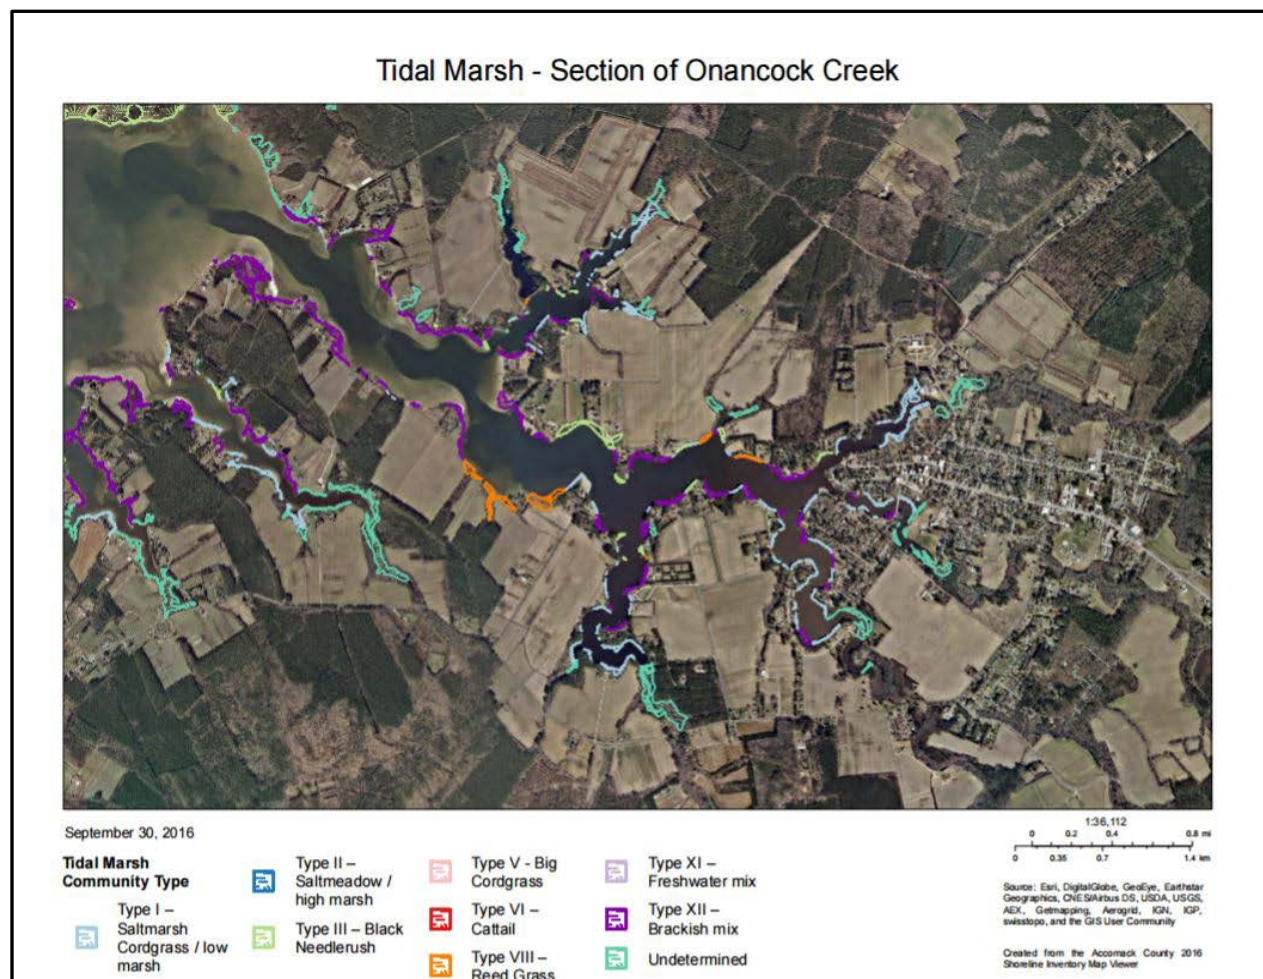
Finally, users have the option to personalize their own maps (i.e. map extent, data displayed, map title, etc.) and save them as a pdf file by clicking “Select Print Layout” button. The page can be set up for printing to 8.5 x 11 portrait or landscape style. Figure 8 is an example of a customized map generated for a section of Onancock Creek. Here the tidal marsh communities are displayed, and the community type is reported in the legend beside the illustration.

Figure 8. Customized print window for a section of Onancock Creek
