# **City of Chesapeake, Virginia Shoreline Inventory Report Methods and Guidelines**

**Comprehensive Coastal Inventory Program  
Center for Coastal Resources Management  
Virginia Institute of Marine Science, College of William and Mary  
Gloucester Point, Virginia  
December 2016**

Special report in Applied Marine Science and Ocean Engineering No. 451 of the Virginia  
Institute of Marine Science

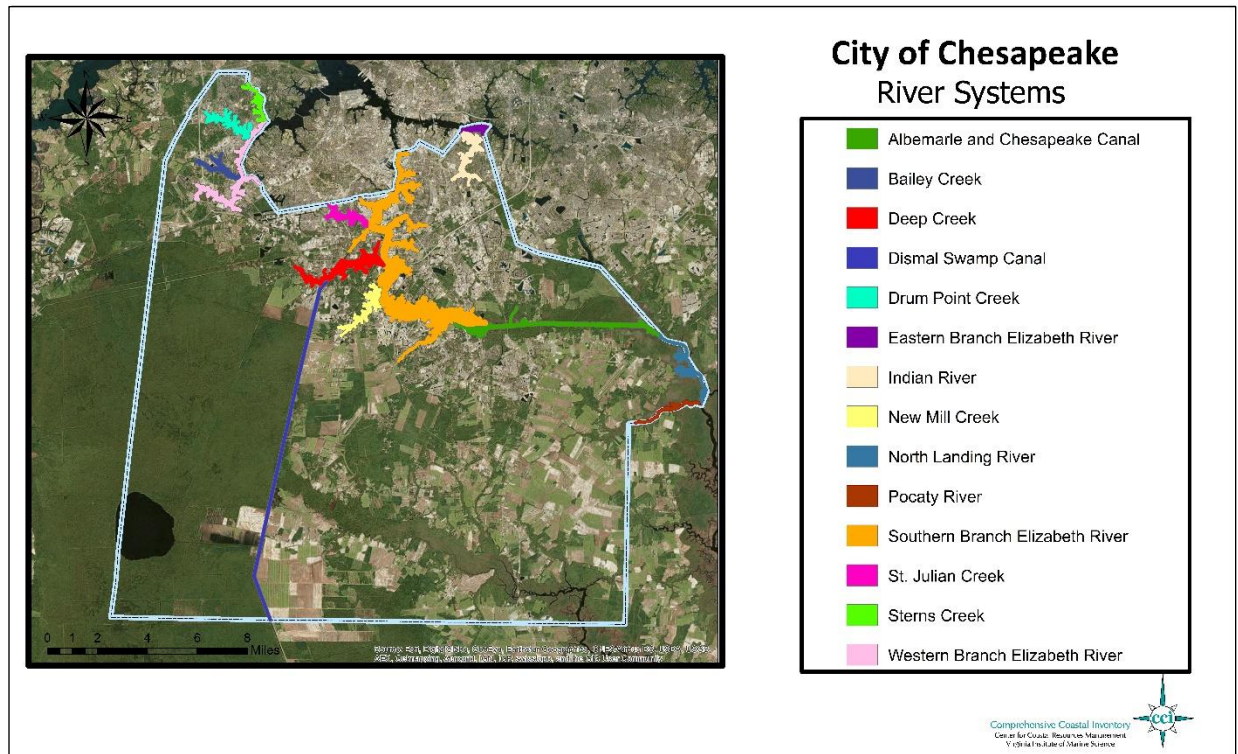
Figure 2. River Systems in the City of Chesapeake

Summary tables (Tables 4-7) quantify conditions observed on the basis of river systems (Figure 2). Refer to Figure 2 for the location of these rivers systems. Note, river systems do not correspond to watershed boundaries. They were developed for convenience in reporting data.

Tables 4, 5, 6, and 7, quantify features and conditions mapped along the rivers using frequency analysis techniques in ArcInfo. For linear features, values are reported in actual miles. Point features are enumerated. Polygon features are reported in acres surveyed (marshes). These tables are downloadable as pdf files from the website. They are not included in this document.

The top toolbar also includes tabs to access some important status information for the locality. By clicking on the “River System Pie Charts” button, users can obtain a statistical summary distribution of the riparian land use and amount of hardened shoreline for a specific water body selected from the drop down menu in the upper left (Figure 7). More detailed results in table format can be found by clicking the City of Chesapeake Summary PDF button also in the window. The summary statistics are reported by river systems (Figure 2).

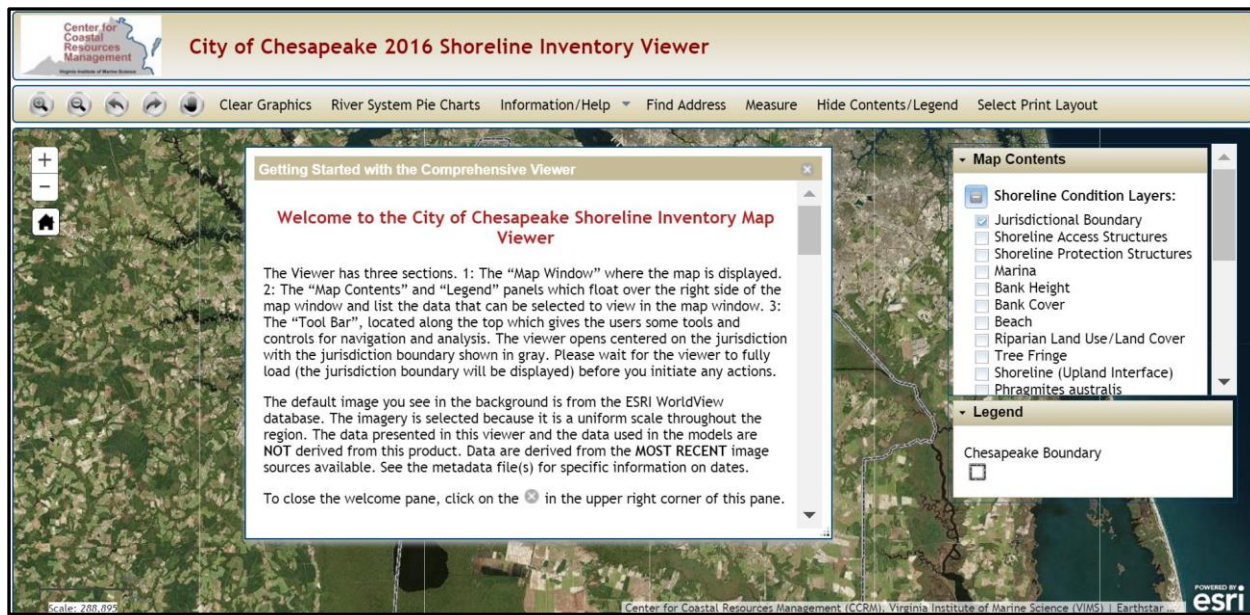
Figure 3. Opening page for the City of Chesapeake Shoreline Inventory Viewer

The Viewer has two panels: “Map Window”, where the map is displayed and “Map Contents and Legend”, where data that can be selected and viewed in the map window are listed. A tool bar is located along the top of the “Map Window” which gives users some controls for navigation and analysis (Figure 3.).

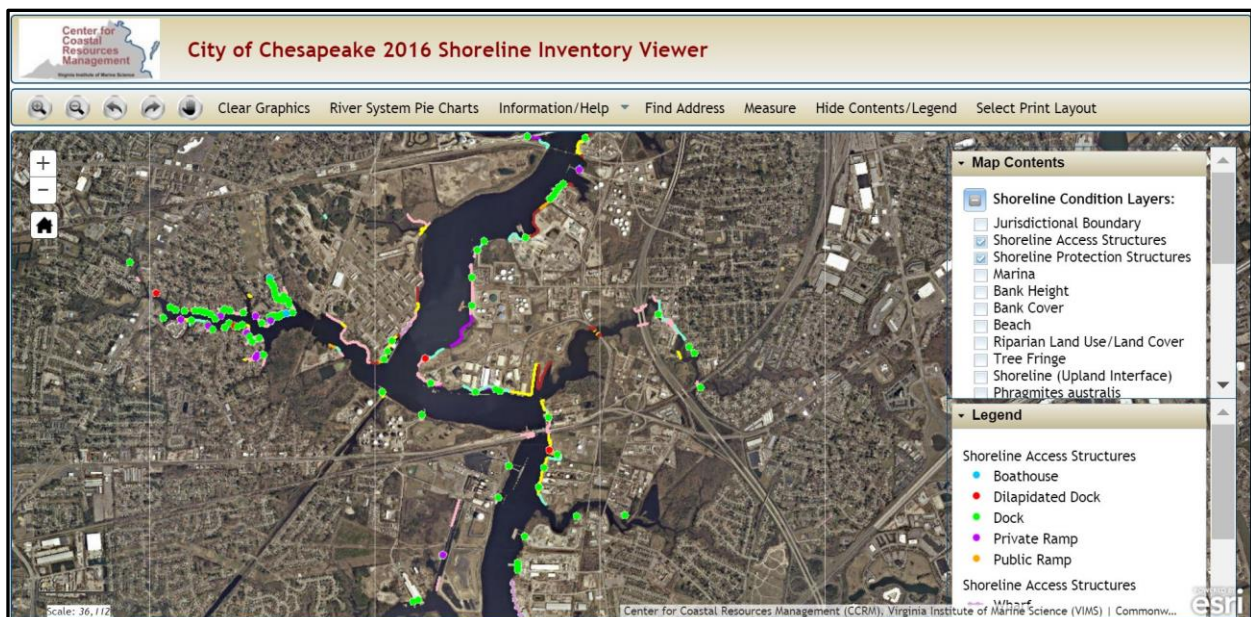
Figure 4. Map Viewer illustrates Shoreline Access and Protection Structures for a section of the City of Chesapeake.

In Figure 4 Shoreline Access Structures, and Shoreline Protection structures are selected. Shoreline Access structures are point features that includes piers and boat ramps. The actual footprint of these structures is not measured; only their location. Shoreline Protection Structures are line features and are mapped and illustrated in the viewer to show where they occur along the shoreline. Figure 5 illustrates riparian land use in the riparian zone for the same section of the County.

From the "Map Contents" the user may check various attribute layers on or off. The user must use the scroll bar on the far right to see the complete list of layers available. When layers are turned on, the corresponding legend appears in the "Legend" panel, and the data are displayed in the "Map Window" (Figure 4).

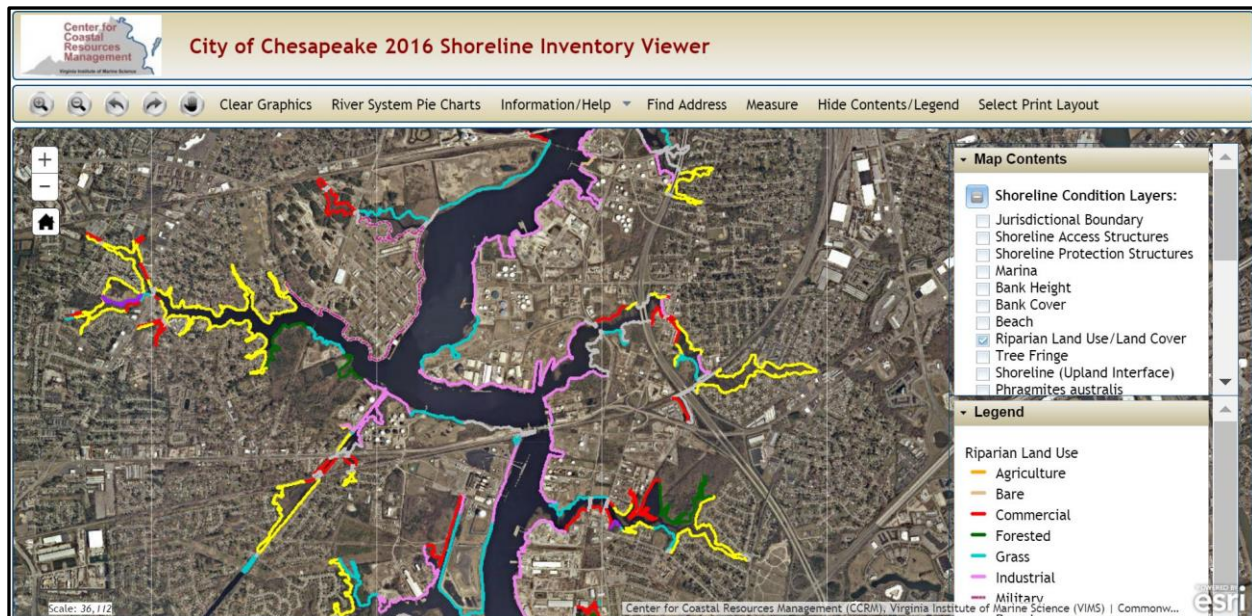
Figure 5. Distribution of land use in the riparian zone is displayed for this region of the City of Chesapeake.

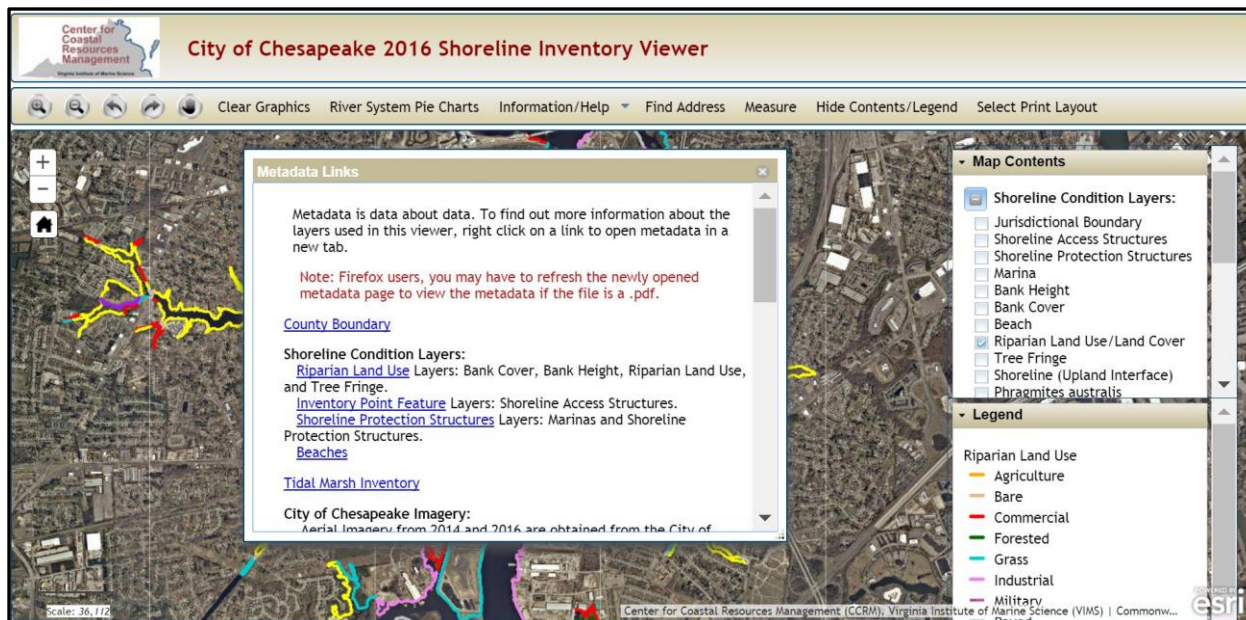
The user can use the zoom and pan tools from the top toolbar or the slide bar on the left side of the map window to change their map extent. If the map resolution is exceeded the window will become illegible. Detailed information can be obtained about the data by selecting the “Information/Help” tab at the top of the map viewer. From here the inventory glossary and metadata records can be easily accessed. In Figure 6 the selection for metadata has been made and different records can be retrieved.

Figure 6. Link to Metadata records has been selected from the top Information tab in the toolbar.

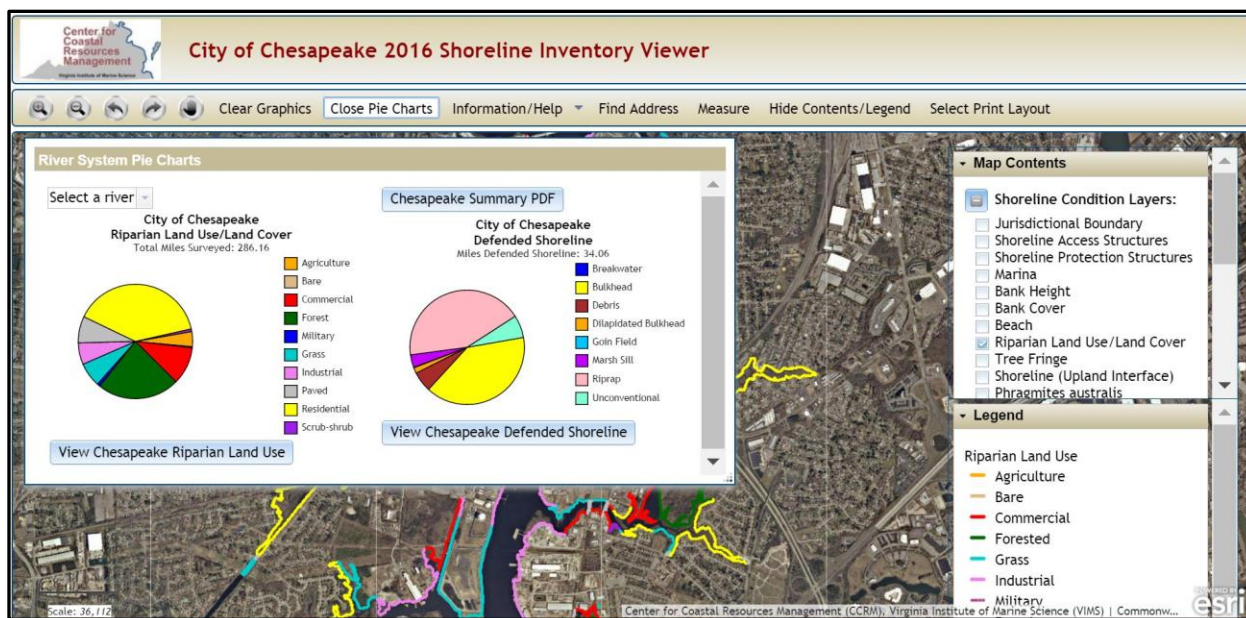
Figure 7. Pie charts display land use and shoreline hardening statistics for each tributary.

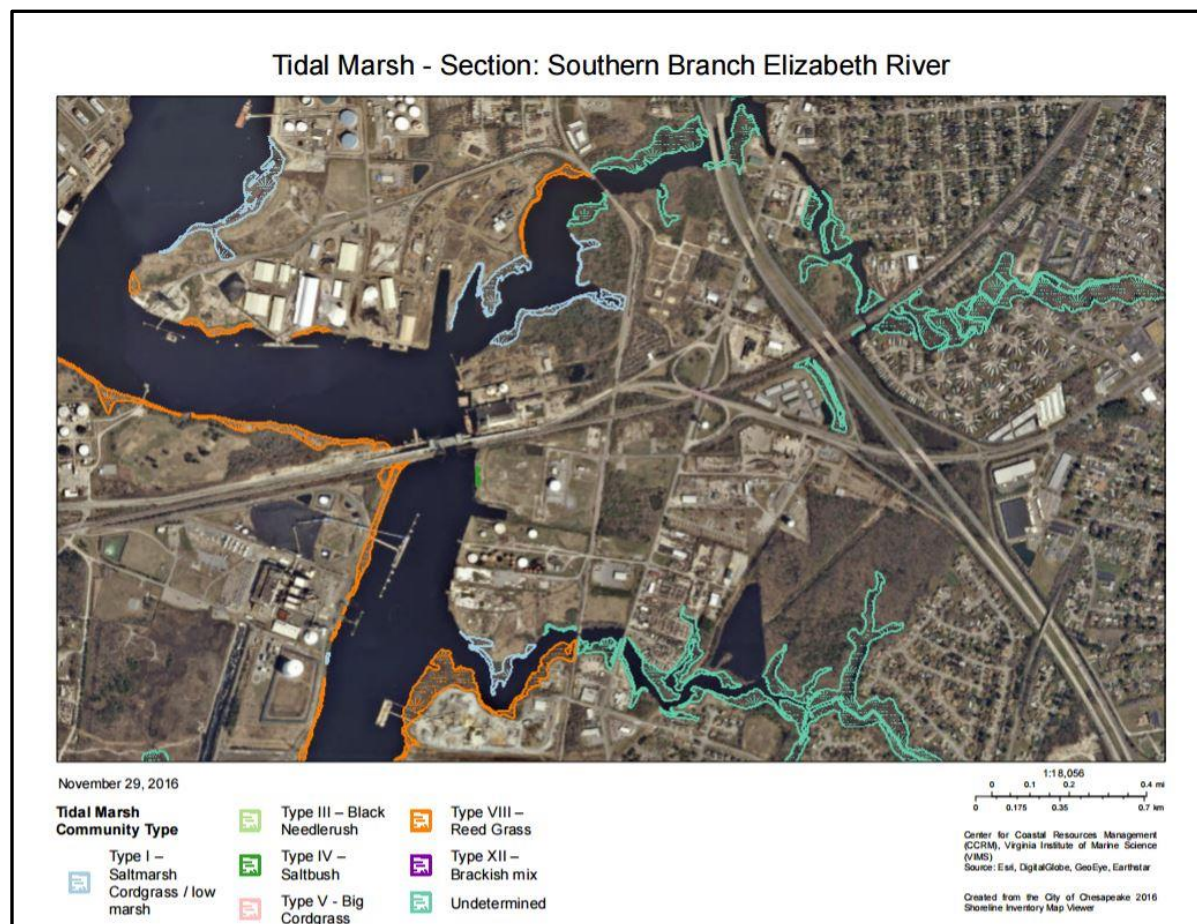
Finally, users have the option to personalize their own maps (i.e. map extent, data displayed, map title, etc.) and save them as a pdf file by clicking “Select Print Layout” button. The page can be set up for printing to 8.5 x 11 portrait or landscape style. Figure 8 is an example of a customized map generated for a section of the Elizabeth River (Southern Branch). Here the tidal marsh communities are displayed, and the community type is reported in the legend beside the illustration.

Figure 8. Customized print window for a section of the Elizabeth River (Southern Branch)
