# Gloucester County, Virginia Shoreline Inventory Report Methods and Guidelines

**Comprehensive Coastal Inventory Program  
Center for Coastal Resources Management  
Virginia Institute of Marine Science, College of William and Mary  
Gloucester Point, Virginia  
January 2015**

Special report in Applied Marine Science and Ocean Engineering No. 441 of the Virginia Institute of Marine Science

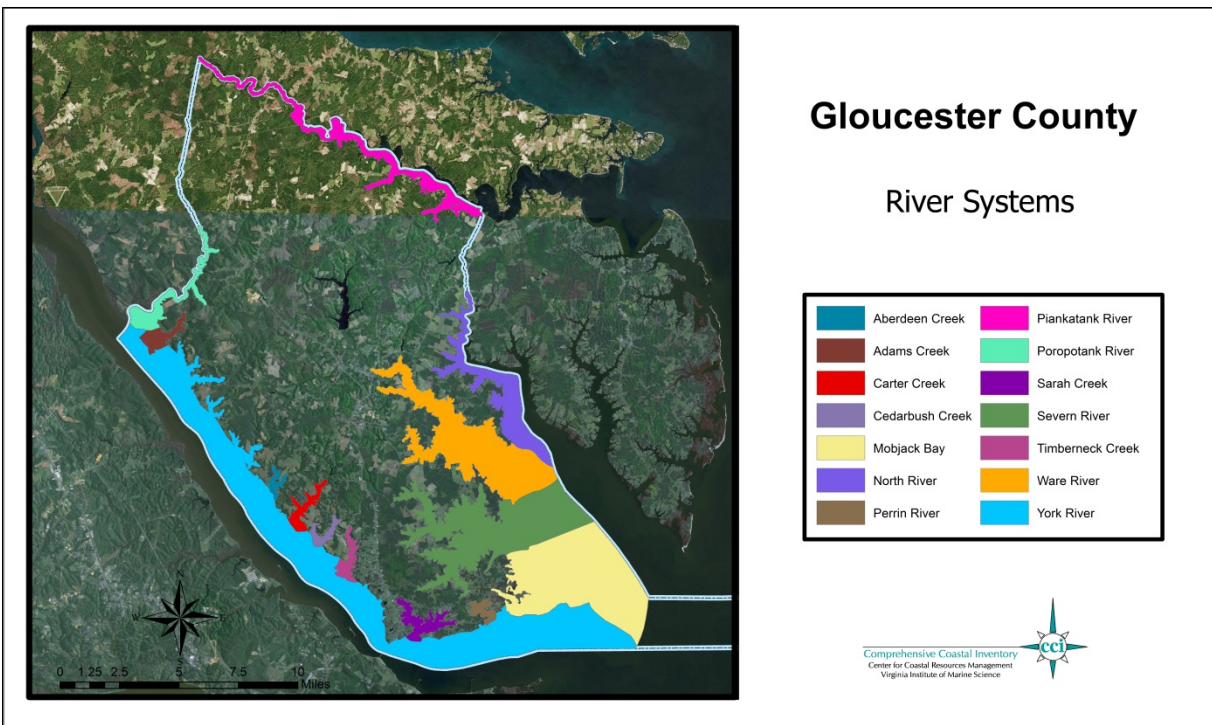
Figure 2. River Systems in Gloucester County

Summary tables (Tables 4-7) quantify conditions observed on the basis of river systems (Figure 2). Refer to Figure 2 for the location of these rivers systems. In Gloucester County, 569 miles of shoreline were remotely surveyed. All these areas are noted in Table 4.

The top toolbar also includes tabs to access some important status information for the locality. By clicking on the “River System Pie Charts” button, users can obtain a statistical summary distribution of the riparian land use and amount of hardened shoreline for a specific water body selected from the drop down menu in the upper left (Figure 7). More detailed results in table format can be found by clicking the Gloucester County Summary PDF button also in the window. The summary statistics are reported by river systems (Figure 2).

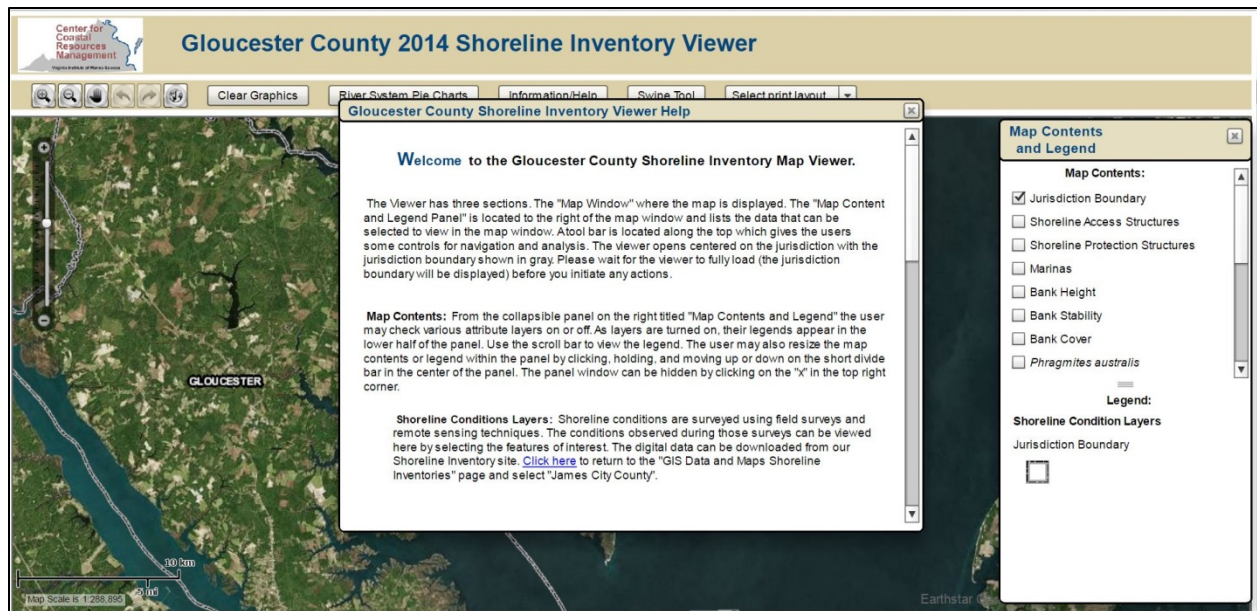
Figure 3. Opening page for the Gloucester County Shoreline Inventory Viewer

The Viewer has two panels: “Map Window”, where the map is displayed and “Map Contents and Legend”, where data that can be selected and viewed in the map window are listed. A tool bar is located along the top of the “Map Window” which gives users some controls for navigation and analysis (Figure 3.).

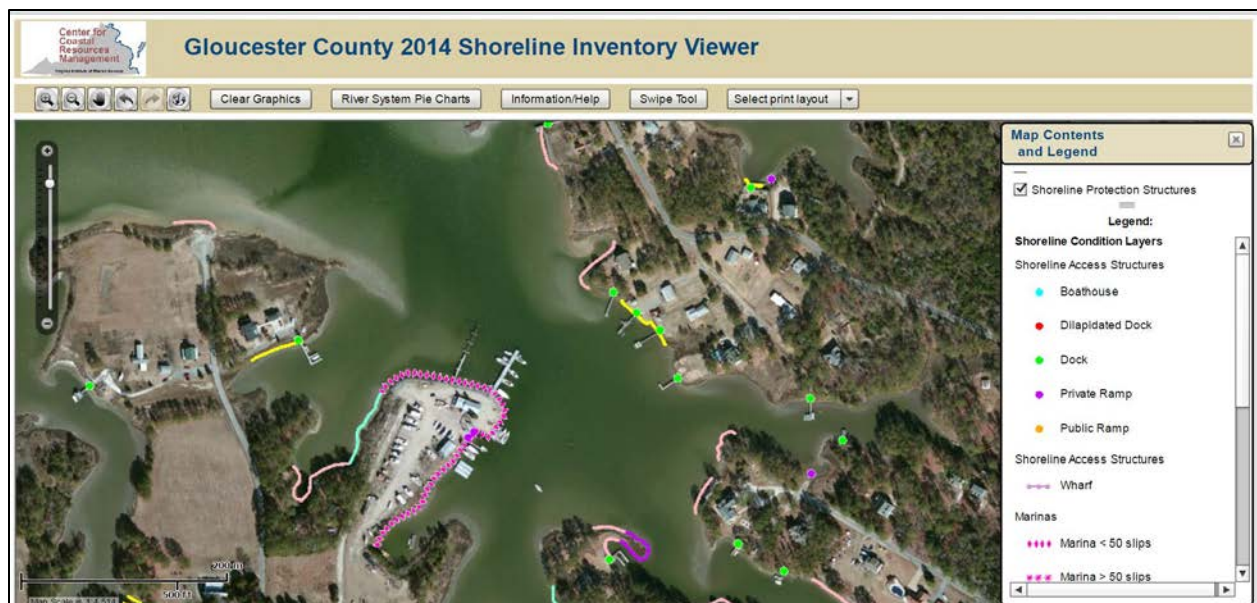
Figure 4. Map Viewer illustrates Shoreline Access and Protection Structures for a section of the County.

In Figure 4 Shoreline Access Structures, and Shoreline Protection structures are selected. Shoreline Access structures are point features that includes piers and boat ramps. The actual footprint of these structures is not measured; only their location. Shoreline Protection Structures are line features and are mapped and illustrated in the viewer to show where they occur along the shoreline. Figure 5 illustrates riparian land use in the riparian zone for the same section of the County.

From the “Map Contents and Legend” the user may check various attribute layers on or off. The user must use the scroll bar on the far right to see the complete list of attributes available. When layers are turned on, the corresponding legend appears in the lower half of the panel, and the data are displayed in the “Map Window” (Figure 4).

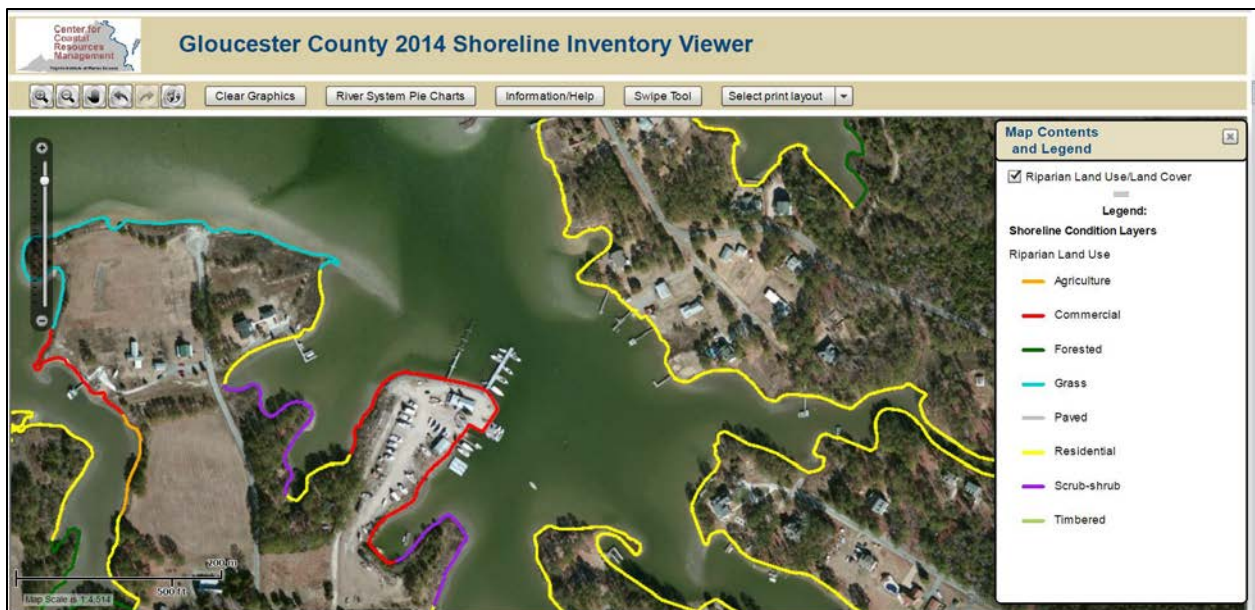
Figure 5. Distribution of land use in the riparian zone is displayed for this region of the County.

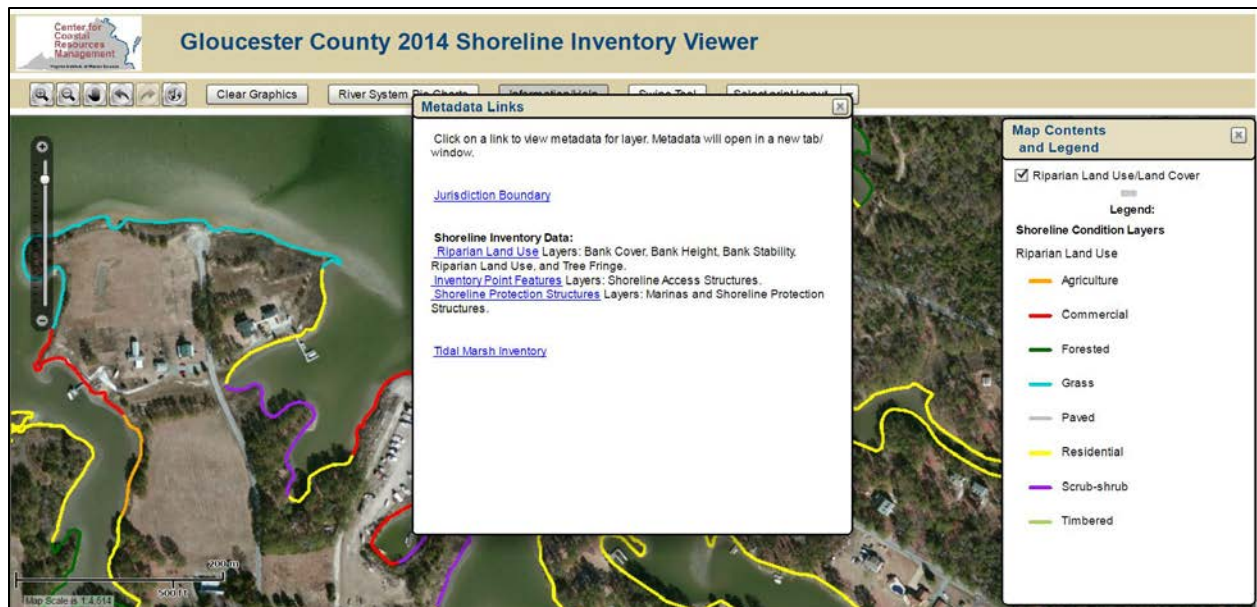
Figure 6. Link to Metadata records has been selected from the top Information tab in the toolbar.

The user can use the zoom and pan tools from the top toolbar or the slide bar on the left side of the map window to change their map extent. If the map resolution is exceeded the window will become illegible. Detailed information can be obtained about the data by selecting the “Information/Help” tab at the top of the map viewer. From here the inventory glossary and metadata records can be easily accessed. In Figure 6 the selection for metadata has been made and 5 possible records can be retrieved.

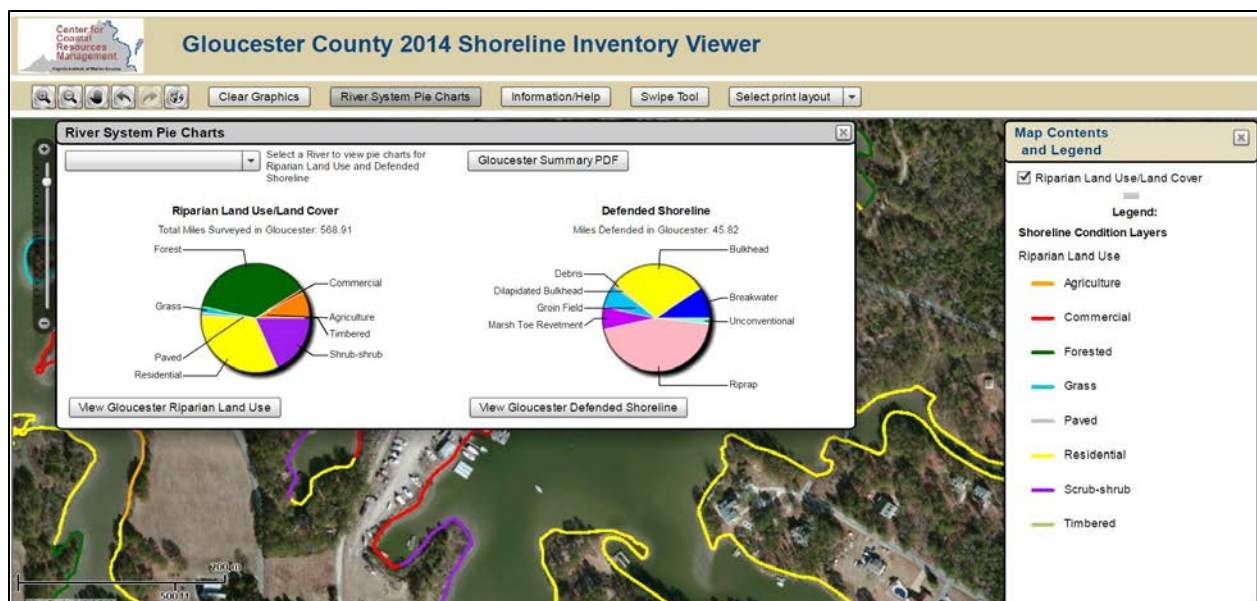
Figure 7. Pie charts display land use and shoreline hardening statistics for each tributary.

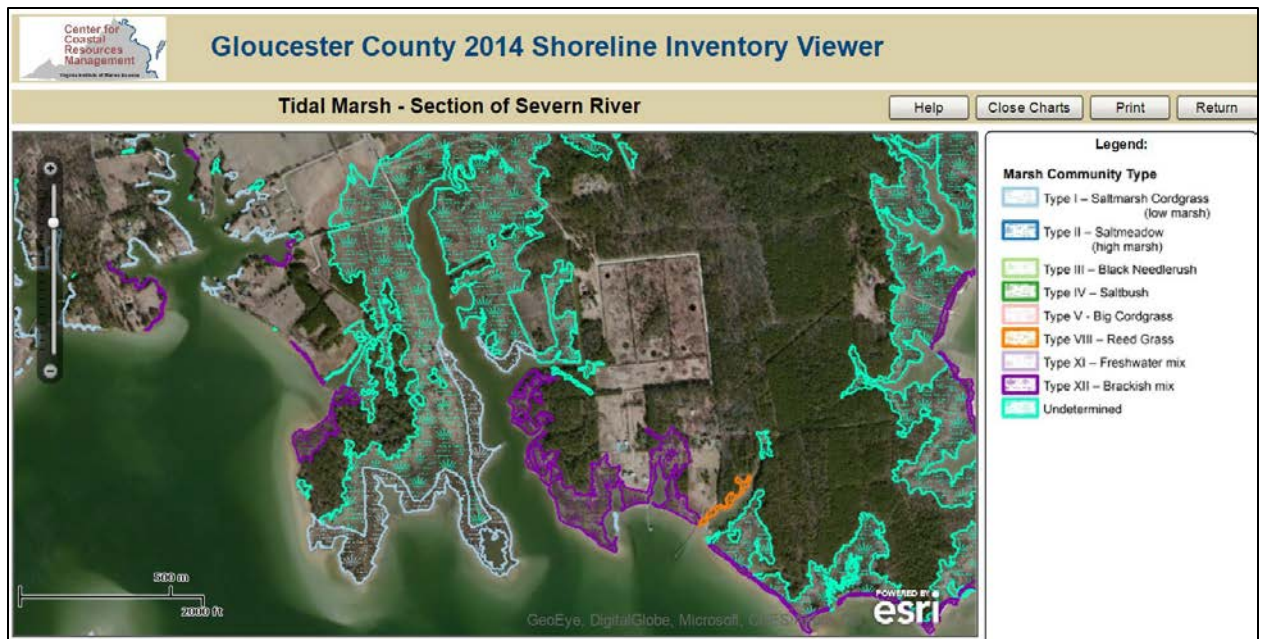
Figure 8. Customized print window for a section of Severn River.

Finally, users have the option to personalize their own maps (i.e. map extent, data displayed, map title, etc) and print them by clicking “Go to Print” button. The map legend and the charts display below the map. The page can be set up for printing to 8.5 x 11 portrait or landscape style. Figure 8 is an example of a customized map generated for a section of the Severn River. Here the tidal marsh communities are displayed, and the community type is reported in the legend beside the illustration.
