# **James City County and City of Williamsburg, Virginia Shoreline Inventory Report Methods and Guidelines**

Special report in Applied Marine Science and Ocean Engineering No. 440 of the Virginia Institute of Marine Science

## James City County and City of Williamsburg- Shoreline Inventory Report

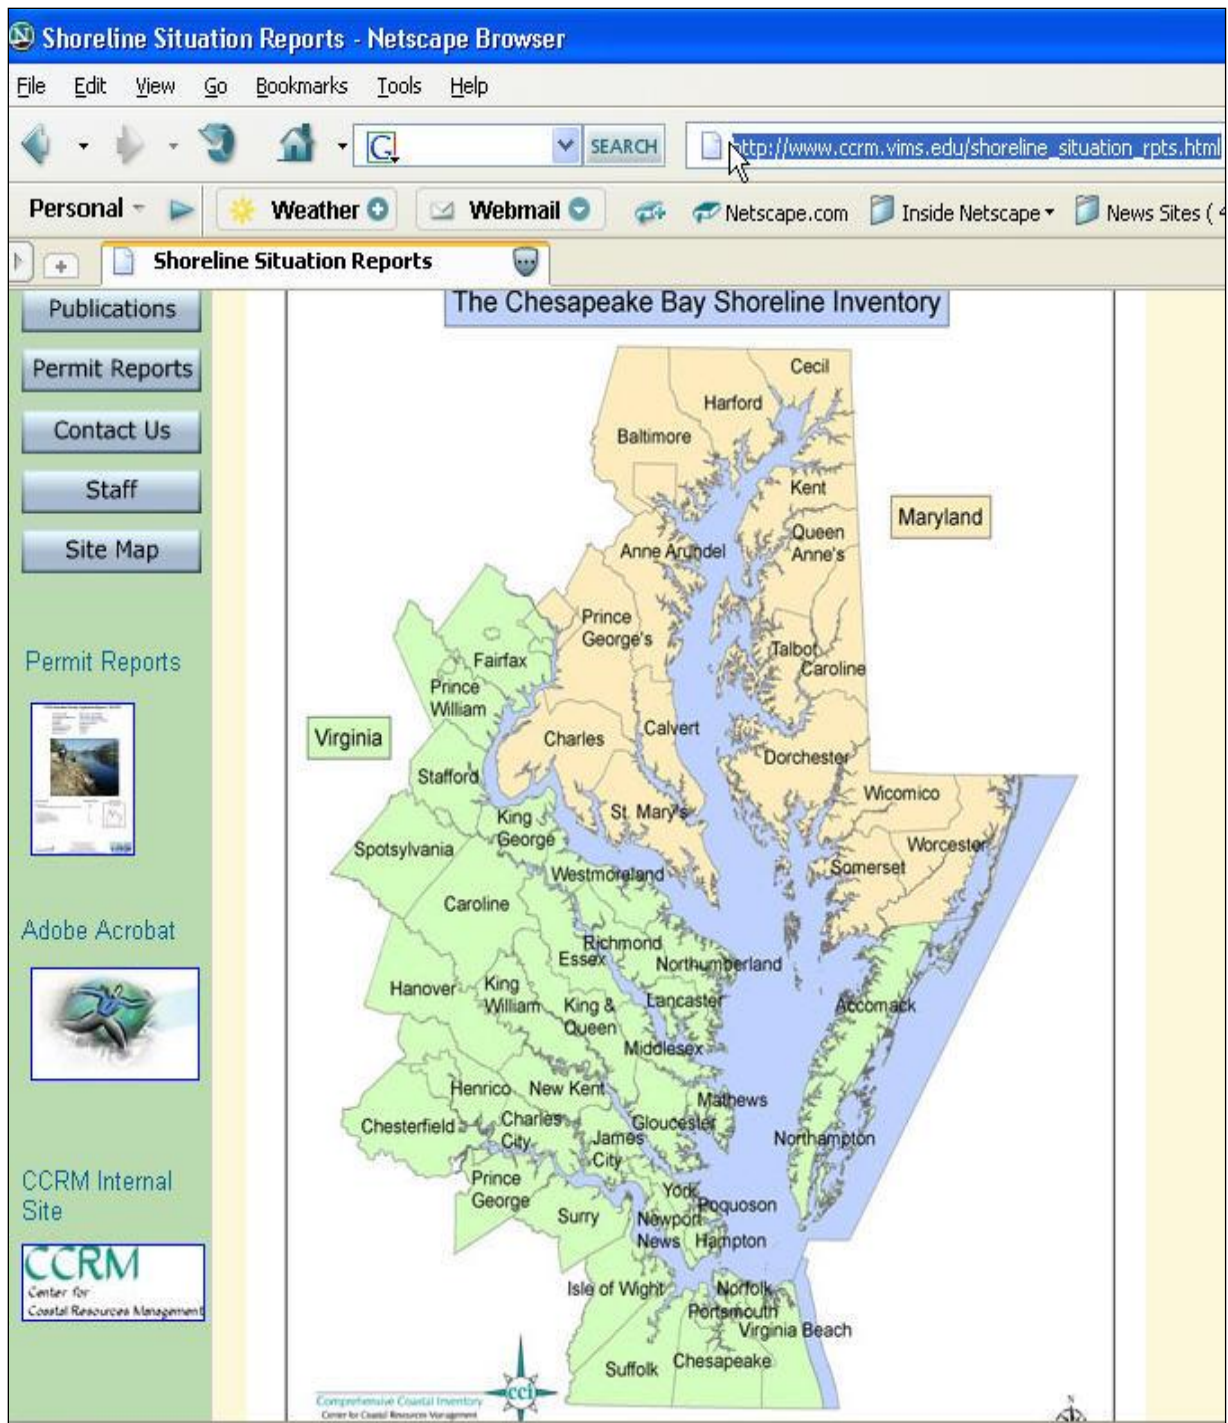
Figure 1. Shoreline Inventory Website

2.4c.) Map Viewer and Summary Tables: The James City County and City of Williamsburg Shoreline Inventory is delivered to the end user through a website; [http://ccrm.vims.edu/gis\\_data\\_maps/shoreline\\_inventories/index.html](http://ccrm.vims.edu/gis_data_maps/shoreline_inventories/index.html) (Figure 1.), by clicking on James City County and City of Williamsburg in the map or list of localities. The format for this inventory includes a map viewing tool rather than individual maps as in previous inventories. The map viewer allows users to interact with the datasets within a familiar “google” type map service that was developed in a Flex/Flash framework. Here they can view data of their choice and customize map products for printing themselves. Access to the GIS data, summary tables and methods report is also available through this website.

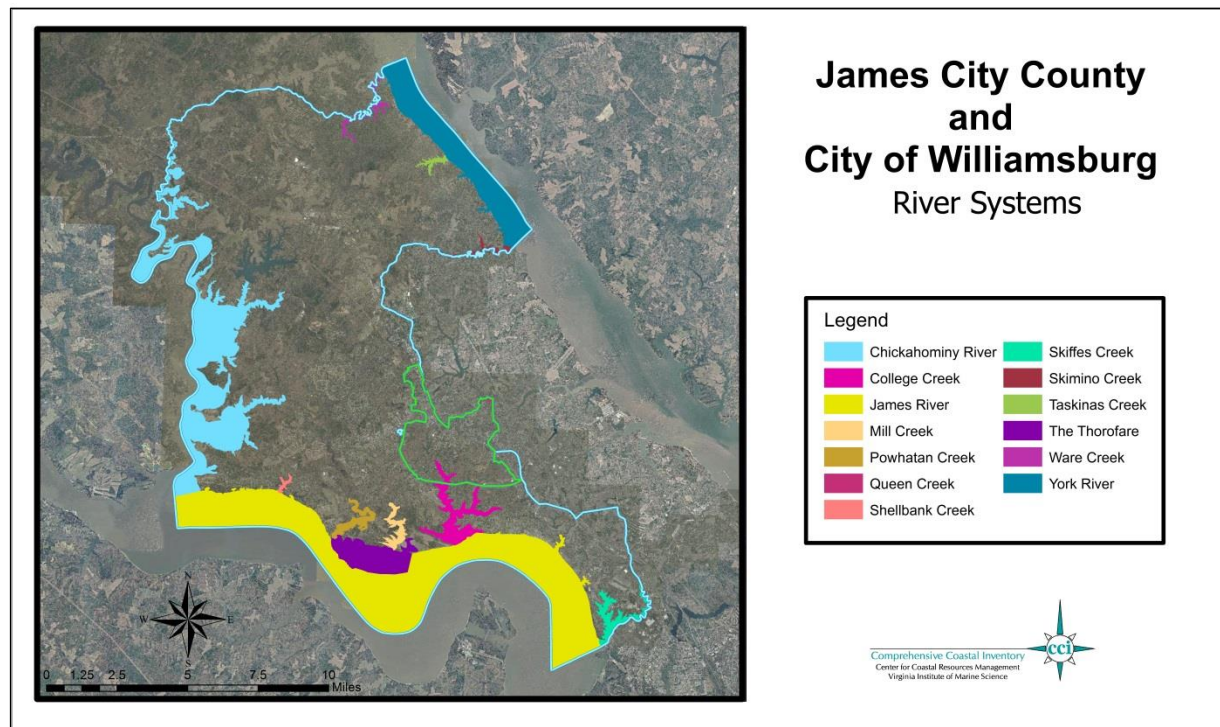
Figure 2. River Systems in James City County and City of Williamsburg

Summary tables (Tables 4-7) quantify conditions observed on the basis of river systems (Figure 2). Refer to Figure 2 for the location of these rivers systems. In James City County, 410 miles of shoreline were remotely surveyed and a total of 5 miles were remotely surveyed for the City of Williamsburg. All these areas are noted in Table 4.

The top toolbar also includes tabs to access some important status information for the locality. By clicking on the “River System Pie Charts” button, users can obtain a statistical summary distribution of the riparian land use and amount of hardened shoreline for a specific water body selected from the drop down menu in the upper left (Figure 7). More detailed results in table format can be found by clicking the James City County or City of Williamsburg Summary PDF button also in the window. The summary statistics are reported by river systems (Figure 2).

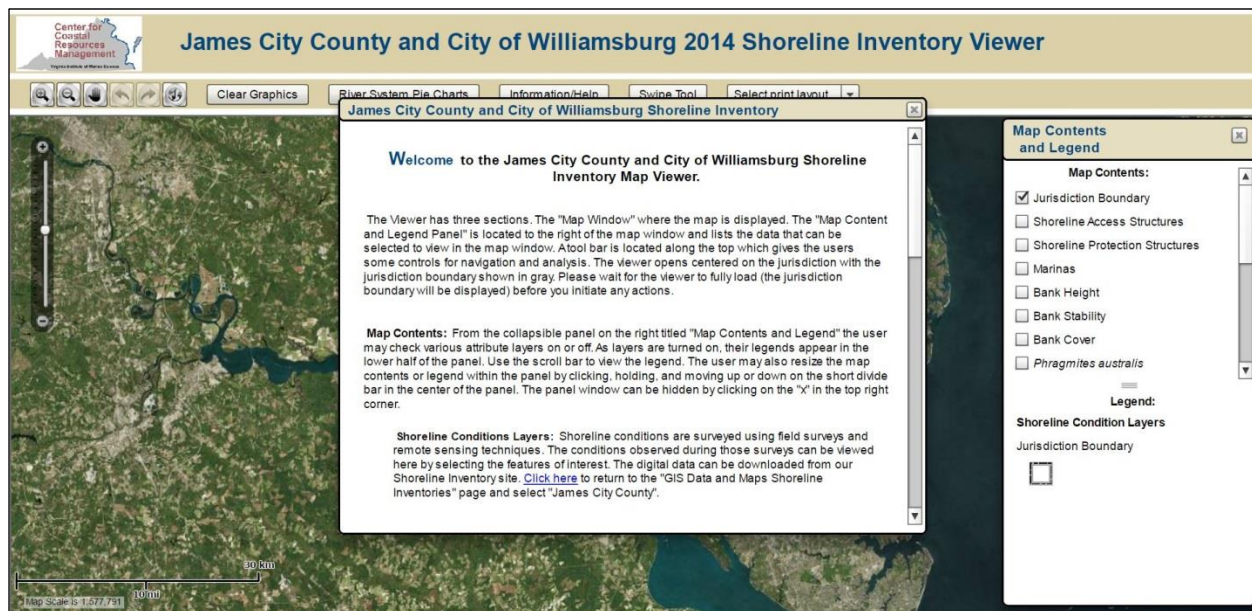
Figure 3. Opening page for the James City County and City of Williamsburg Shoreline Inventory Viewer

The Viewer has two panels: “Map Window”, where the map is displayed and “Map Contents and Legend”, where data that can be selected and viewed in the map window are listed. A tool bar is located along the top of the “Map Window” which gives users some controls for navigation and analysis (Figure 3.).

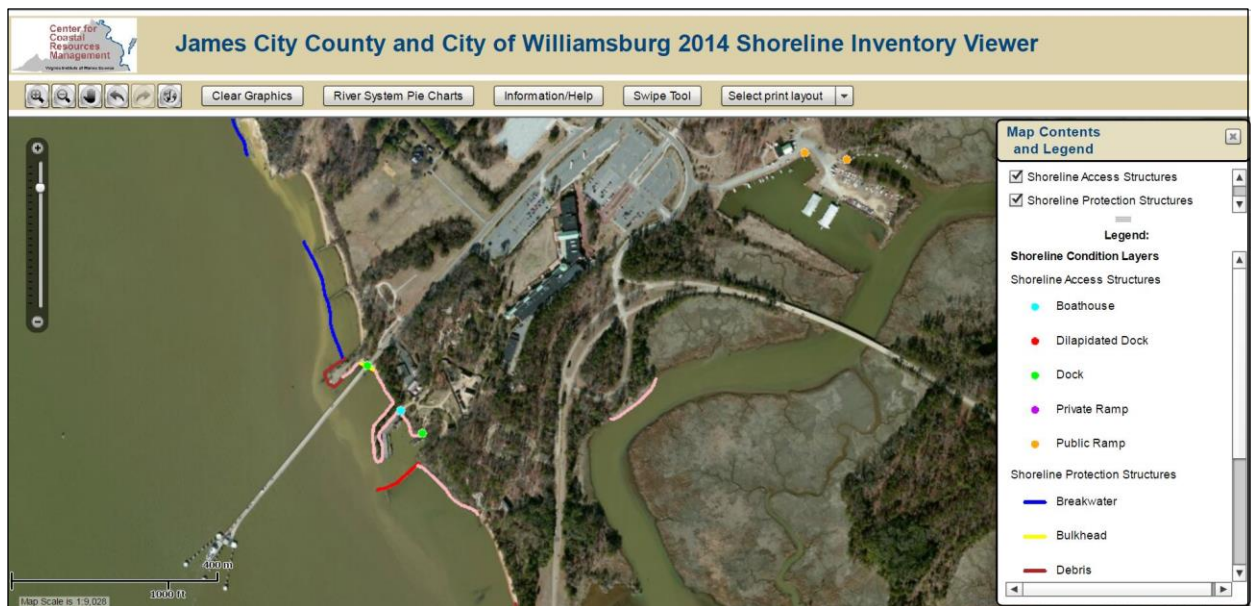
Figure 4. Map Viewer illustrates Shoreline Access and Protection Structures for a section of the County.

In Figure 4 Shoreline Access Structures, and Shoreline Protection structures are selected. Shoreline Access structures are point features that includes piers and boat ramps. The actual footprint of these structures is not measured; only their location. Shoreline Protection Structures are line features and are mapped and illustrated in the viewer to show where they occur along the shoreline. Figure 5 illustrates riparian land use in the riparian zone for the same section of the County.

From the “Map Contents and Legend” the user may check various attribute layers on or off. The user must use the scroll bar on the far right to see the complete list of attributes available. When layers are turned on, the corresponding legend appears in the lower half of the panel, and the data are displayed in the “Map Window” (Figure 4).

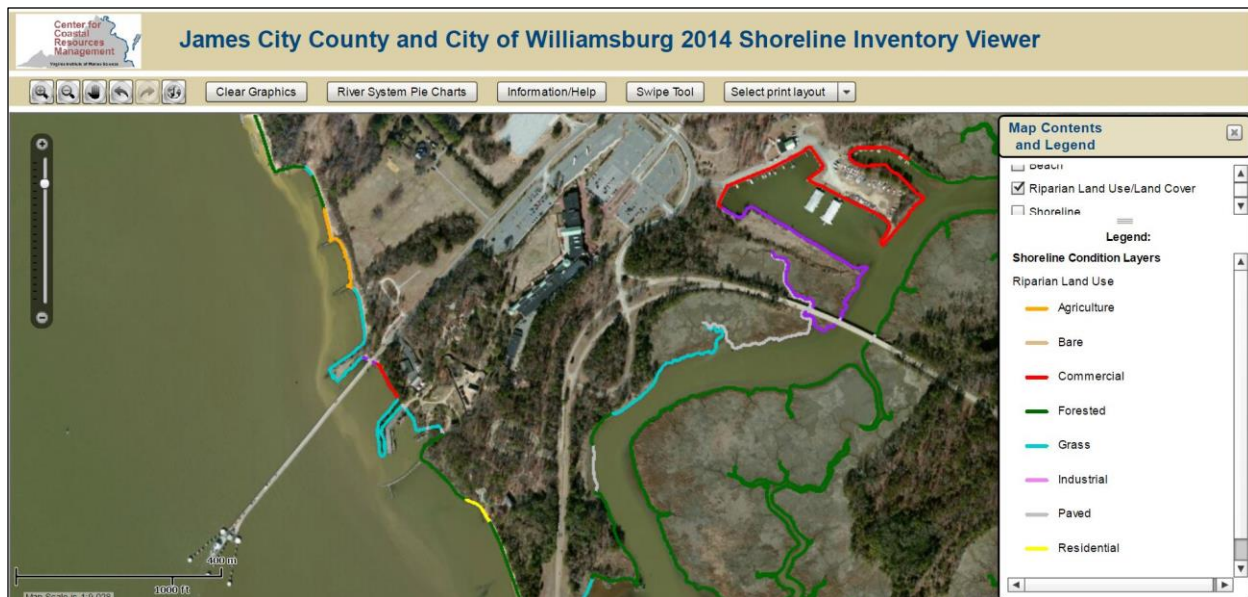
Figure 5. Distribution of land use in the riparian zone is displayed for this region of the County.

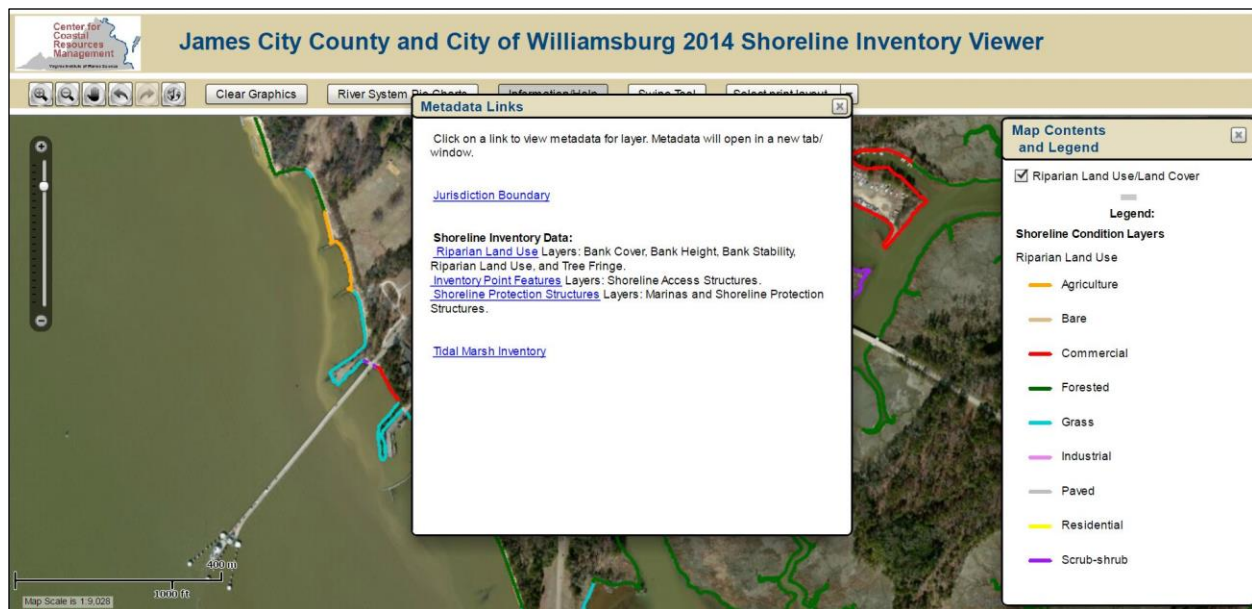
The user can use the zoom and pan tools from the top toolbar or the slide bar on the left side of the map window to change their map extent. If the map resolution is exceeded the window will become illegible. Detailed information can be obtained about the data by selecting the “Information/Help” tab at the top of the map viewer. From here the inventory glossary and metadata records can be easily accessed. In Figure 6 the selection for metadata has been made and 5 possible records can be retrieved.

Figure 6. Link to Metadata records has been selected from the top Information tab in the toolbar.

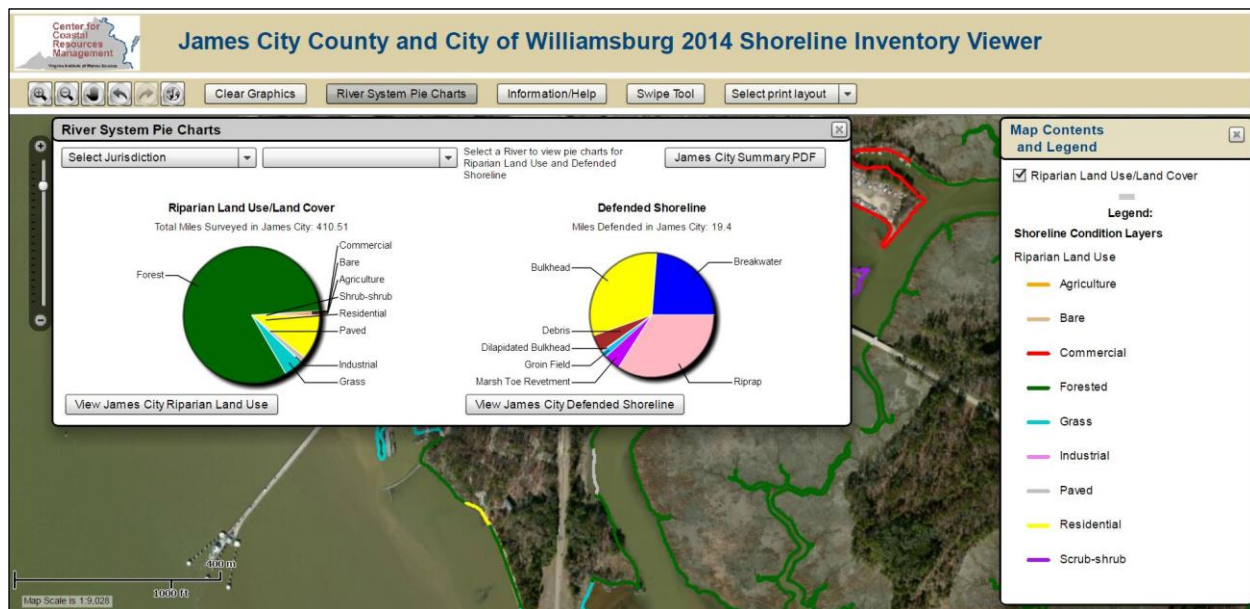
Figure 7. Pie charts display land use and shoreline hardening statistics for each tributary.

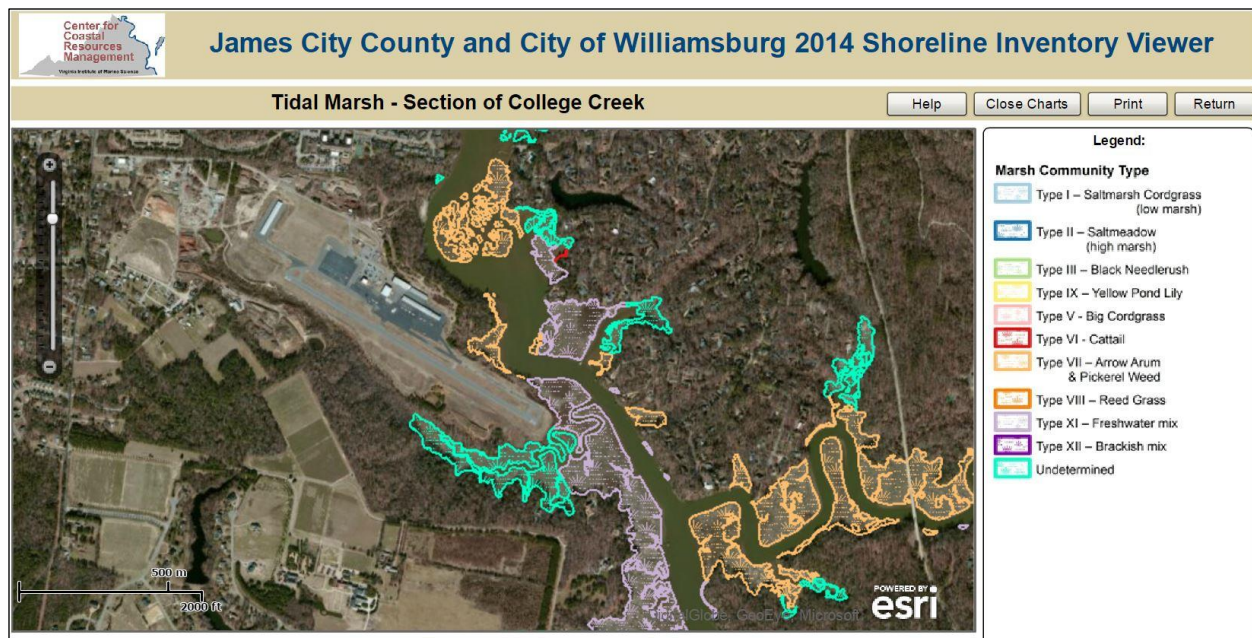
Finally, users have the option to personalize their own maps (i.e. map extent, data displayed, map title, etc.) and print them by clicking “Go to Print” button. The map legend and the charts display below the map. The page can be set up for printing to 8.5 x 11 portrait or landscape style. Figure 8 is an example of a customized map generated for a section of College Creek. Here the tidal marsh communities are displayed, and the community type is reported in the legend beside the illustration.

Figure 8. Customized print window for a section of College Creek.
