# **Lancaster County, Virginia Shoreline Inventory Report Methods and Guidelines**

**Comprehensive Coastal Inventory Program  
Center for Coastal Resources Management  
Virginia Institute of Marine Science, College of William and Mary  
Gloucester Point, Virginia  
December 2015**

Special report in Applied Marine Science and Ocean Engineering No. 448 of the Virginia Institute of Marine Science

## Lancaster County- Shoreline Inventory Report

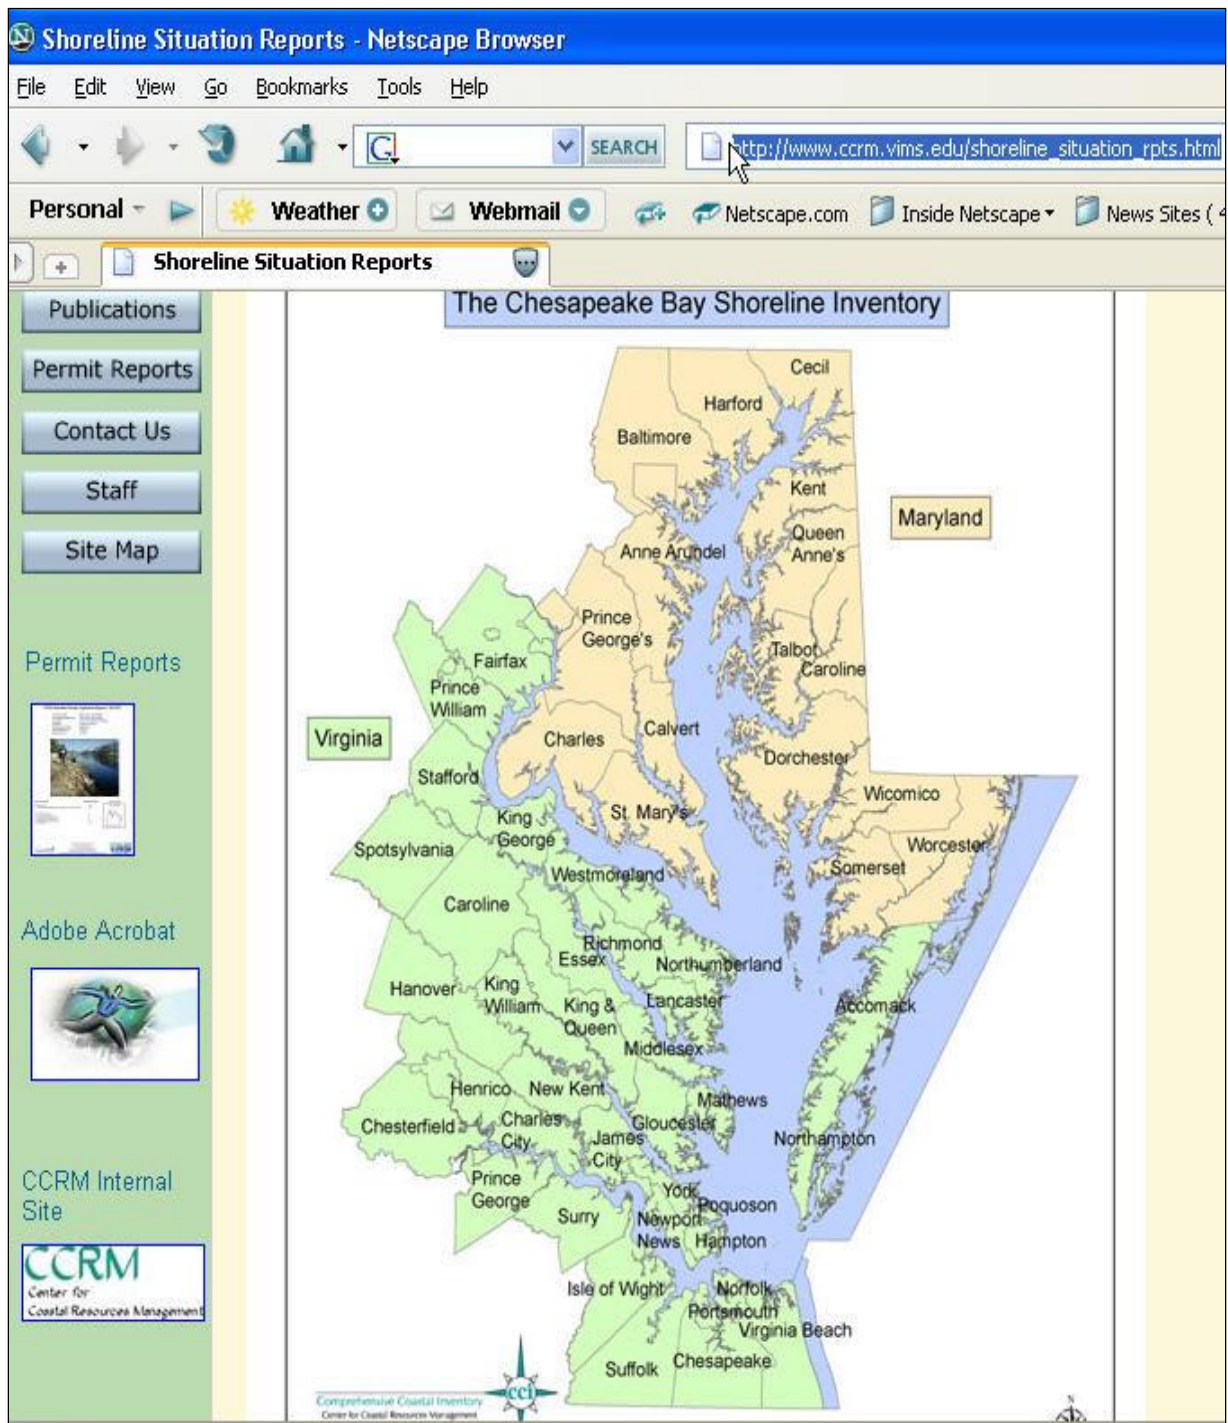
Figure 1. Shoreline Inventory Website

2.4c.) Map Viewer and Summary Tables: The Lancaster County Shoreline Inventory is delivered to the end user through a website; [http://ccrm.vims.edu/gis\\_data\\_maps/shoreline\\_inventories/index.html](http://ccrm.vims.edu/gis_data_maps/shoreline_inventories/index.html) (Figure 1.), by clicking on Lancaster County in the map or list of localities. The new format for Shoreline Inventories includes a map viewing tool rather than maps in pdf format. The map viewer allows users to interact with the datasets within a familiar “google” type map service that was developed with Javascript. Here users can view data of their choice and customize map products for printing themselves. Access to the GIS data, summary tables and methods report is also available through this website.

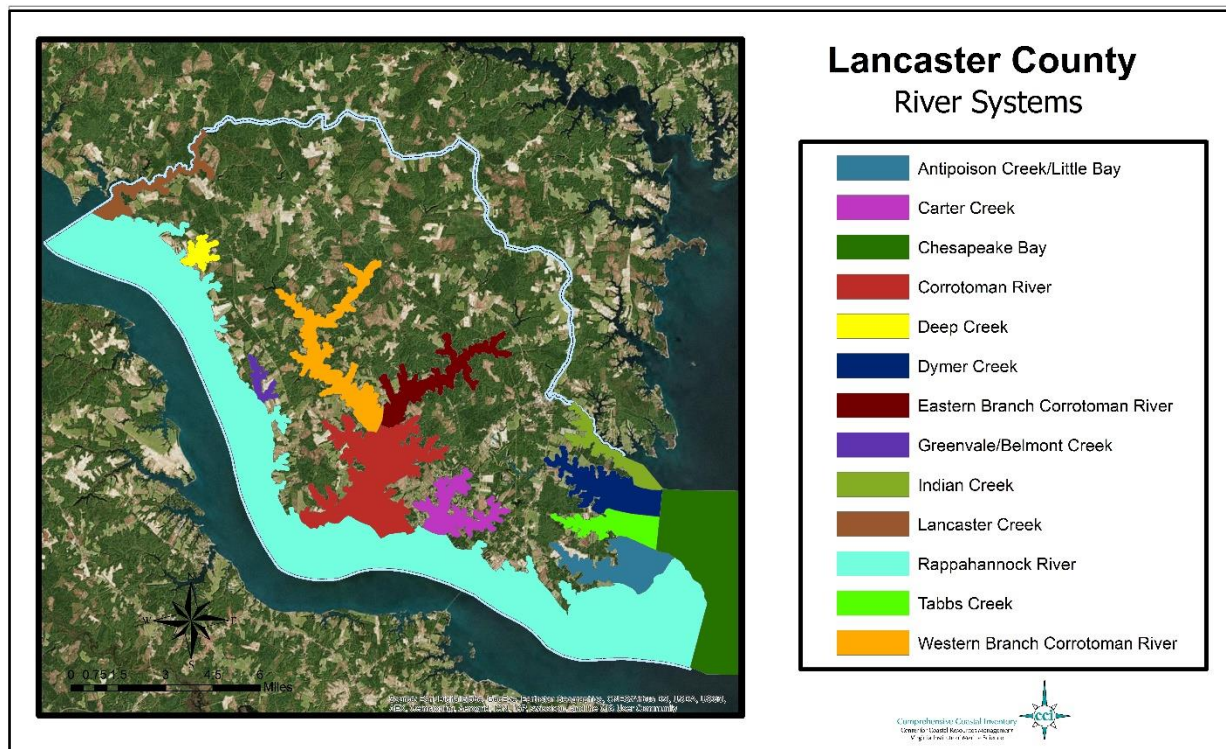
Figure 2. River Systems in the Lancaster County

Summary tables (Tables 4-7) quantify conditions observed on the basis of river systems (Figure 2). Refer to Figure 2 for the location of these rivers systems. Note, river systems do not correspond to watershed boundaries. They were developed for convenience in reporting data.

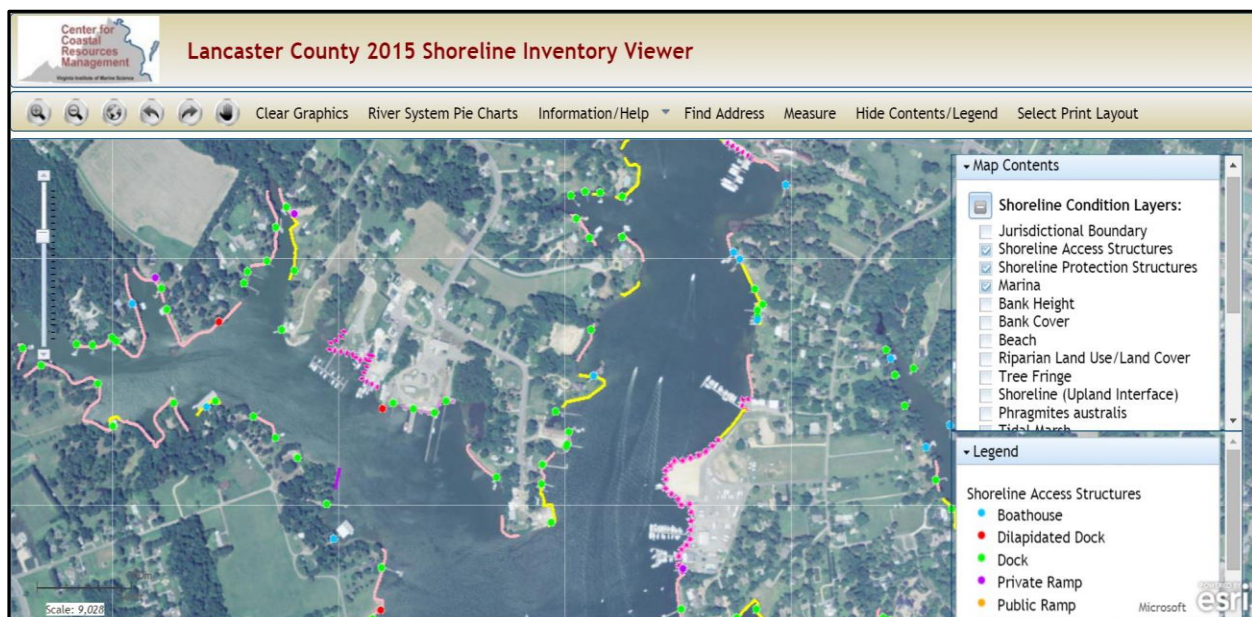
Figure 4. Map Viewer illustrates Shoreline Access and Protection Structures for a section of the County

In Figure 4 Shoreline Access Structures, and Shoreline Protection structures are selected. Shoreline Access structures are point features that includes piers and boat ramps. The actual footprint of these structures is not measured; only their location. Shoreline Protection Structures are line features and are mapped and illustrated in the viewer to show where they occur along the shoreline. Figure 5 illustrates riparian land use in the riparian zone for the same section of the County.

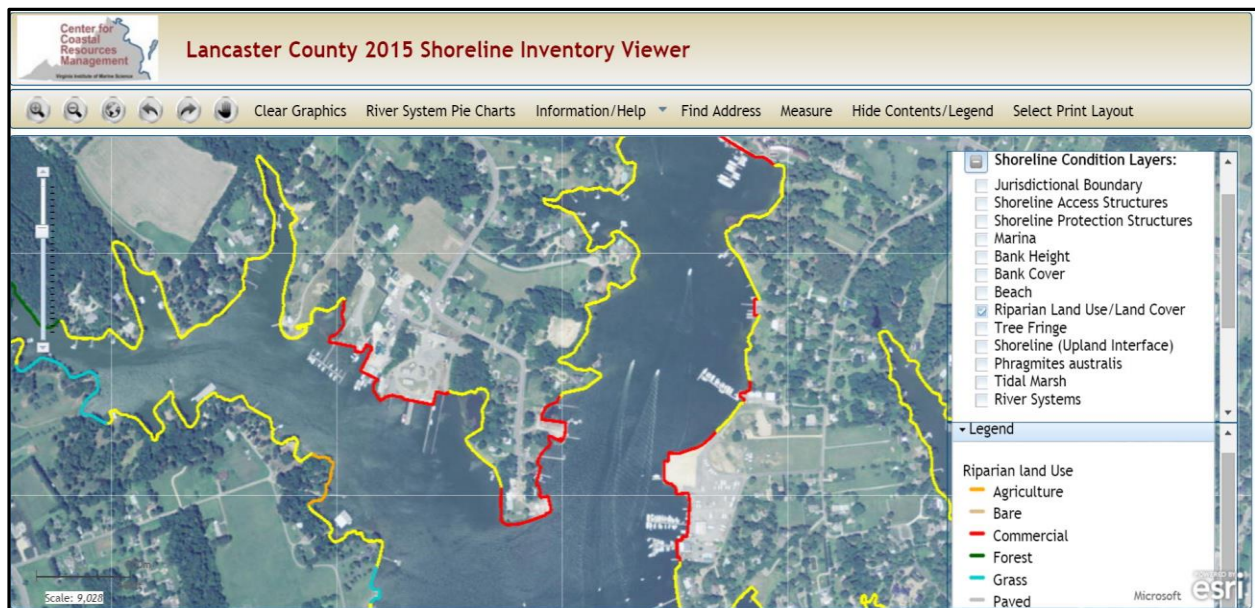
Figure 5. Distribution of land use in the riparian zone is displayed for this region of the County.

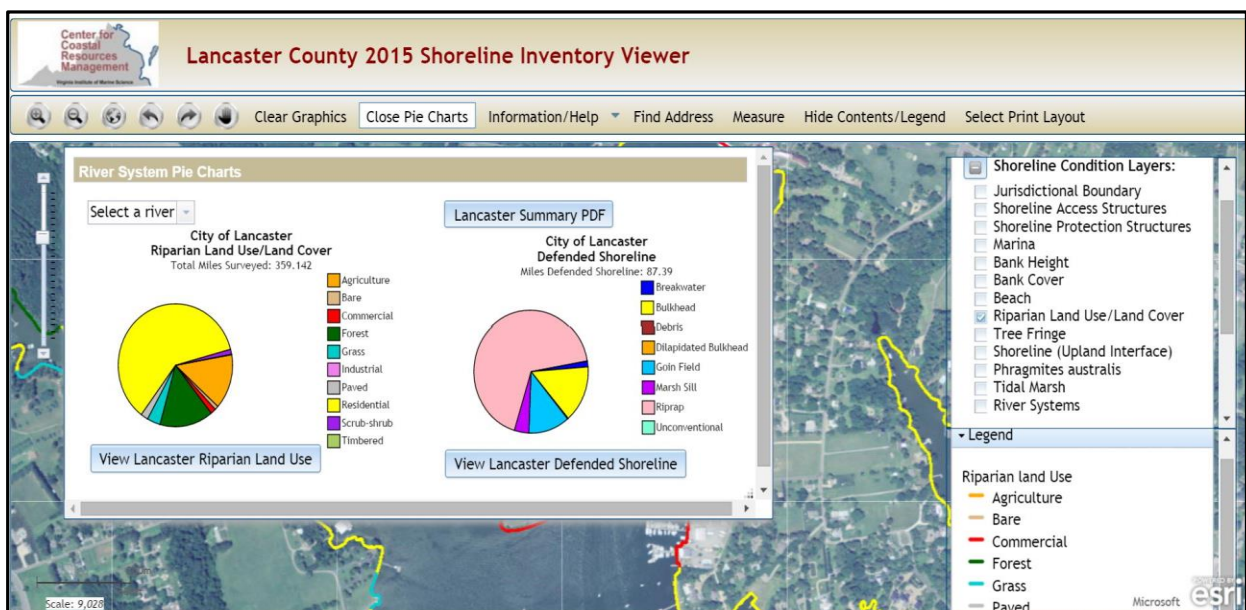
Figure 7. Pie charts display land use and shoreline hardening statistics for each tributary.

The top toolbar also includes tabs to access some important status information for the locality. By clicking on the “River System Pie Charts” button, users can obtain a statistical summary distribution of the riparian land use and amount of hardened shoreline for a specific water body selected from the drop down menu in the upper left (Figure 7). More detailed results in table format can be found by clicking the Lancaster County Summary PDF button also in the window. The summary statistics are reported by river systems (Figure 2).
