# **Middlesex County, Virginia Shoreline Inventory Report Methods and Guidelines**

Special report in Applied Marine Science and Ocean Engineering No 447 of the Virginia Institute of Marine Science

## Middlesex County- Shoreline Inventory Report

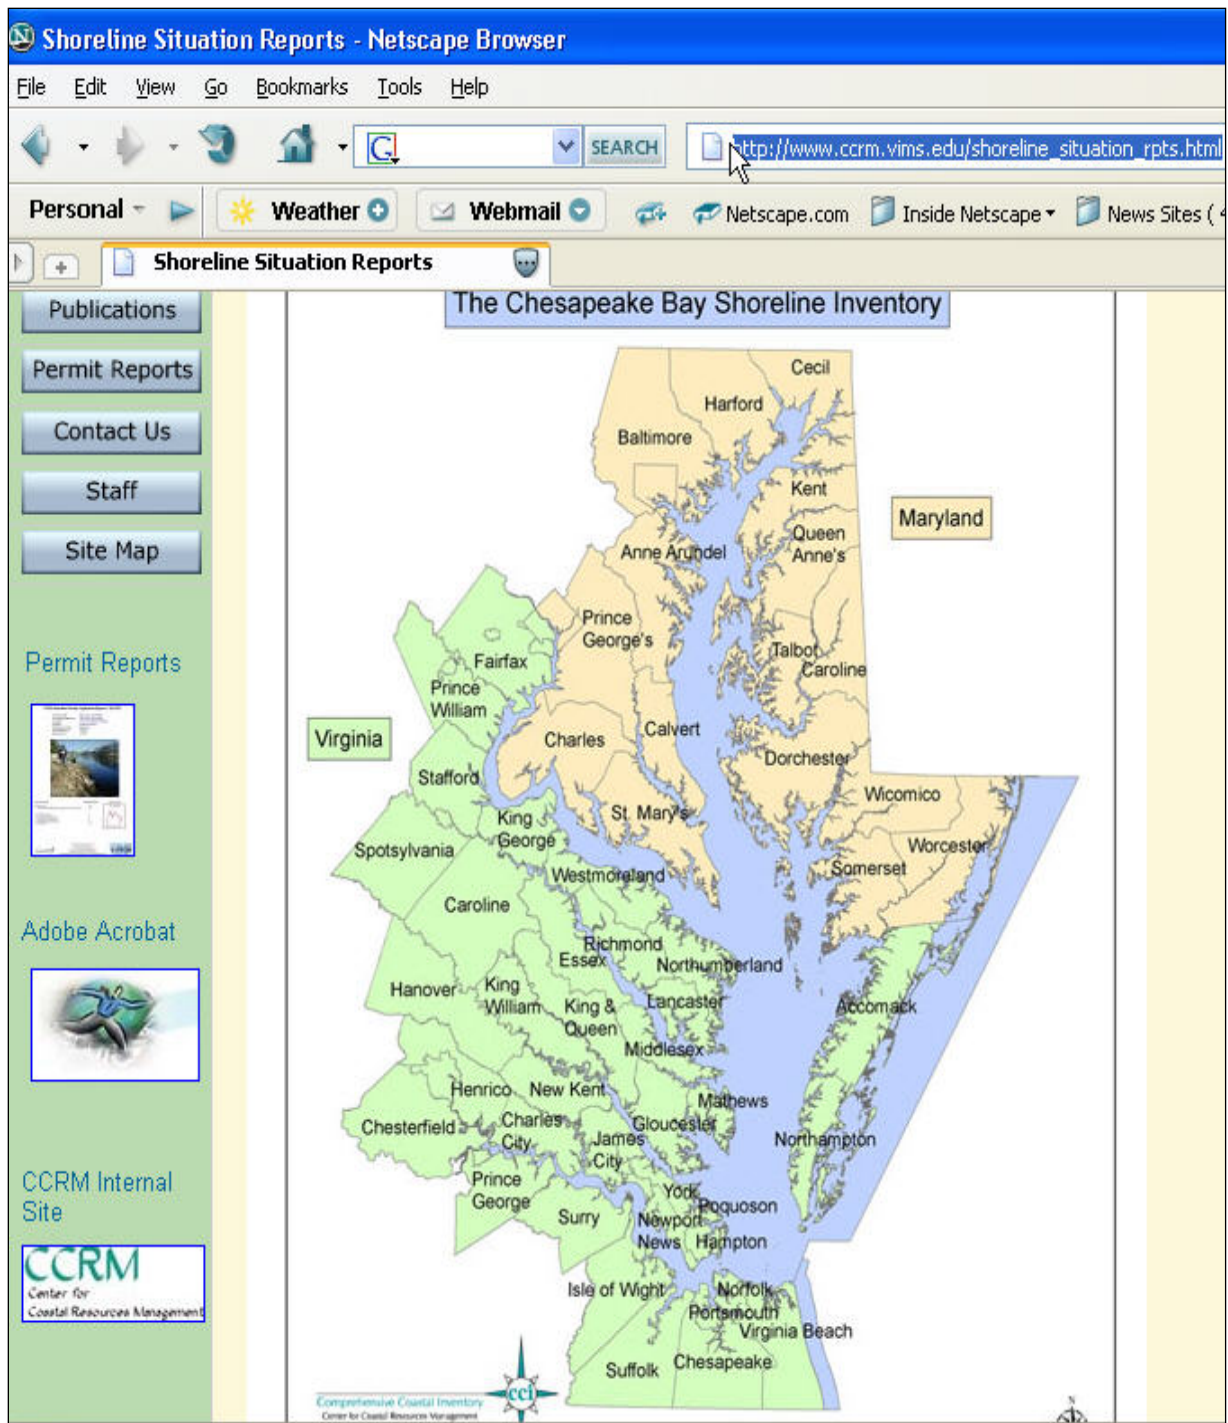
Figure 1. Shoreline Inventory Website

2.4c.) Map Viewer and Summary Tables: The Middlesex County Shoreline Inventory is delivered to the end user through a website; [http://ccrm.vims.edu/gis\\_data\\_maps/shoreline\\_inventories/index.html](http://ccrm.vims.edu/gis_data_maps/shoreline_inventories/index.html) (Figure 1.), by clicking on Middlesex County in the map or list of localities. The new format for Shoreline Inventories includes a map viewing tool rather than maps in pdf format. The map viewer allows users to interact with the datasets within a familiar “google” type map service that was developed with Javascript. Here they can view data of their choice and customize map products for printing themselves. Access to the GIS data, summary tables and methods report is also available through this website.

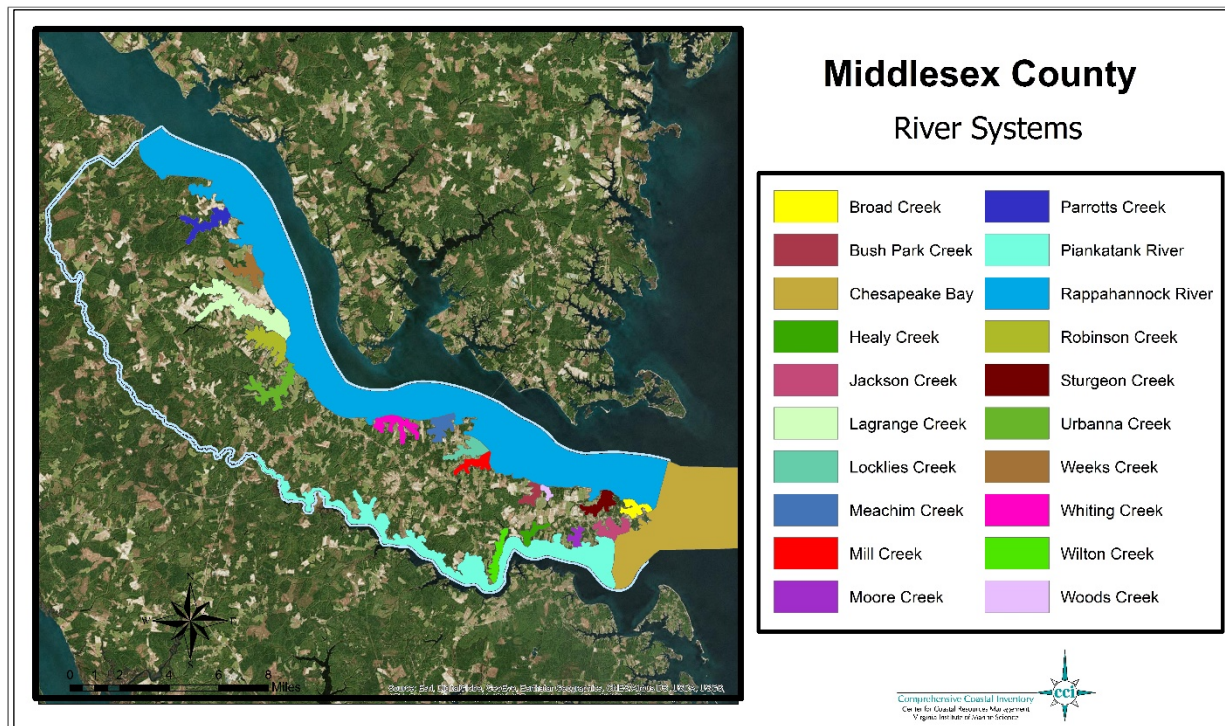
Figure 2. River Systems in Middlesex County

Summary tables (Tables 4-7) quantify conditions observed on the basis of river systems (Figure 2). Refer to Figure 2 for the location of these rivers systems. Note, river systems do not correspond to watershed boundaries. They were developed for convenience in reporting data.

The top toolbar also includes tabs to access some important status information for the locality. By clicking on the “River System Pie Charts” button, users can obtain a statistical summary distribution of the riparian land use and amount of hardened shoreline for a specific water body selected from the drop down menu in the upper left (Figure 7). More detailed results in table format can be found by clicking the Middlesex County Summary PDF button also in the window. The summary statistics are reported by river systems (Figure 2).

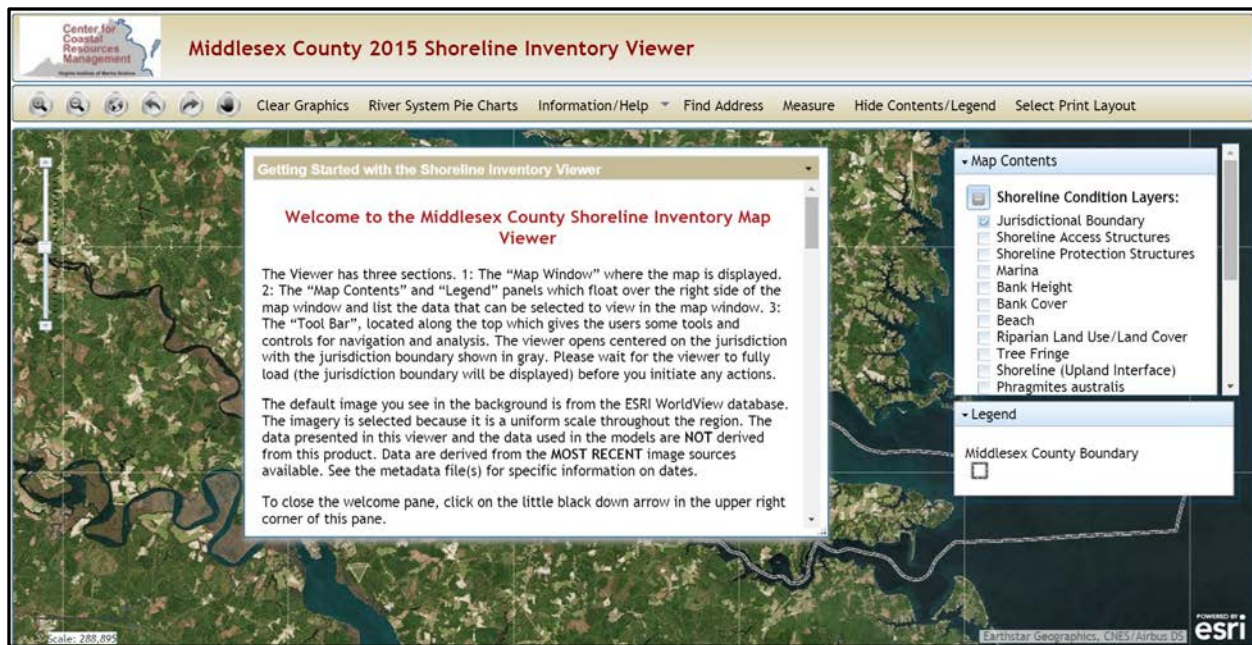
Figure 3. Opening page for the Middlesex County Shoreline Inventory Viewer

The Viewer has two panels: “Map Window”, where the map is displayed and “Map Contents and Legend”, where data that can be selected and viewed in the map window are listed. A tool bar is located along the top of the “Map Window” which gives users some controls for navigation and analysis (Figure 3.).

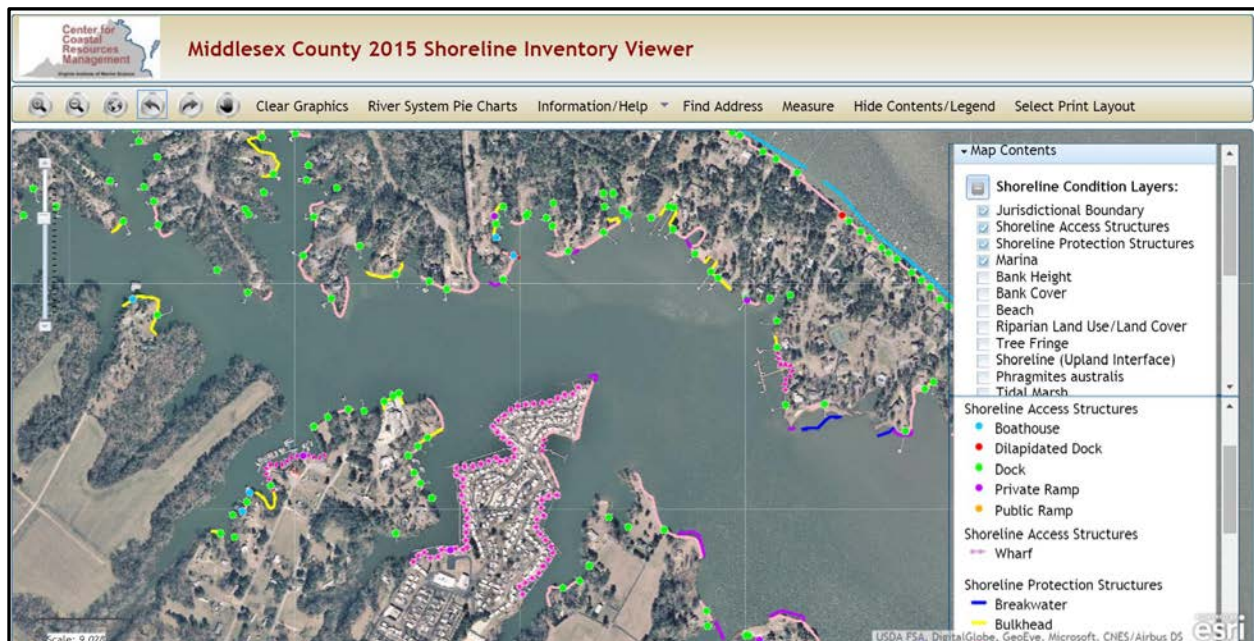
Figure 4. Map Viewer illustrates Shoreline Access and Protection Structures for a section of the County.

In Figure 4 Shoreline Access Structures, and Shoreline Protection structures are selected. Shoreline Access structures are point features that includes piers and boat ramps. The actual footprint of these structures is not measured; only their location. Shoreline Protection Structures are line features and are mapped and illustrated in the viewer to show where they occur along the shoreline. Figure 5 illustrates riparian land use in the riparian zone for the same section of the County.

From the "Map Contents" the user may check various attribute layers on or off. The user must use the scroll bar on the far right to see the complete list of layers available. When layers are turned on, the corresponding legend appears in the "Legend" panel, and the data are displayed in the "Map Window" (Figure 4).

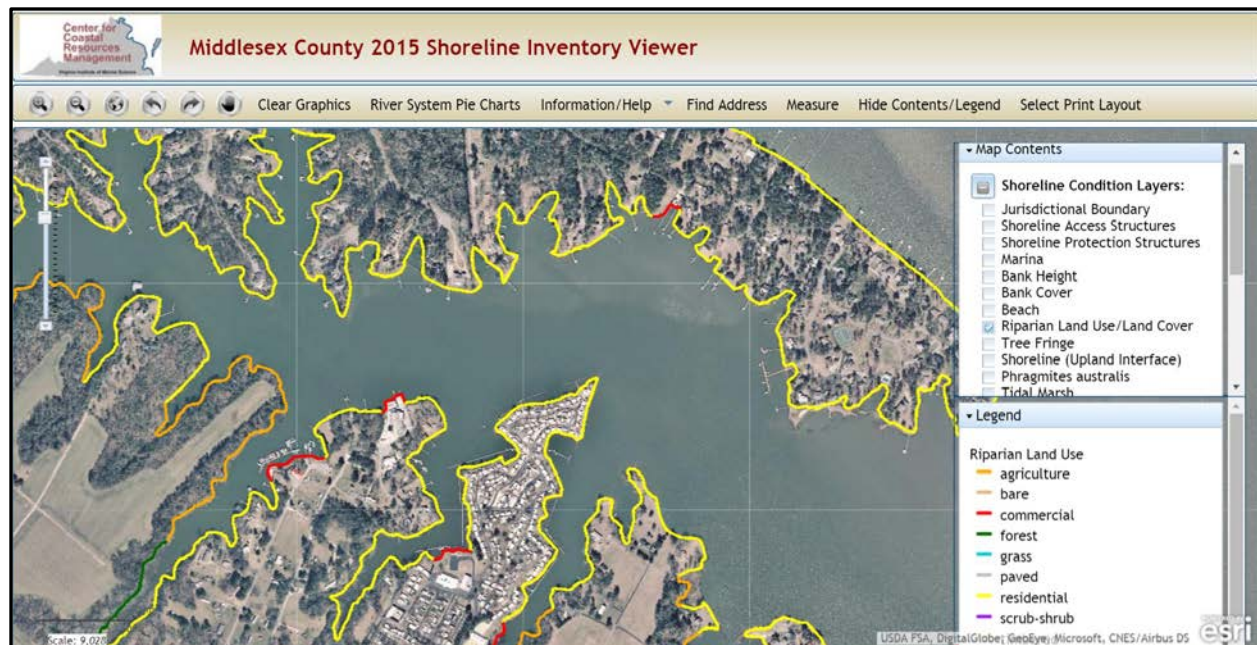
Figure 5. Distribution of land use in the riparian zone is displayed for this region of the County.

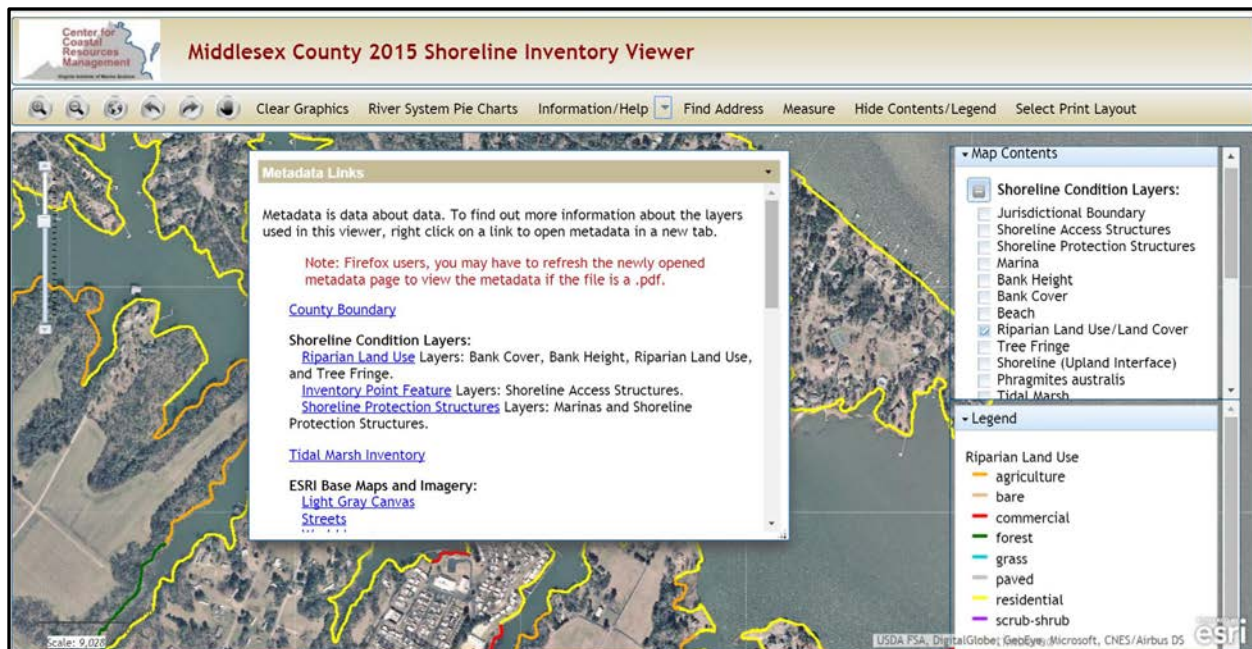
The user can use the zoom and pan tools from the top toolbar or the slide bar on the left side of the map window to change their map extent. If the map resolution is exceeded the window will become illegible. Detailed information can be obtained about the data by selecting the "Information/Help" tab at the top of the map viewer. From here the inventory glossary and metadata records can be easily accessed. In Figure 6 the selection for metadata has been made and 5 possible records can be retrieved.

Figure 6. Link to Metadata records has been selected from the top Information tab in the toolbar.

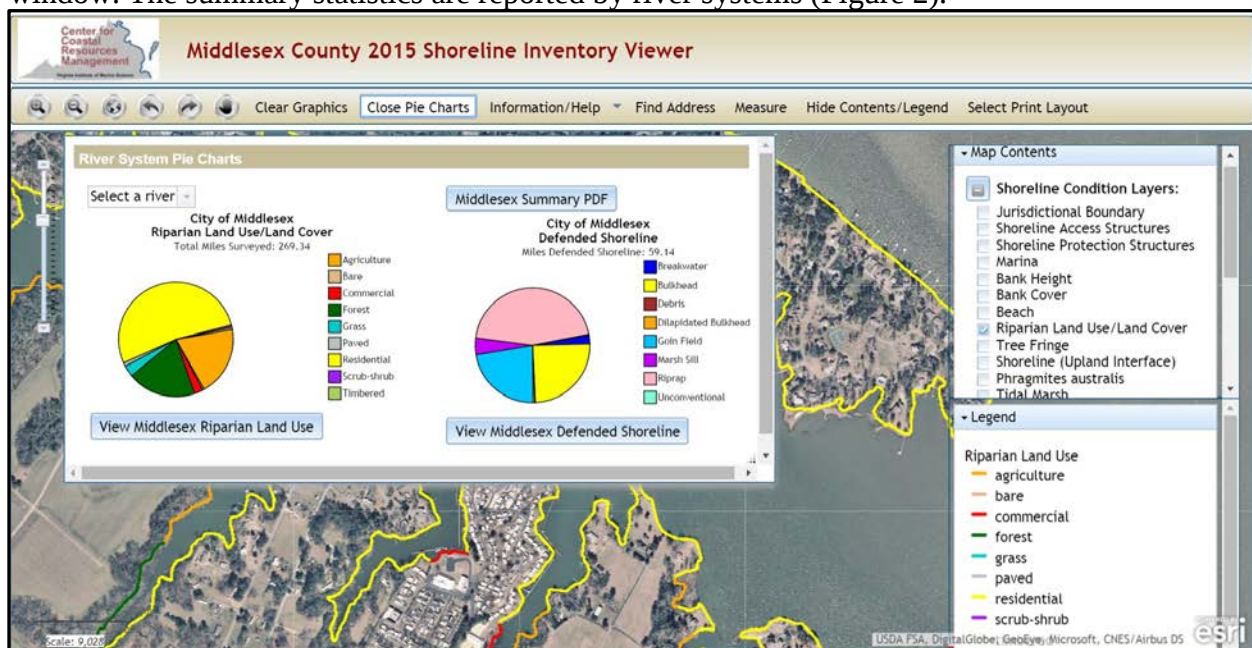
Figure 7. Pie charts display land use and shoreline hardening statistics for each tributary.

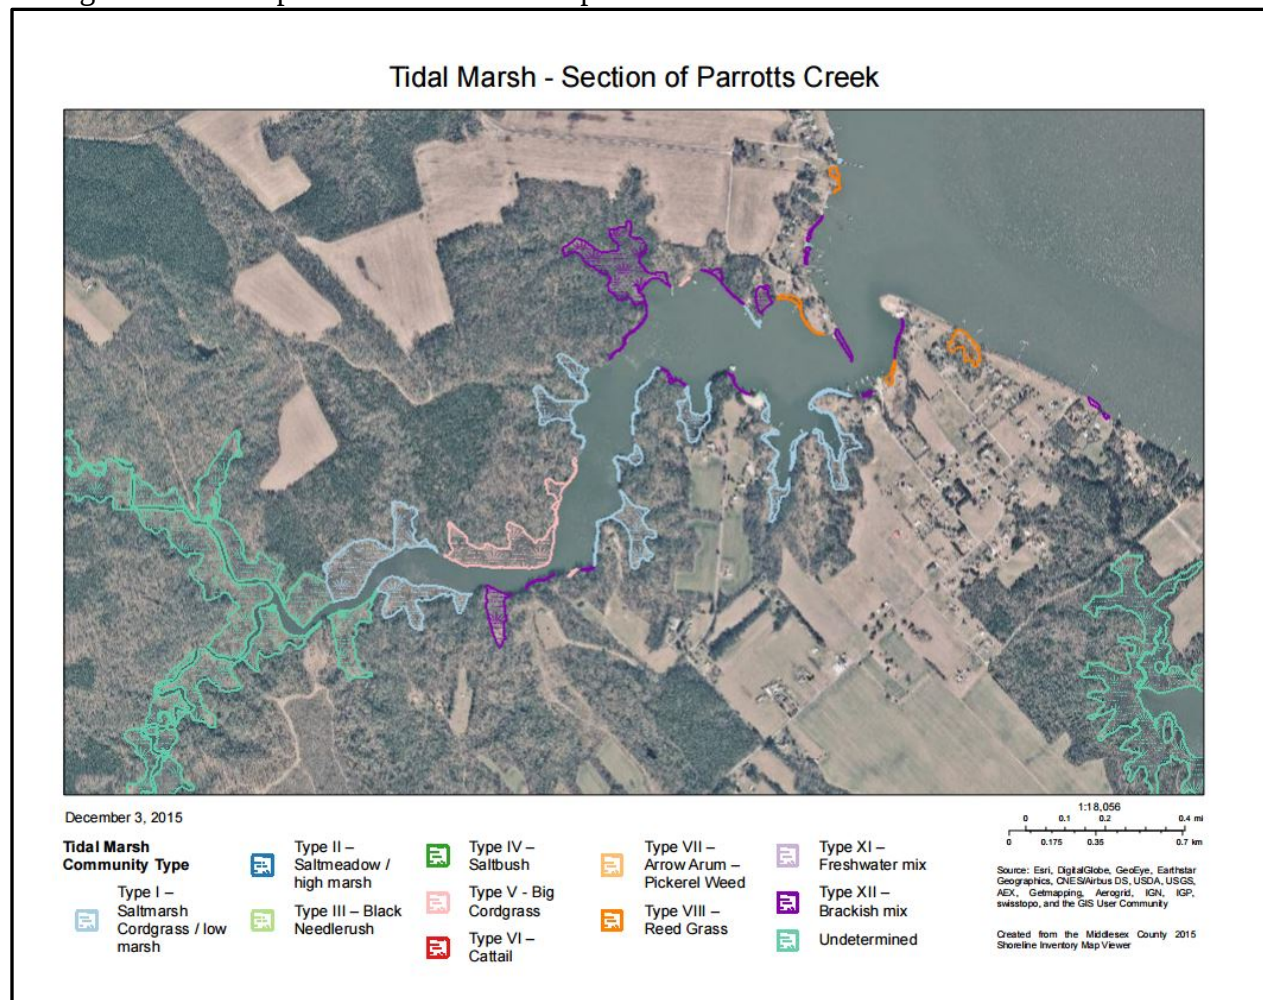
Finally, users have the option to personalize their own maps (i.e. map extent, data displayed, map title, etc.) and save them as a pdf file by clicking “Select Print Layout” button. The page can be set up for printing to 8.5 x 11 portrait or landscape style. Figure 8 is an example of a customized map generated for a section of Parrotts Creek. Here the tidal marsh communities are displayed, and the community type is reported in the legend beside the illustration.

Figure 8. Customized print window for a section of Parrotts Creek
