# Stafford County, Virginia Shoreline Inventory Report Methods and Guidelines

**Comprehensive Coastal Inventory Program  
Center for Coastal Resources Management  
Virginia Institute of Marine Science, College of William and Mary  
Gloucester Point, Virginia  
September 2015**

Special report in Applied Marine Science and Ocean Engineering No. 445 of the Virginia Institute of Marine Science

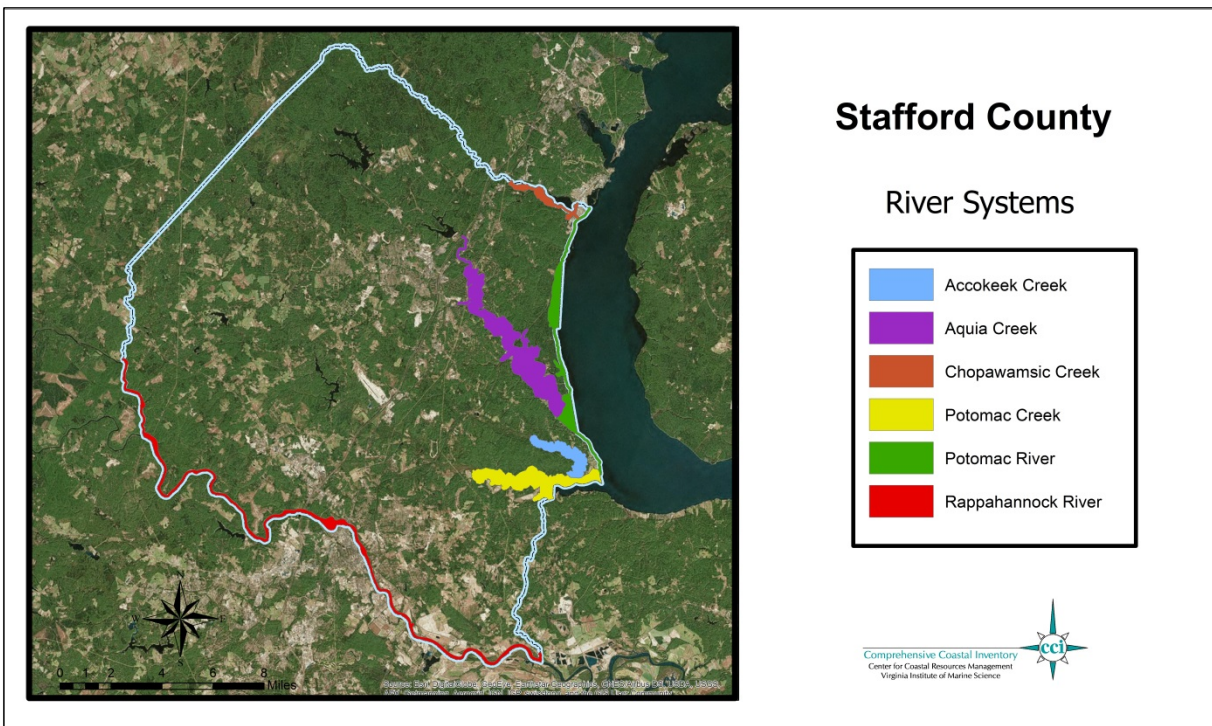
Figure 2. River Systems in Stafford County

Summary tables (Tables 4-7) quantify conditions observed on the basis of river systems (Figure 2). Refer to Figure 2 for the location of these rivers systems. Note, river systems do not correspond to watershed boundaries. They were developed for convenience in reporting data.

The top toolbar also includes tabs to access some important status information for the locality. By clicking on the “River System Pie Charts” button, users can obtain a statistical summary distribution of the riparian land use and amount of hardened shoreline for a specific water body selected from the drop down menu in the upper left (Figure 7). More detailed results in table format can be found by clicking the Stafford County Summary PDF button also in the window. The summary statistics are reported by river systems (Figure 2).

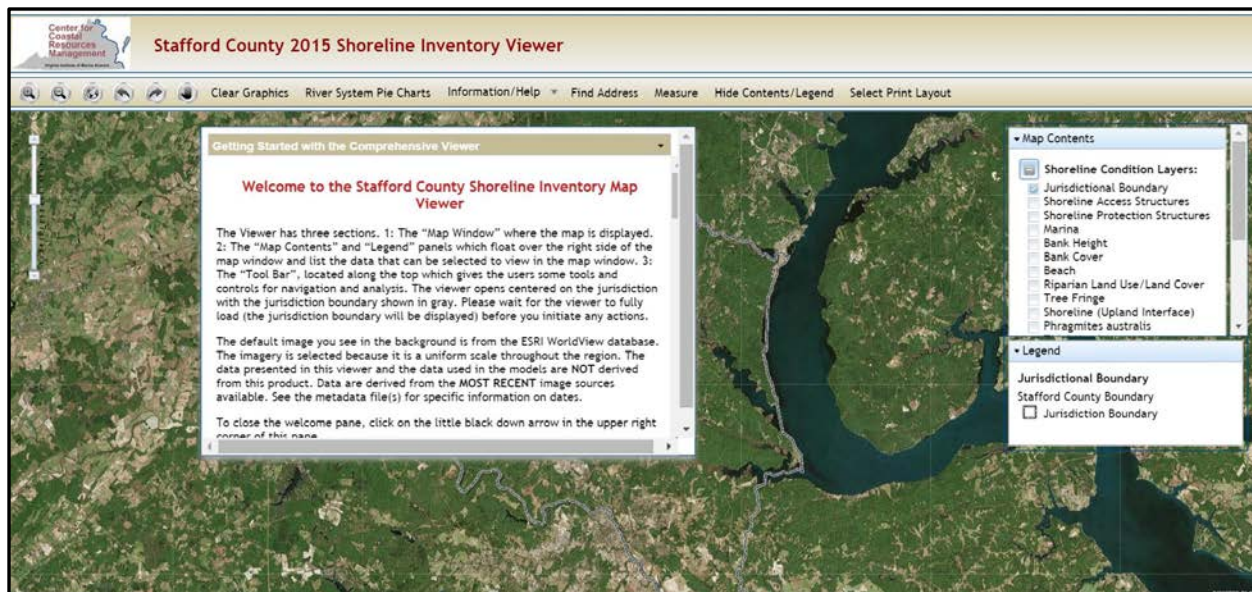
Figure 3. Opening page for the Stafford County Shoreline Inventory Viewer

The Viewer has two panels: “Map Window”, where the map is displayed and “Map Contents and Legend”, where data that can be selected and viewed in the map window are listed. A tool bar is located along the top of the “Map Window” which gives users some controls for navigation and analysis (Figure 3.).

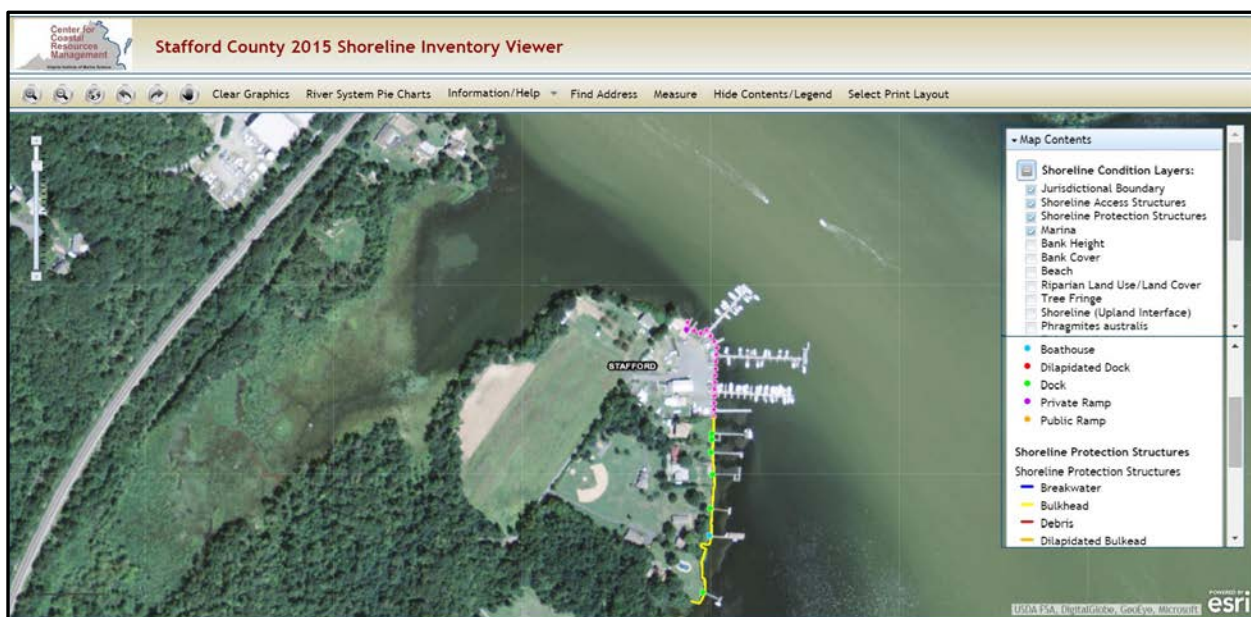
Figure 4. Map Viewer illustrates Shoreline Access and Protection Structures for a section of the County.

In Figure 4 Shoreline Access Structures, and Shoreline Protection structures are selected. Shoreline Access structures are point features that includes piers and boat ramps. The actual footprint of these structures is not measured; only their location. Shoreline Protection Structures are line features and are mapped and illustrated in the viewer to show where they occur along the shoreline. Figure 5 illustrates riparian land use in the riparian zone for the same section of the County.

From the “Map Contents” the user may check various attribute layers on or off. The user must use the scroll bar on the far right to see the complete list of layers available. When layers are turned on, the corresponding legend appears in the “Legend” panel, and the data are displayed in the “Map Window” (Figure 4).

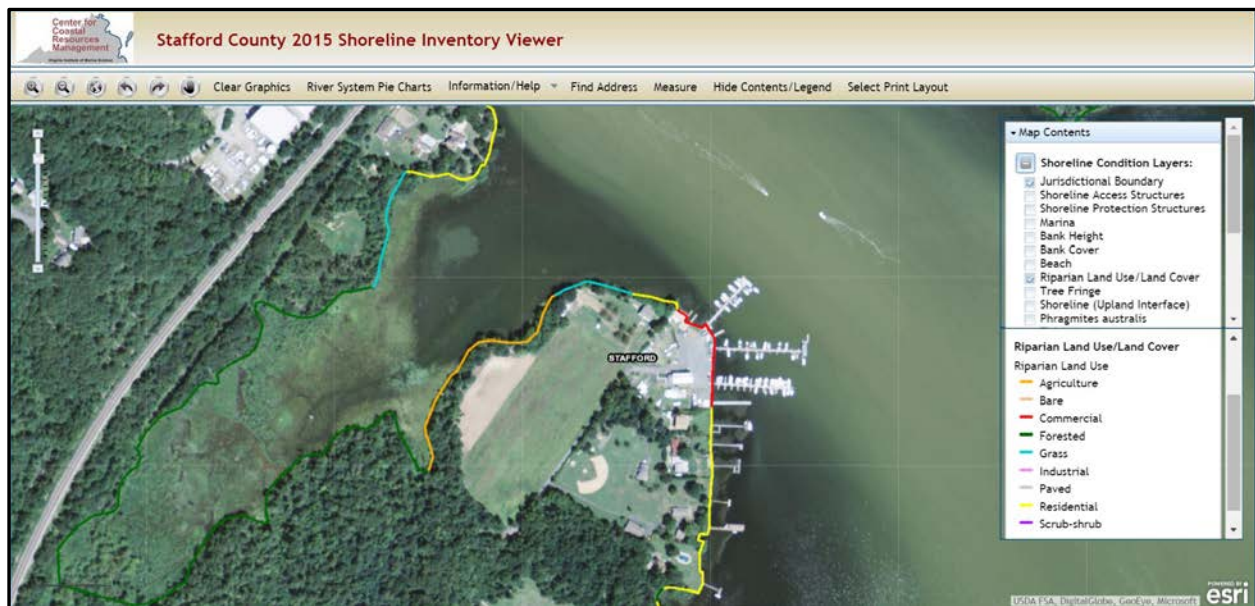
Figure 5. Distribution of land use in the riparian zone is displayed for this region of the County.

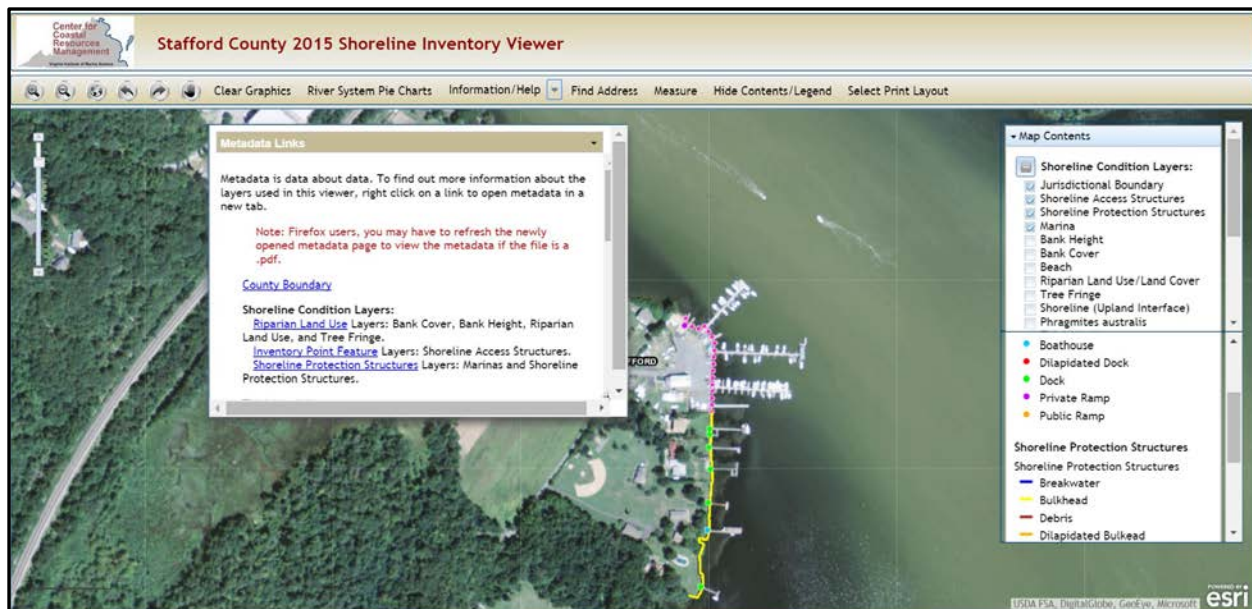
Figure 6. Link to Metadata records has been selected from the top Information tab in the toolbar.

The user can use the zoom and pan tools from the top toolbar or the slide bar on the left side of the map window to change their map extent. If the map resolution is exceeded the window will become illegible. Detailed information can be obtained about the data by selecting the “Information/Help” tab at the top of the map viewer. From here the inventory glossary and metadata records can be easily accessed. In Figure 6 the selection for metadata has been made and 5 possible records can be retrieved.

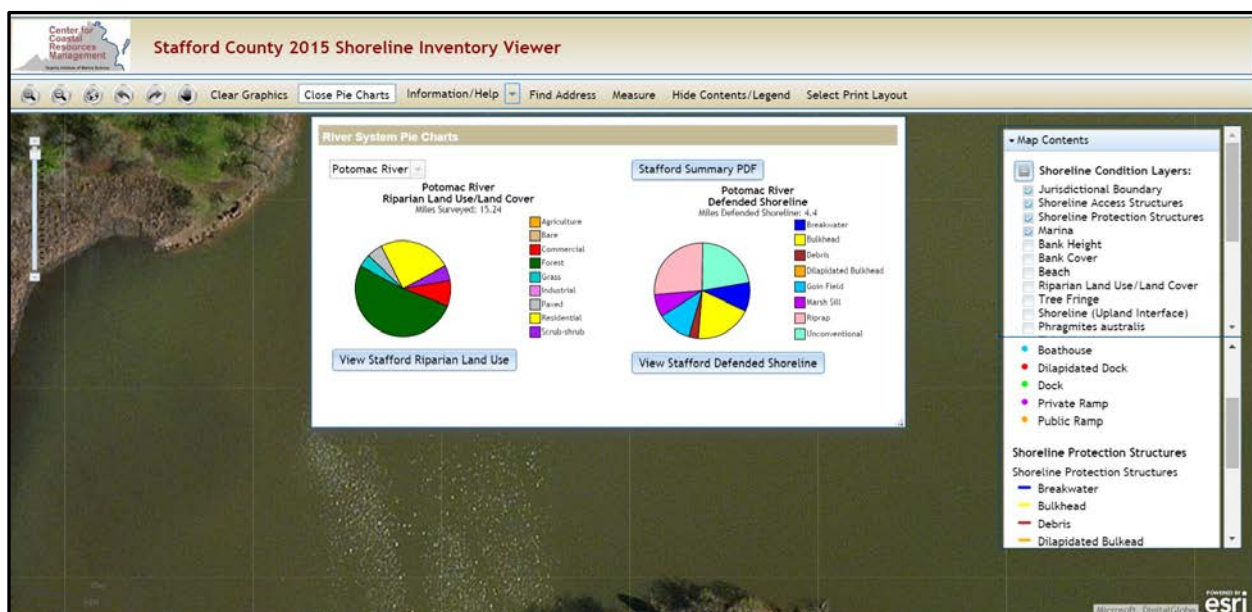
Figure 7. Pie charts display land use and shoreline hardening statistics for each tributary.

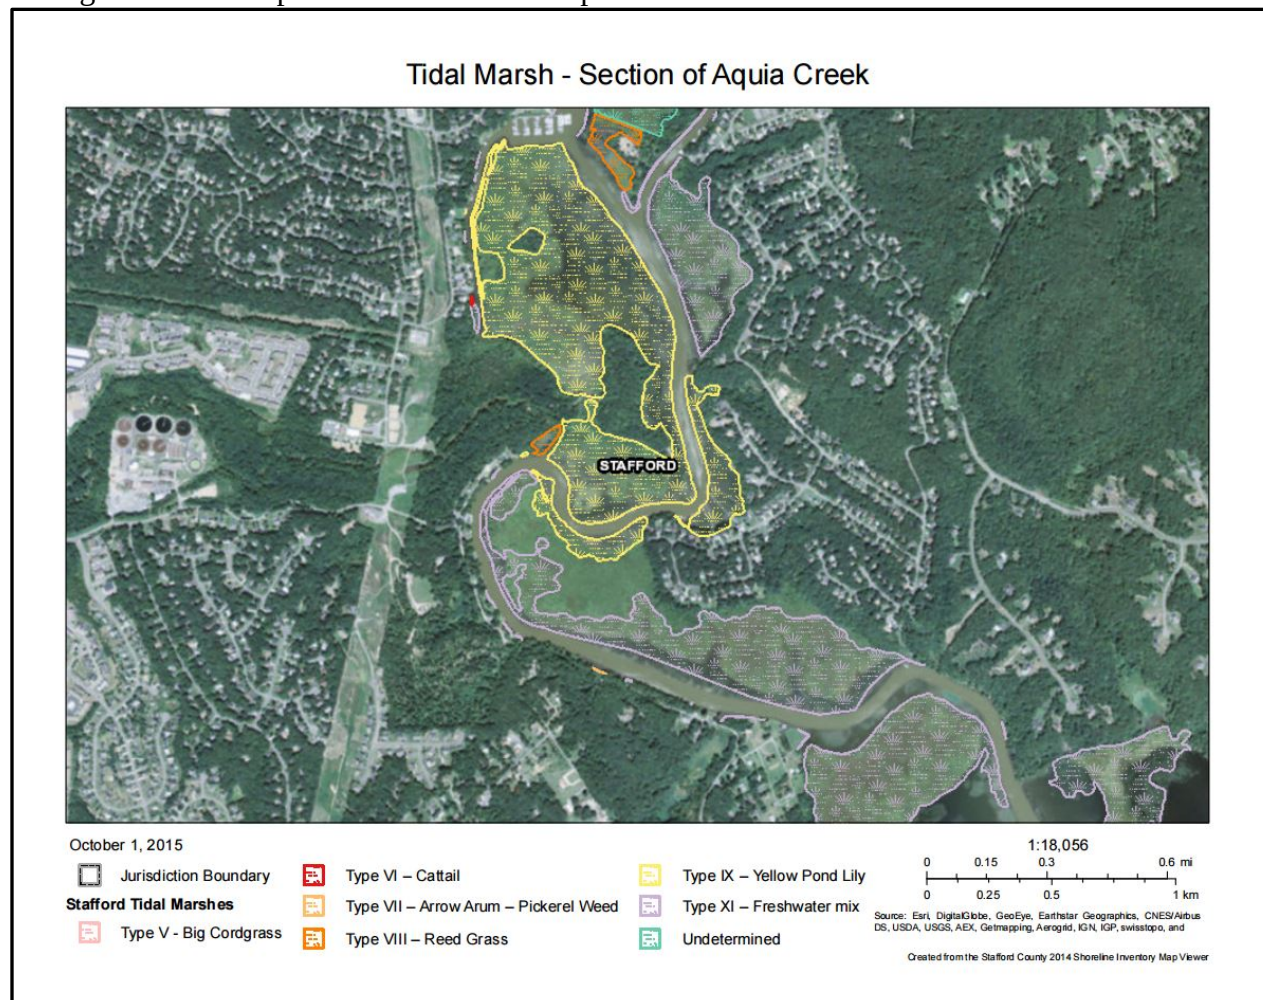
Figure 8. Customized print window for a section of Aquia Creek

Finally, users have the option to personalize their own maps (i.e. map extent, data displayed, map title, etc.) and save them as a pdf file by clicking “Select Print Layout” button. The page can be set up for printing to 8.5 x 11 portrait or landscape style. Figure 8 is an example of a customized map generated for a section of Aquia Creek. Here the tidal marsh communities are displayed, and the community type is reported in the legend beside the illustration.
