# Development of the Maryland Shoreline Inventory Methods and Guidelines for Cecil County

Prepared by the Comprehensive Coastal Inventory Program,  
Center for Coastal Resources Management, Virginia Institute of Marine Science,  
College of William and Mary, Gloucester Point, Virginia.

August, 2006

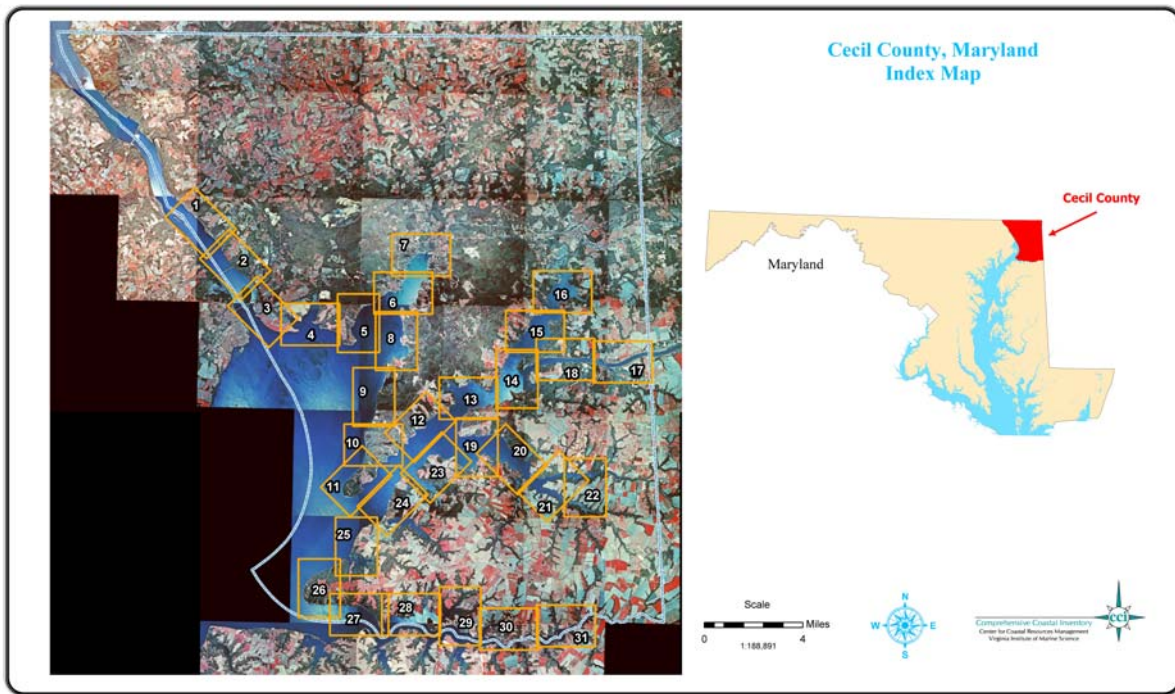
Figure 2. Map index for Cecil County

From the page above, the user will be linked to a project review and disclaimer page where basic project and data use limitations are presented. There are 6 links at the bottom of the disclaimer page. The links are self-explanatory. The link to maps will take you to an index page illustrating the plate boundaries (Figure 2). This is useful if you are interested in a specific area. When you click on “Maps” the county index page will appear. The index illustrates the distribution of plates geographically.
