# Development of the Maryland Shoreline Inventory Methods and Guidelines for Charles County

Prepared by the Comprehensive Coastal Inventory Program,  
Center for Coastal Resources Management, Virginia Institute of Marine Science,  
College of William and Mary, Gloucester Point, Virginia.

August, 2006

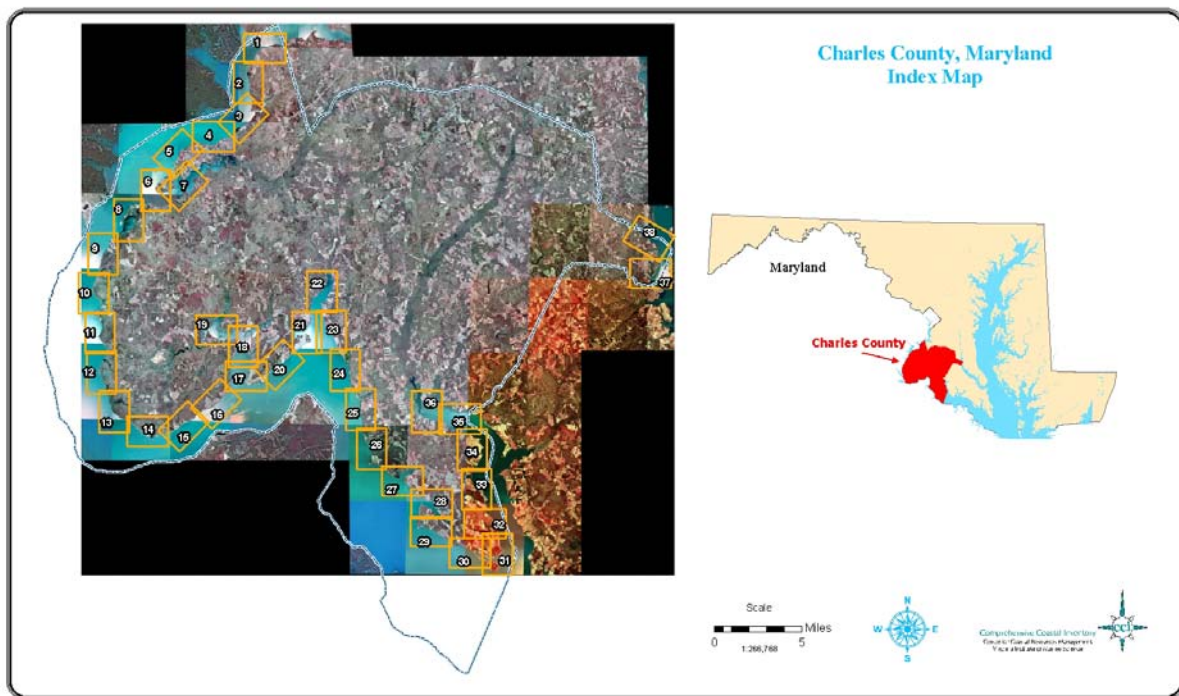
Figure 2. Map index for Charles County

From the page above, the user will be linked to a project review and disclaimer page where basic project and data use limitations are presented. There are 6 links at the bottom of the disclaimer page. The links are self-explanatory. The link to maps will take you to an index page illustrating the plate boundaries (Figure 2). This is useful if you are interested in a specific area. When you click on “Maps” the county index page will appear. The index illustrates the distribution of plates geographically.

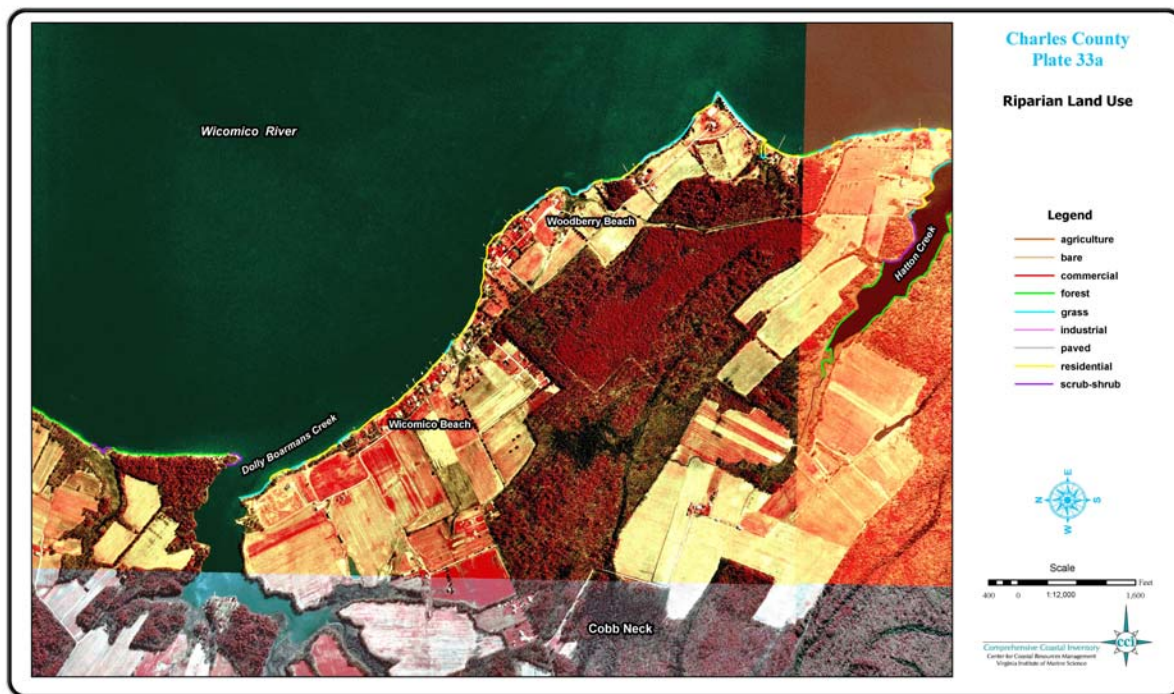
Figure 4. Riparian Land Use map for plate 33 in Charles County

Once you determine which plate you want, the scroll down menu on the left has links to the three part series for each plate. Riparian Land Use is first (Figure 3). You can scroll down to see the link to Bank and Buffer conditions and Shoreline Features. The content and details of the three part plate series was described in detail in Chapter 2. The actual map will come up when you click on the plate number. For example, Figure 4 is the riparian land use map for plate 33. Figure 5 is the map illustrating Bank and Buffer conditions for plate 33, and Figure 6 shows all the shoreline features for that same area. You may open all three plates for the series, but can view only one at a time in most browsers. Tools for zooming and panning should be on the tool bar. The maps can be printed at full resolution up to 11x17 color. Color printers are necessary. Summary statistics for all data are reported in tables (see link on the project disclaimer page).

Data collected for the SSR can assist with targeting efforts for designating AOCs. AOCs can be areas where riparian buffers are fragmented, and could be restored. Use Plate A to identify forested upland. Breaks in the continuity of the riparian forest can be easily observed in the line segments, and background image. Land use between the breaks relates to potential opportunity for restoring the buffer where fragmentation has occurred. Agricultural tracts which breach forest buffers are more logical targets for restoration than developed residential or commercial stretches. Agricultural areas, therefore, offer the highest opportunity for conversion. Priority sites for riparian forest restoration should target forested tracts breached by “agriculture” or “grass” land.

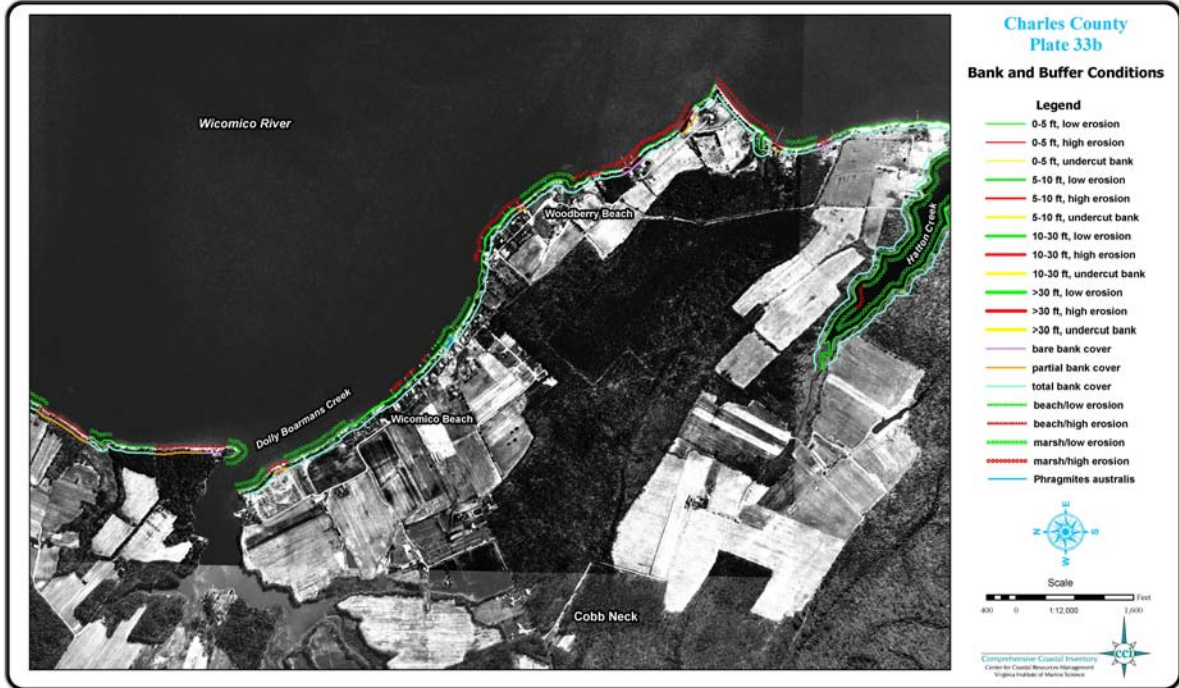
Figure 5. Map illustrating bank and buffer conditions for plate 33 in Charles County

Plate B illustrates bank condition and any natural buffers present. Four lines, and a combination of color and patterns are used to depict bank and natural buffer information. The line furthest inland describes the bank cover. Bank cover is distinguished by colors. Bare banks (<25% cover) are illustrated in pink, partial cover (25-75%) is an orange line, and total cover (>75%) is indicated by a light blue line. Colors may vary with different printers. Moving toward the water, the next line represents bank height and stability. Bank height varies with the thickness of the line; where the thickest lines designate the highest banks (> 30 feet), and the thinnest line indicates the bank is between 0 and 5 feet high. A red line indicates the bank is unstable, a green line indicates stability, and a yellow line indicates the bank is undercut. If present a darker blue line will delineate the occurrence of *Phragmites australis*. A pattern of small circles just channel ward of the shoreline delineates the presence of natural buffers. Open

circles represent a natural fringe marsh along the base of the bank. Solid circles indicate a sand beach buffer at the base of the bank. It is possible to have both. If the buffer exhibits erosion the circles will be red, and green if the buffer is stable. As conditions change, the symbology changes. Plate B uses a gray scale version of the DOQQ image for the backdrop.

Plate “b” can be used to identify sites for BMPs. Look for where eroding bank conditions persist. The thickness of the line tells something about the bank height. The fetch, or the distance of exposure across the water, can offer some insight into the type of BMP that might be most appropriate. Marsh planting may be difficult to establish at the toe of a bank with high exposure to wave conditions. Look for other marsh fringe in the vicinity as an indicator. Plate “c” should be checked for existing shoreline erosion structures in place.

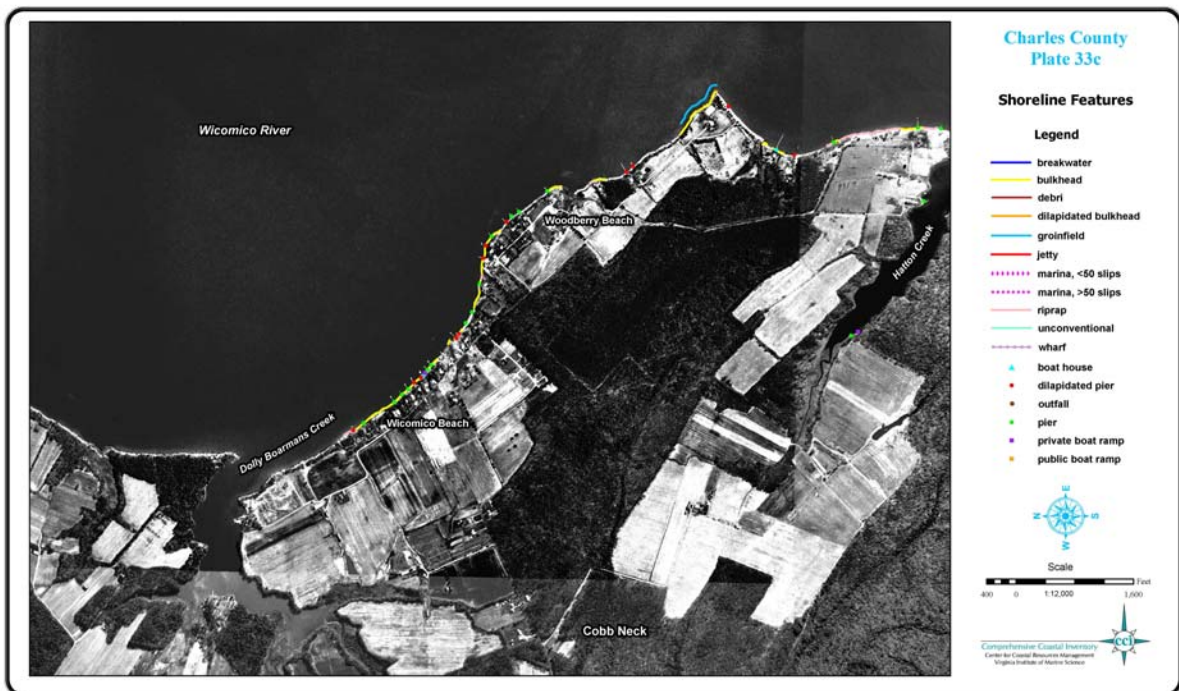
Figure 6. Map illustrating shoreline features for plate 33 in Charles County

**Boat Ramp** - Boat ramps provide vessels access to the waterway. They are usually constructed of concrete, but wood and gravel ramps are also found. Point identification of boat ramps does not discriminate based on type, size, material, or quality of the launch. Access at these sites is not guaranteed, as many may be located on private property. The location of these ramps was determined from static ten second GPS observations. Ramps are illustrated as purple squares on the maps.
