# Development of the Maryland Shoreline Inventory Methods and Guidelines for Queen Anne's County

Prepared by the Comprehensive Coastal Inventory Program,  
Center for Coastal Resources Management, Virginia Institute of Marine Science,  
College of William and Mary, Gloucester Point, Virginia.

August, 2006

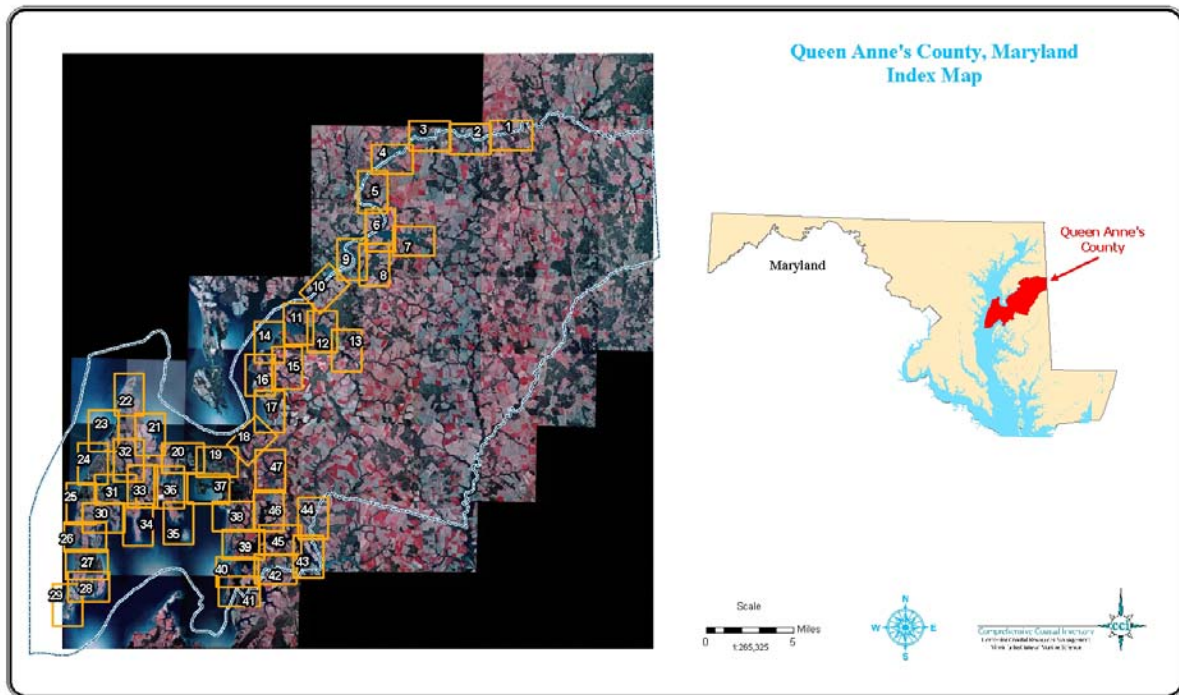
Figure 2. Map index for Queen Anne's County

From the page above, the user will be linked to a project review and disclaimer page where basic project and data use limitations are presented. There are 6 links at the bottom of the disclaimer page. The links are self-explanatory. The link to maps will take you to an index page illustrating the plate boundaries (Figure 2). This is useful if you are interested in a specific area. When you click on "Maps" the county index page will appear. The index illustrates the distribution of plates geographically.

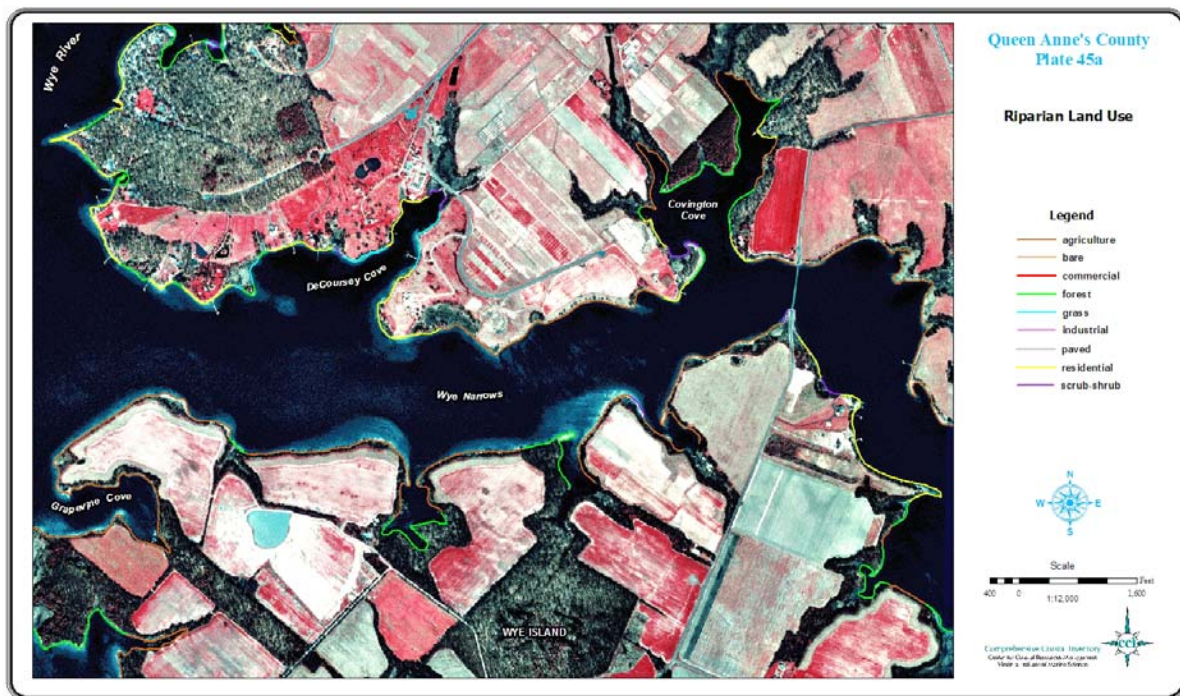
Figure 4. Riparian Land Use map for plate 45 in Queen Anne's County

Once you determine which plate you want, the scroll down menu on the left has links to the three part series for each plate. Riparian Land Use is first (Figure 3). You can scroll down to see the link to Bank and Buffer conditions and Shoreline Features. The content and details of the three part plate series was described in detail in Chapter 2. The actual map will come up when you click on the plate number. For example, Figure 4 is the riparian land use map for plate 45. Figure 5 is the map illustrating Bank and Buffer conditions for plate 45, and Figure 6 shows all the shoreline features for that same area. You may open all three plates for the series, but can view only one at a time in most browsers. Tools for zooming and panning should be on the tool bar. The maps can be printed at full resolution up to 11x17 color. Color printers are necessary. Summary statistics for all data are reported in tables (see link on the project disclaimer page).

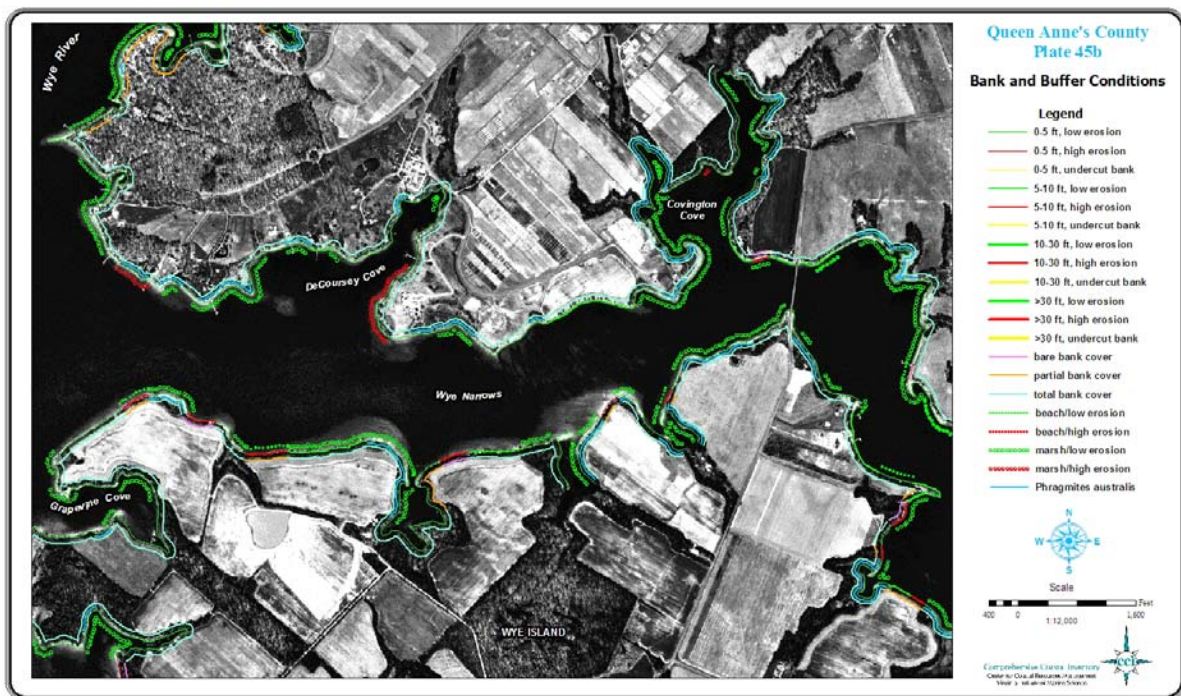
Figure 5. Map illustrating bank and buffer conditions for plate 45 in Queen Anne's County

Plate B illustrates bank condition and any natural buffers present. Four lines, and a combination of color and patterns are used to depict bank and natural buffer information. The line furthest inland describes the bank cover. Bank cover is distinguished by colors. Bare banks (<25% cover) are illustrated in pink, partial cover (25-75%) is an orange line, and total cover (>75%) is indicated by a light blue line. Colors may vary with different printers. Moving toward the water, the next line represents bank height and stability. Bank height varies with the thickness of the line; where the thickest lines designate the highest banks (> 30 feet), and the thinnest line indicates the bank is between 0 and 5 feet high. A red line indicates the bank is unstable, a green line indicates stability, and a yellow line indicates the bank is undercut. If present a darker blue line will delineate the occurrence of *Phragmites australis*. A pattern of small circles just channel ward of the shoreline delineates the presence of natural buffers. Open circles represent a natural fringe marsh along the base of the bank. Solid circles indicate a sand beach buffer at the base of the bank. It is possible to have both. If the buffer exhibits erosion the circles will be red, and green if the buffer is stable. As conditions change, the symbology changes. Plate B uses a gray scale version of the DOQQ image for the backdrop.

Plate “b” can be used to identify sites for BMPs. Look for where eroding bank conditions persist. The thickness of the line tells something about the bank height. The fetch, or the distance of exposure across the water, can offer some insight into the type of BMP that might be most appropriate. Marsh planting may be difficult to establish at the toe of a bank with high exposure to wave conditions. Look for other marsh fringe in the vicinity as an indicator. Plate “c” should be checked for existing shoreline erosion structures in place.

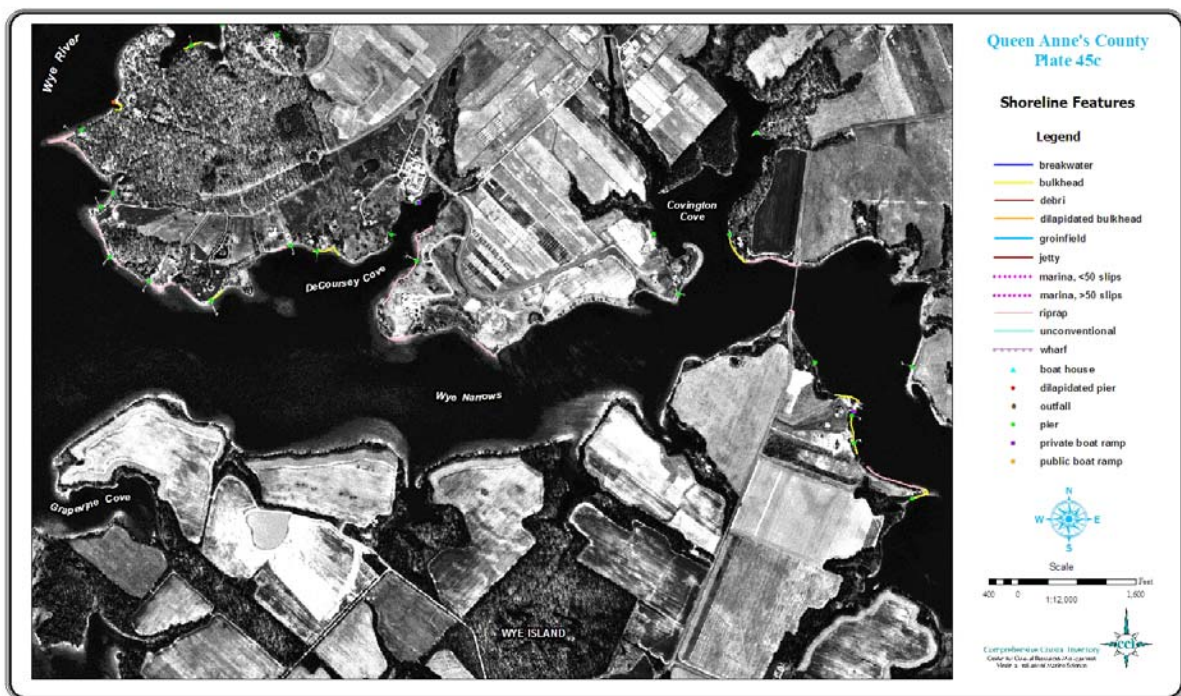
Figure 6. Map illustrating shoreline features for plate 45 in Queen Anne's County

colors and symbols to plot the positions on the map. Grey scale DOQQ imagery is used as a backdrop, and all shoreline feature data are superimposed.
