# Development of the Maryland Shoreline Inventory Methods and Guidelines for Worcester County

Prepared by the Comprehensive Coastal Inventory Program,  
Center for Coastal Resources Management, Virginia Institute of Marine Science,  
College of William and Mary, Gloucester Point, Virginia.

August, 2006

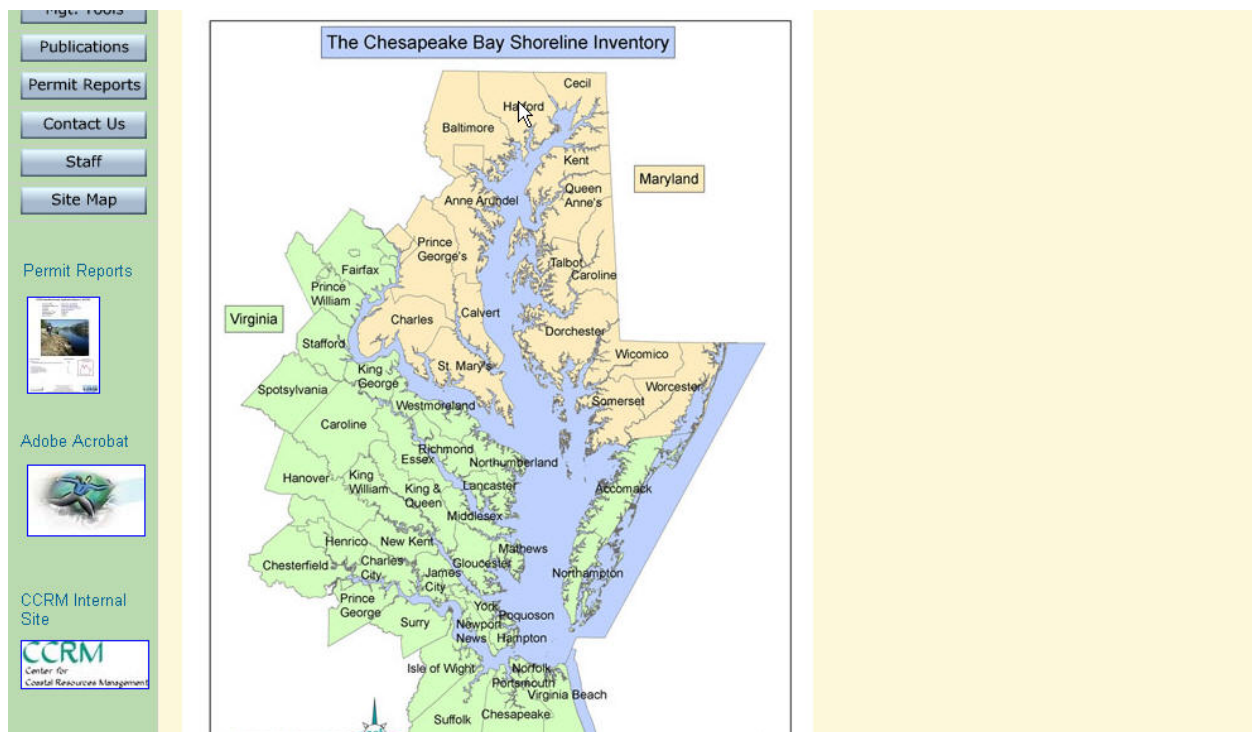
Figure 1. Shoreline (Inventory) Situation Report Website

From the page above, the user will be linked to a project review and disclaimer page where basic project and data use limitations are presented. There are 6 links at the bottom of the disclaimer page. The links are self-explanatory. The link to maps will take you to an index page illustrating the plate boundaries (Figure 2). This is useful if you are interested in a specific area.

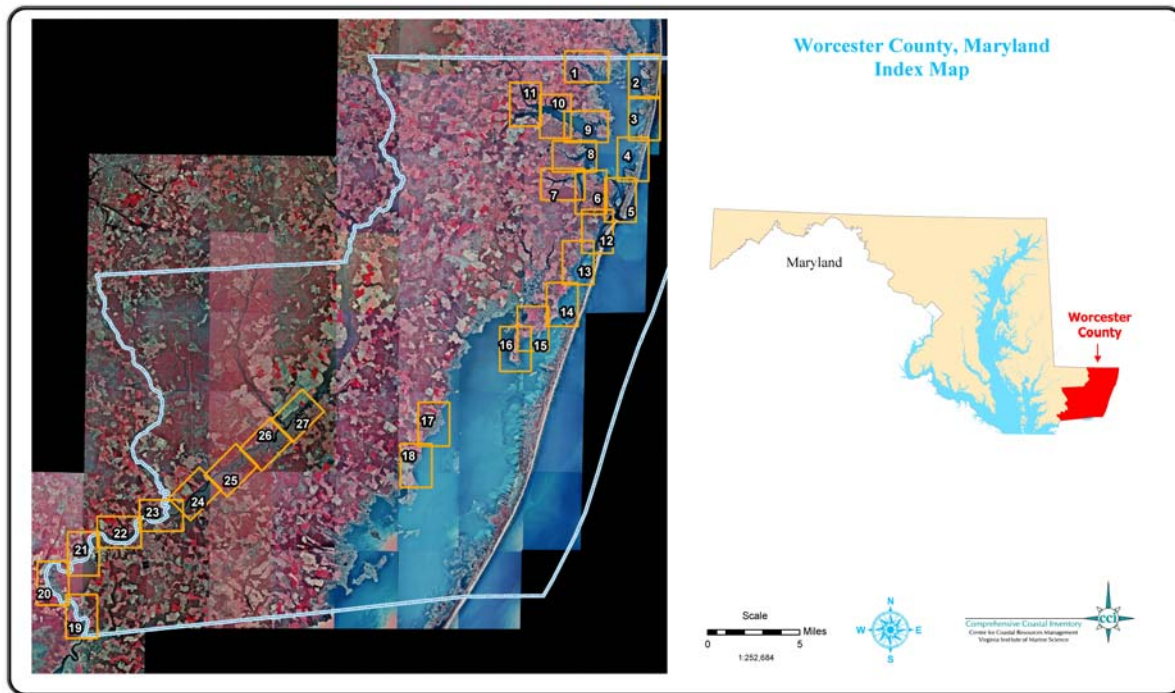
Figure 2. Map index for Worcester County

When you click on “Maps” the county index page will appear. The index illustrates the distribution of plates geographically.

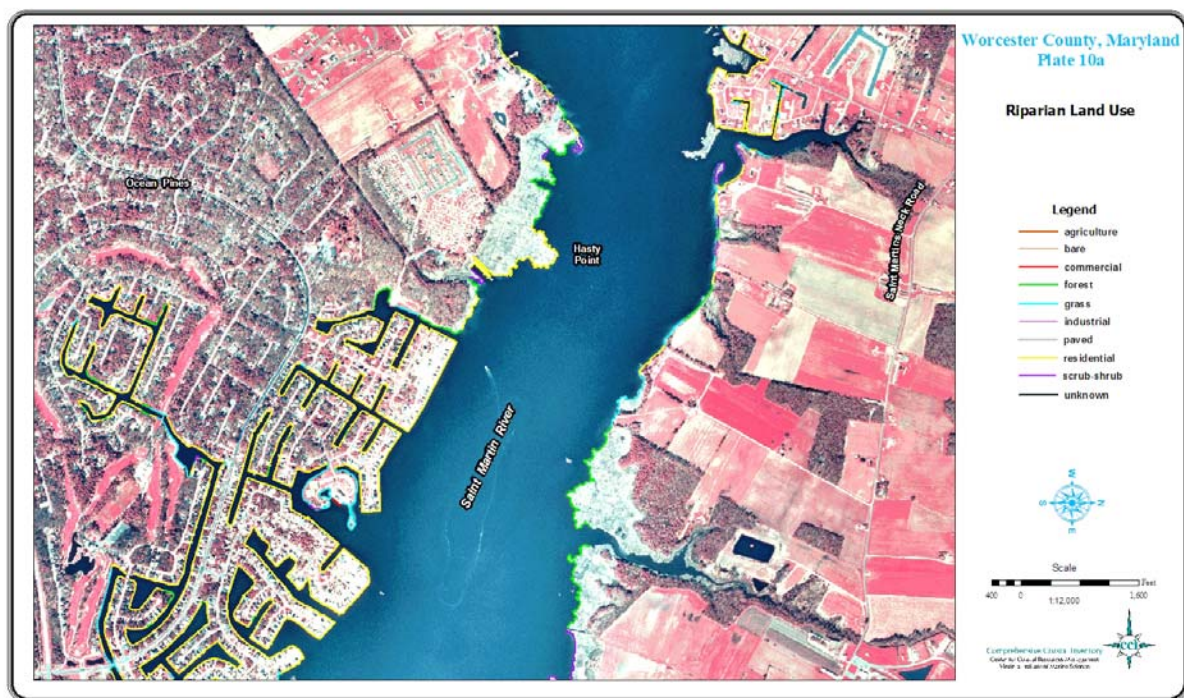
Figure 4. Riparian Land Use map for plate 10 in Worcester County

Once you determine which plate you want, the scroll down menu on the left has links to the three part series for each plate. Riparian Land Use is first (Figure 3). You can scroll down to see the link to Bank and Buffer conditions and Shoreline Features. The content and details of the three part plate series was described in detail in Chapter 2. The actual map will come up when you click on the plate number. For example, Figure 4 is the riparian land use map for plate 10. Figure 5 is the map illustrating Bank and Buffer conditions for plate 10, and Figure 6 shows all the shoreline features for that same area. You may open all three plates for the series, but can view only one at a time in most browsers. Tools for zooming and panning should be on the tool bar. The maps can be printed at full resolution up to 11x17 color. Color printers are necessary. Summary statistics for all data are reported in tables (see link on the project disclaimer page).

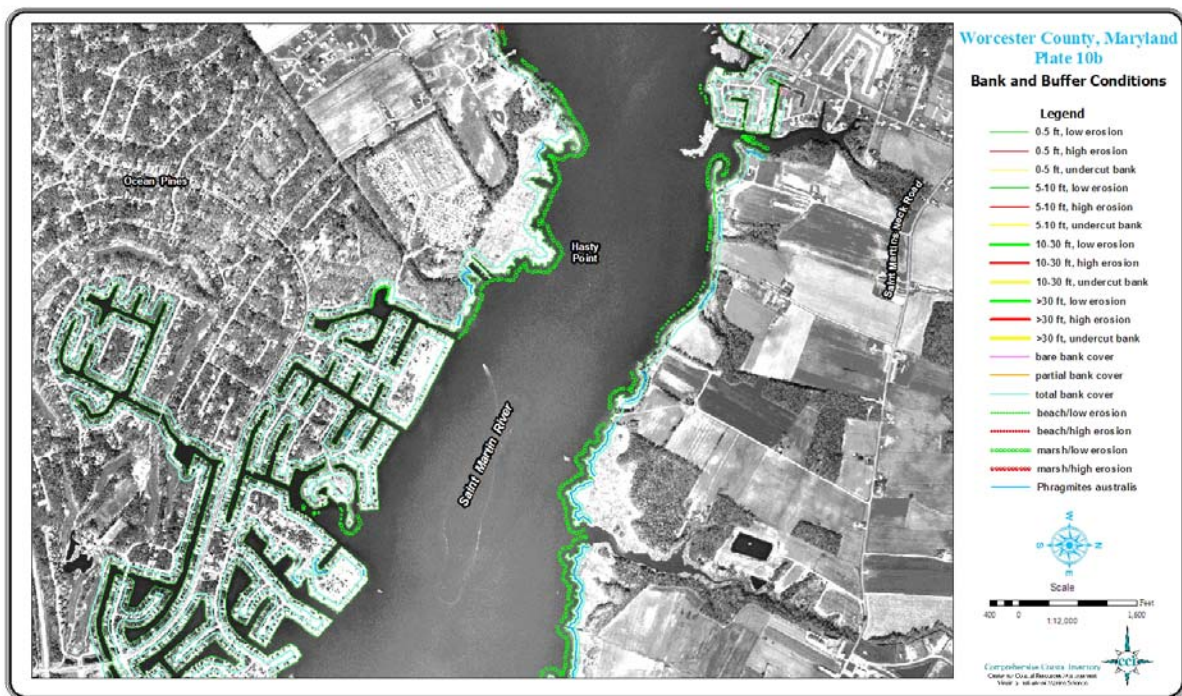
Figure 5. Map illustrating bank and buffer conditions for plate 10 in Worchester County

Plate B illustrates bank condition and any natural buffers present. Four lines, and a combination of color and patterns are used to depict bank and natural buffer information. The line furthest inland describes the bank cover. Bank cover is distinguished by colors. Bare banks (<25% cover) are illustrated in pink, partial cover (25-75%) is an orange line, and total cover (>75%) is indicated by a light blue line. Colors may vary with different printers. Moving toward the water, the next line represents bank height and stability. Bank height varies with the thickness of the line; where the thickest lines designate the highest banks (> 30 feet), and the thinnest line indicates the bank is between 0 and 5 feet high. A red line indicates the bank is unstable, a green line indicates stability, and a yellow line indicates the bank is undercut. If present a darker blue line will delineate the occurrence of *Phragmites australis*. A pattern of

small circles just channel ward of the shoreline delineates the presence of natural buffers. Open circles represent a natural fringe marsh along the base of the bank. Solid circles indicate a sand beach buffer at the base of the bank. It is possible to have both. If the buffer exhibits erosion the circles will be red, and green if the buffer is stable. As conditions change, the symbology changes. Plate B uses a gray scale version of the DOQQ image for the backdrop.

Plate “b” can be used to identify sites for BMPs. Look for where eroding bank conditions persist. The thickness of the line tells something about the bank height. The fetch, or the distance of exposure across the water, can offer some insight into the type of BMP that might be most appropriate. Marsh planting may be difficult to establish at the toe of a bank with high exposure to wave conditions. Look for other marsh fringe in the vicinity as an indicator. Plate “c” should be checked for existing shoreline erosion structures in place.
